LIMITED OCCURRENCE INVESTIGATION REPORT – FINAL

| Reference Number | CA18/2/3/10214 | | | | | | |
| Registration | ZS-SPT | | | | | | |
| Make; Model; S/N | Piper PA-28-140 Cherokee, Serial Number: 28-7725021 | | | | | | |

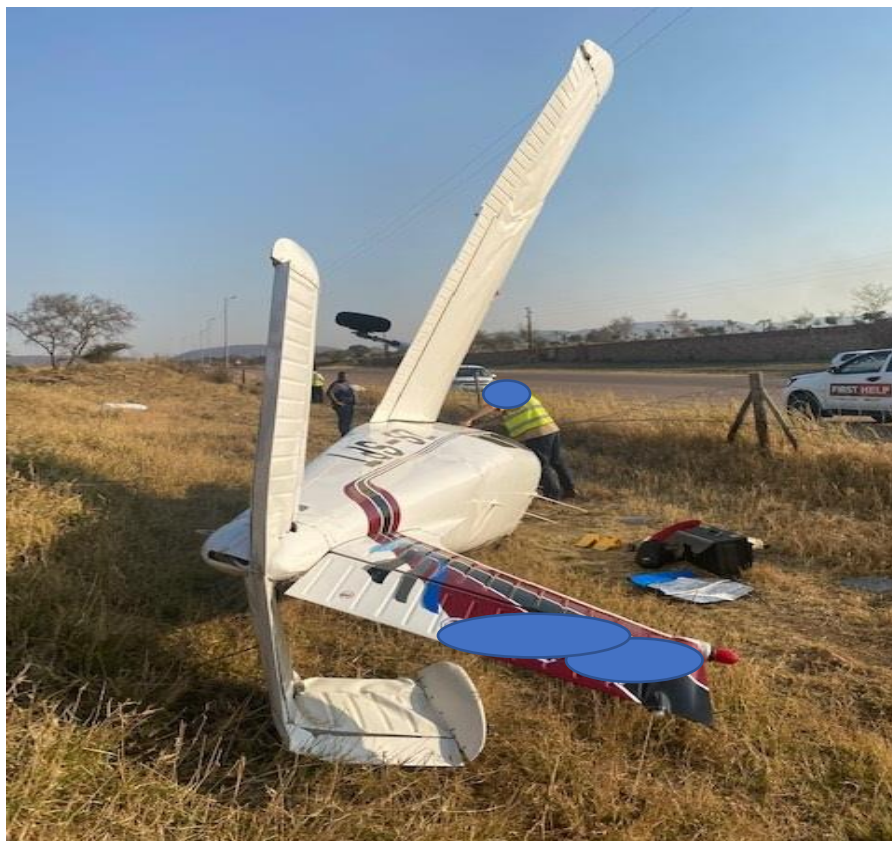
Figure 2: The aircraft at the accident site with the flaps in a retracted position.

Examination of the wreckage was conducted by the engineers and the investigator-in-charge (IIC). None of the circuit breakers (CBs) had tripped; the front seats remained secured to their rails. The Emergency Locator Transmitter (ELT) was found transmitting an emergency signal at the accident site. The aircraft's flap operating lever, located on the floor between the front seats was found in its lowest detent, indicating that the flaps were in a retracted position at impact (Figure 2).

Continuity check of the flying controls indicated that they were connected and functioning correctly. The tail and the fuselage area behind the cockpit were intact, with impact damage on the right horizontal stabiliser (Figure 2). The propeller blades were slightly bent rearward but did not have any leading edge or tip damage. The spinner had a big dent from impact but there were no radial score marks, this indicated that the propeller was rotating under power when it struck an obstacle during the accident sequence.

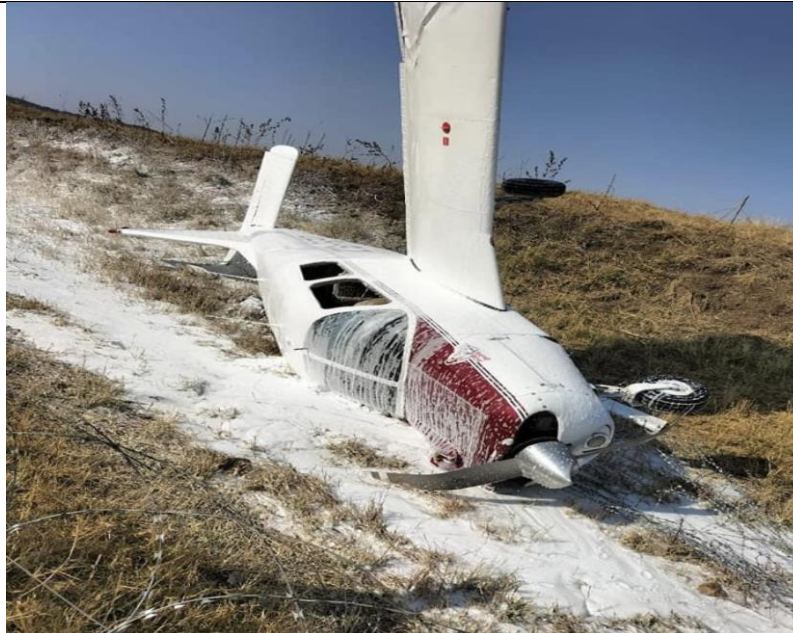
Figure 3: The aircraft covered in foam.

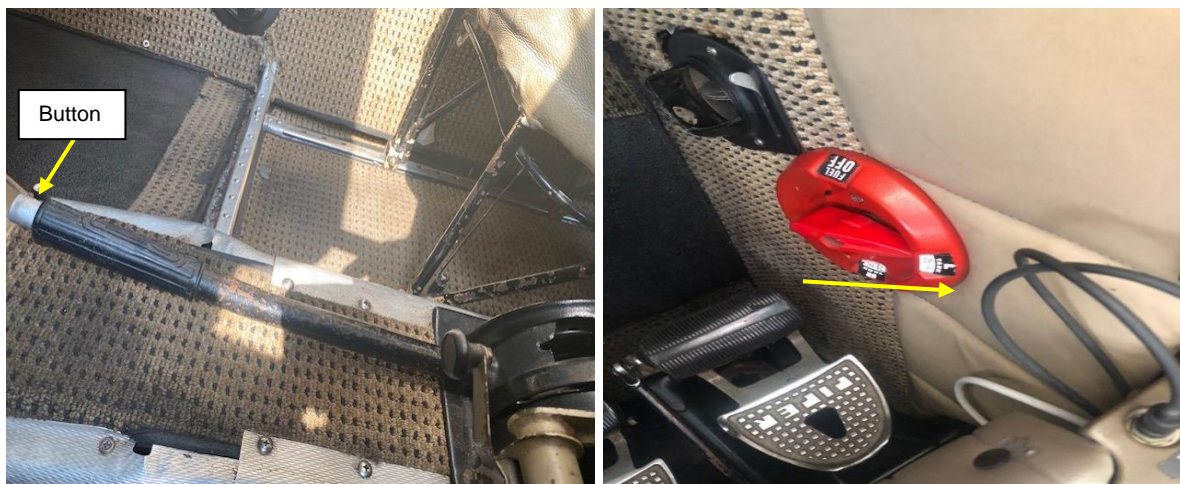
Figures 4 and 5: Flap operating lever in its lowest detent (left picture). The fuel selector valve set to the left tank.

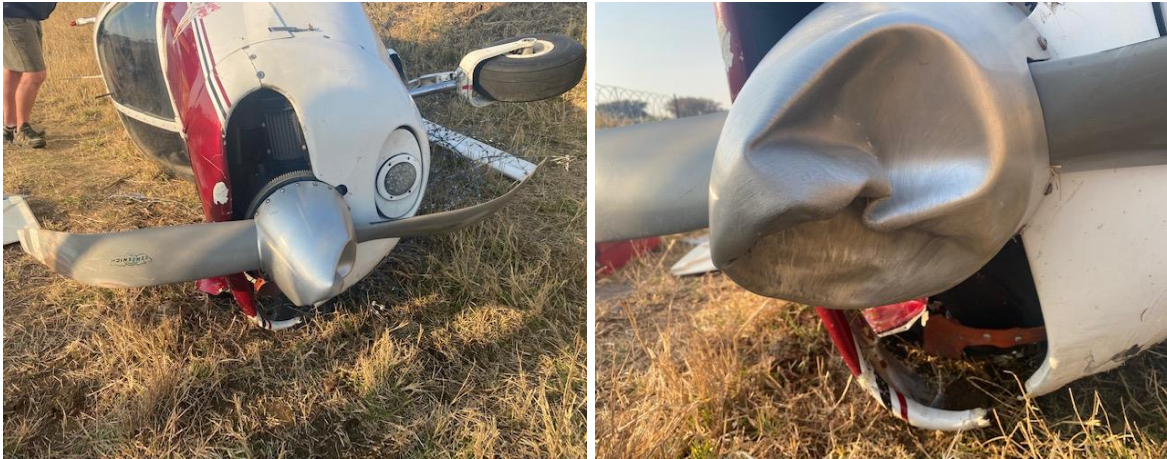
Figures 6 and 7: The propeller as found at the accident site (left picture). The dented spinner (right picture).

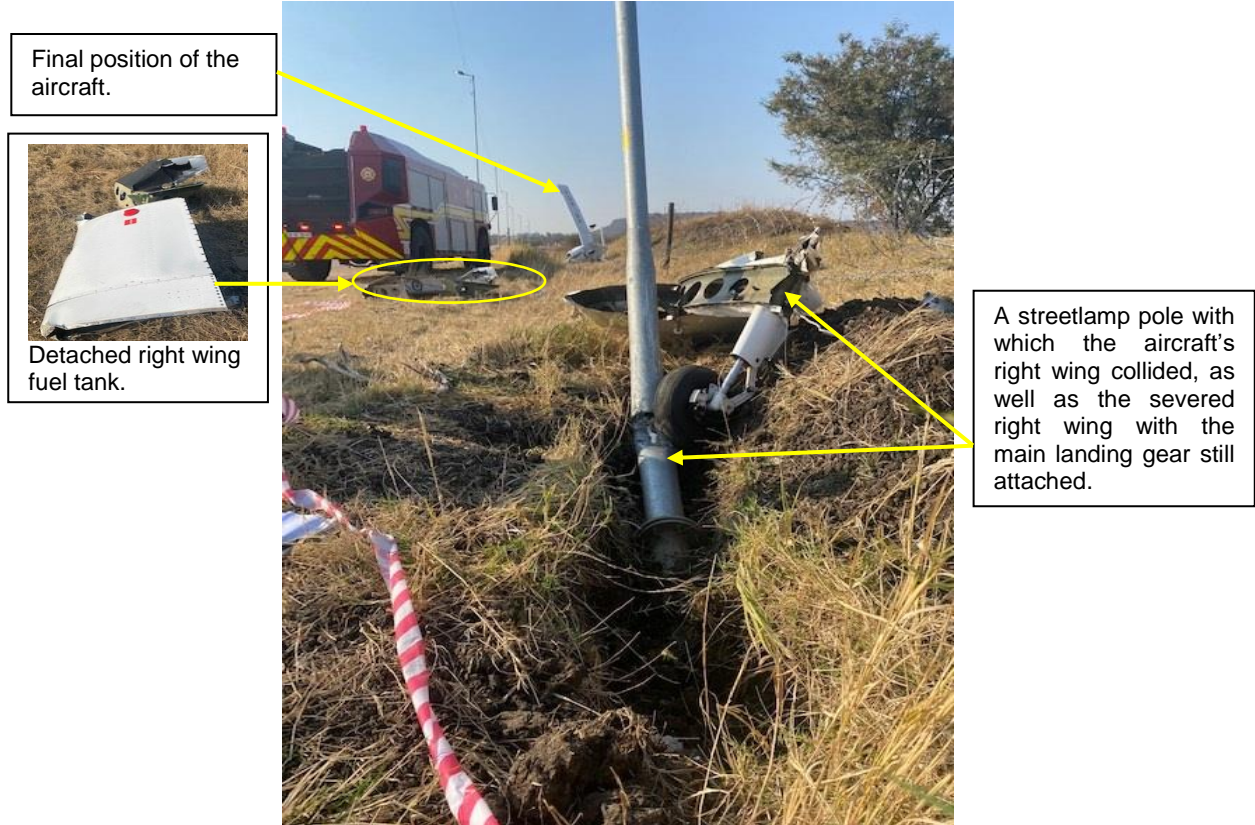
Upon arrival at the accident site, the aircraft was found resting on its right-side fuselage with the left wing up and facing the direction at which it (the aircraft) had approached (south). The right wing and main landing gear had separated from the fuselage after impacting a streetlamp pole during the accident sequence. The right fuel tank had also separated from the wing structure. The right tank fuel cap was found in place and the tank contained fuel that was free of contaminants. The fuel tanks, vents and filters were inspected, and no foreign objects or obstructions were found. The fuel selector valve handle was set to the left tank. The left tank was damaged, however, there was sufficient fuel remaining for analysis. The throttle and mixture control levers were found in a closed position and the carburettor heat selector was selected to cold position. The throttle and the mixture control cables were appropriately connected to their respective control levers and were responsive. Fuel samples were taken from the left fuel tank and were analysed for the correct grade and the presence of contaminants, and no anomalies were found.

Figure 8: The wreckage layout at the accident site.
