LIMITED OCCURRENCE INVESTIGATION REPORT – FINAL

Reference Number	CA18/2/3/10215						
Classification	Accident	Date	31 August 2022			Time	1007Z
Type of Operation	Training Part 141						
Location							
Place of Departure	Morning Star Aerodrome, Western Cape Province			Place of Intended Landing	Morning Star Aerodrome, Western Cape Province		
Place of Occurrence	On Runway 19, Cape Town International Airport, Western Cape Province						
GPS Co-ordinates	Latitude	33° 58' 2.47" S	Longitude	018° 36' 9.57" E	Elevation	145ft	
Aircraft Information							
Registration	ZU-FTF						
Make; Model; S/N	Sling 2 (Serial Number: 071)						
Damage to Aircraft	Substantial			Total Aircraft Hours	4 313.43		
Pilot-in-command							
Licence Type	Student Pilot Licence (SPL)		Gender	Female		Age	27
Licence Valid	Yes	Total Hours	48.3		Total Hours on Type	48.3	
Total Hours 30 Days	13.5		Total Flying on Type Past 90 Days	47.3			
People On-board	1+0	Injuries	0	Fatalities	0	Other (on ground)	0

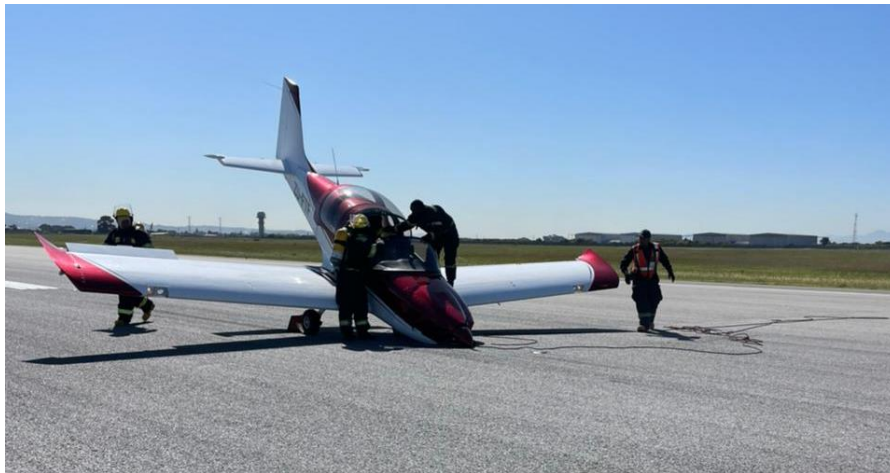
Figure 1: The final position of the ZU-FTF aircraft. (Source: ATO)

- 1.7 During the flight, the student pilot became disorientated about her position and, with the assistance of FACT FIS, she was eventually redirected to FACT. In an interview post-accident, the student pilot stated that she flared the aircraft too high, and it landed hard and bounced. This caused the nose wheel to bend, followed by the propeller blades which struck the runway and, hence, broke off. The aircraft came to a stop on the runway.

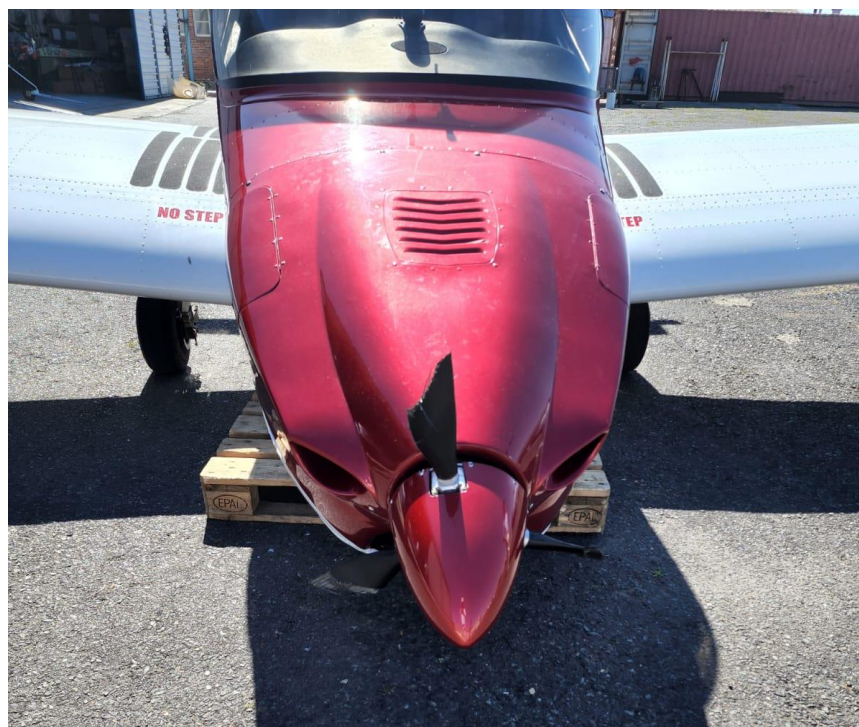
Figure 2: The broken propeller blades. (Source: ATO)

Probable Cause
The aircraft was flared too high during approach for landing and, on touch down, it landed hard and bounced. During the second landing, the nose wheel contacted the ground hard and the nose gear strut bent backward; whilst the propeller blades broke off after striking the runway surface.
Contributing Factor
Limited experience.
Safety Actions
<ul style="list-style-type: none"> • Following the accident, the ATO took the following corrective actions: <ul style="list-style-type: none"> ➤ The student pilot and the instructor completed a training session in circuit and landing operations the next day following the accident to equip them with airmanship and navigational techniques, and to restore their confidence. ➤ The instructor was sent on a crew resource management (CRM) course for additional training on assessment skills and human behavioural skills observation during training. The instructor and the student pilot were offered peer support with Mayday SA.

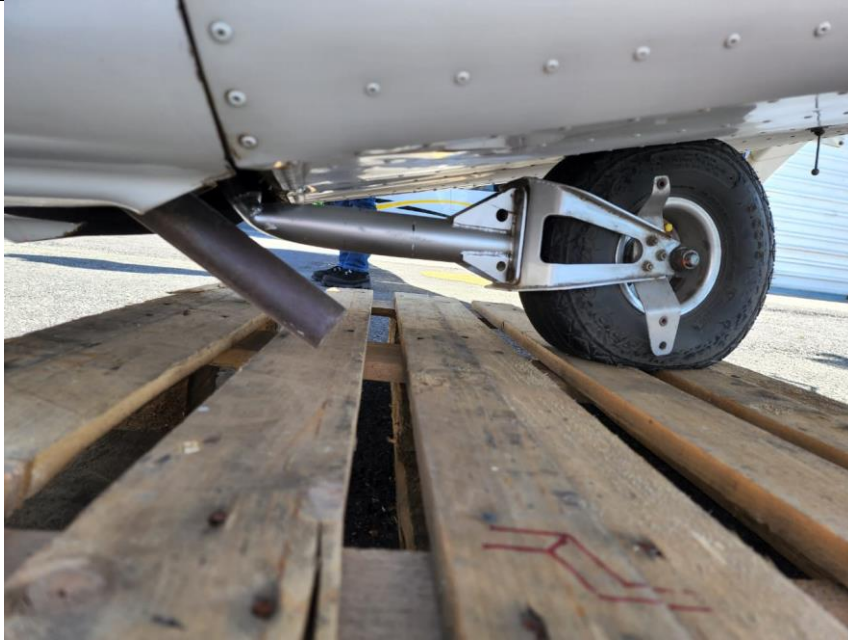
Figure 3: The bent nose gear. (Source: ATO)

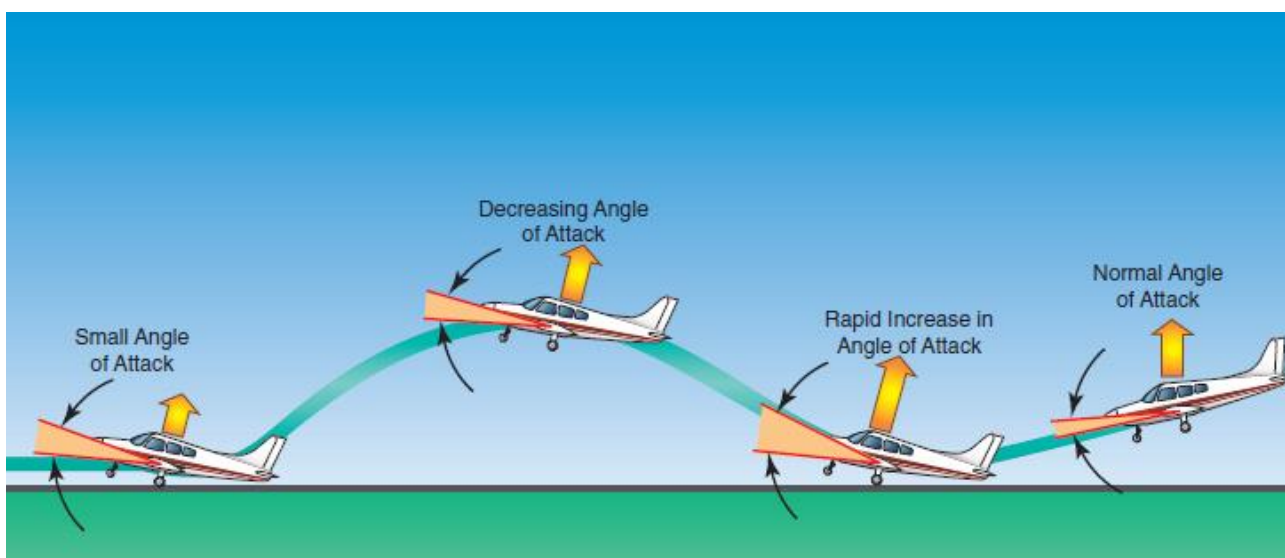
When the airplane contacts the ground with a sharp impact as the result of an improper attitude or an excessive rate of sink, it tends to bounce back into the air. Though the airplane's tyres and shock struts provide some springing action, the airplane does not bounce like a rubber ball. Instead, it rebounds into the air because the wing's angle of attack was abruptly increased, producing a sudden addition of lift. The abrupt change in angle of attack is the result of inertia, instantly forcing the airplane's tail downward when the main wheels contact the ground sharply. The severity of the bounce depends on the airspeed at the moment of contact and the degree to which the angle of attack or pitch attitude was increased. Since a bounce occurs when the airplane makes contact with the ground before the proper touchdown attitude is attained, it is almost invariably accompanied by the application of excessive back-elevator pressure.

This is usually the result of the pilot realising too late that the airplane is not in the proper attitude and attempting to establish it just as the second touchdown occurs. The corrective action for a bounce is the same as for ballooning and similarly depends on its severity. When it is very slight and there is no extreme change in the airplane's pitch attitude, a follow-up landing may be executed by applying sufficient power to cushion the subsequent touchdown, and smoothly adjusting the pitch to the proper touchdown attitude. In the event a very slight bounce is encountered while landing with a crosswind, crosswind correction must be maintained while the next touchdown is made. Remember that since the subsequent touchdown will be made at a slower airspeed, the upwind wing will have to be lowered even further to compensate for drift.

Figure 4: Bouncing during touchdown.

Safety Message
Pilots should execute a go-around immediately if they recognise that their approach is unstable. This is a proven risk mitigation when it comes to avoiding a hard touchdown which may result in damage to the aircraft and/or injury to persons.
About this Report
<p><i>The decision to conduct a limited investigation is based on factors including whether the cause is known and the evidence supporting the cause is clear, the level of safety benefit likely to be obtained from an investigation and that will determine the scope of an investigation. For this occurrence, a limited investigation has been conducted, and the Accident and Incident Investigations Division (AIID) has relied on the information submitted by the affected person/s and organisation/s to compile this limited report. The report has been compiled using information supplied in the initial notification, as well as from follow-up desk top enquiries to bring awareness of potential safety issues to the industry in respect of this occurrence, as well as possible safety action/s that the industry might want to consider in preventing a recurrence of a similar occurrence.</i></p> <p><i>All times given in this report are Co-ordinated Universal Time (UTC) and will be denoted by (Z). South African Standard Time is UTC plus 2 hours.</i></p>
