LIMITED OCCURRENCE INVESTIGATION REPORT – FINAL

Reference Number	CA18/2/3/10216						
Classification	Accident	Date	1 September 2022	Time	1308Z		
Type of Operation	Surveillance (Part 101)						
Location							
Place of Departure	Gamsberg Mine, Northern Cape Province		Place of Intended Landing	Gamsberg Mine, Northern Cape Province			
Place of Occurrence	Gamsberg Mine, Northern Cape Province						
GPS Co-ordinates	Latitude	29°13' 17.6"S	Longitude	18°57'42.4"E	Elevation	2931ft	
Aircraft Information							
Registration	ZT-UHL						
Make; Model; S/N	IQlaser, eBee Plus (Serial Number: EP-11-19486)						
Damage to Aircraft	Destroyed		Total Aircraft Hours	414.3			
Pilot-in-command							
Licence Type	Remote Pilot Licence (RPL)		Gender	Male	Age	24	
Licence Valid	Yes	Total Hours	642.4	Total Hours on Type	33.5		
Total Hours Past 30 Days	07.2		Total Hours on Type Past 90 Days		20.3		
People Controlling	1	Injuries	0	Fatalities	0	Other (on ground)	0
What Happened

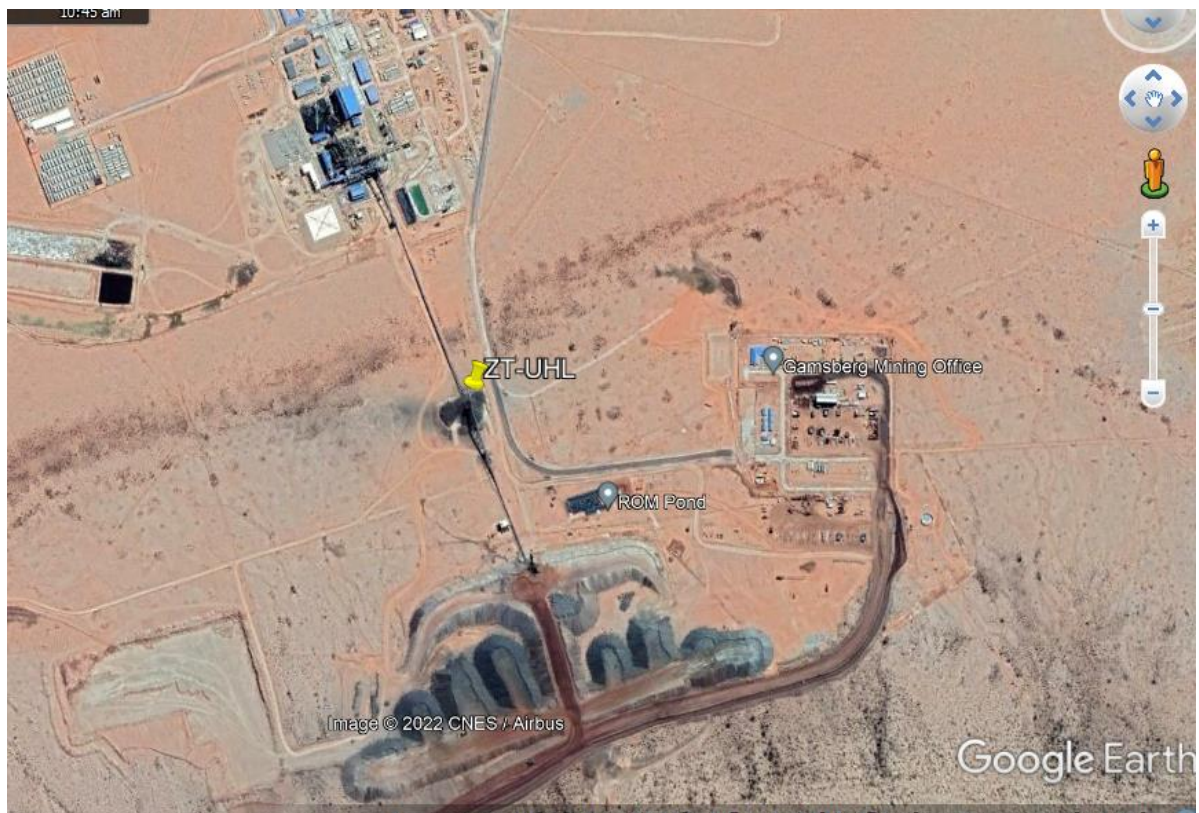
<p>On 1 September 2022, a pilot operating an eBee Plus remotely piloted aircraft (RPA) with registration ZT-UHL launched the RPA for surveillance work at Gamsberg Mine in the Northern Cape province. The flight was conducted Beyond Visual Line of Sight (B-VLOS) by day and under the provisions of Part 101 of the Civil Aviation Regulations (CAR) 2011 as amended.</p> <p>Each mission is programmed in the RPA controller and, when the mission is complete, the RPA automatically resumes a return-to-home (RTH) flight. The operator indicated that the RPA must be landed with a minimum 20% battery power.</p> <p>The pilot stated that he launched the RPA at 1244Z with 100% battery power. After reaching 200 feet (ft) above ground level (AGL), the RPA commenced its programmed mission of taking surveillance pictures of run-of-mine (ROM) piles. Eighteen (18) minutes into the mission (including the flight time), the battery power was at 65%. After 22 minutes and 11 seconds, 52% of battery power remained in the RPA. The RPA completed the mission and commenced a RTH flight. At 22 minutes and 19 seconds, the RPA became unstable. The remote controller monitor at home base transmitted the RPA in a sharp left bank and, thereafter, spiralled towards the ground until the signal was lost. The location where the RPA crashed was above the mined material which was delivered by a roller belt. The RPA wreckage was not found.</p>

Figure 2: Aerial view of the accident site. (Source: Google Earth)

The RPA lost signal and spiralled down towards the ground. The cause of loss of control could not be determined and the RPA was never recovered.
