LIMITED OCCURRENCE INVESTIGATION REPORT – FINAL

Reference Number	CA18/2/3/10217						
Classification	Accident	Date	23 May 2022		Time	1100Z	
Type of Operation	Aerial Survey (Part 101)						
Location							
Place of Departure	Black Rock Manganese Mine in Hotazel, Northern Cape Province		Place of Intended Landing		Black Rock Manganese Mine in Hotazel, Northern Cape Province		
Place of Occurrence	On a rocky terrain in the mine area						
GPS Co-ordinates	Latitude	S27° 15' 75.06"	Longitude	E22° 92'.05 10"	Elevation	3 344 ft	
Aircraft Information							
Registration	ZT-XNU						
Make; Model; S/N	DJI Matrice 300 RTK (Serial Number: 1ZNB7F00C01KE)						
Damage to Aircraft	Substantial			Total Aircraft Hours	39.38		
Pilot-in-command							
Licence Type	Remote Pilot Licence (RPL)		Gender	Male		Age	27
Licence Valid	Yes	Total Hours	22.30		Total Hours on Type	19.46	
Total Hours Past 90 days	19.46		Total Flying Hours on Type Past 90 days			19.46	
People Controlling	1	Injuries	0	Fatalities	0	Other (on ground)	0

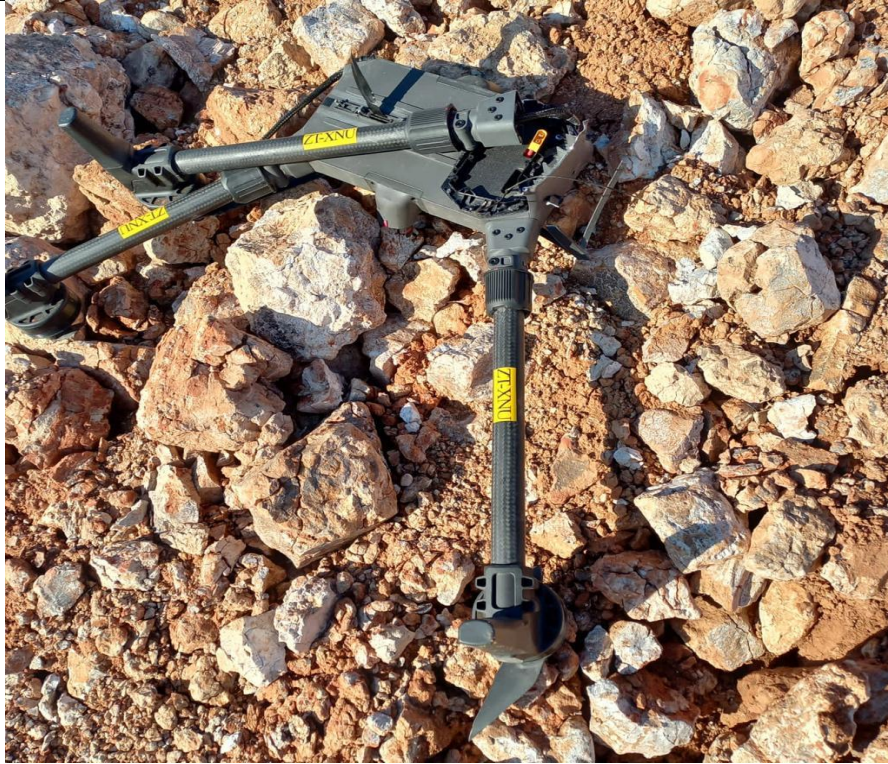
What Happened							
<p>On Monday, 23 May 2022 at 1051Z, a pilot launched a DJI Matrice 300 RTK remotely piloted aircraft (RPA) with registration ZT-XNU to conduct aerial survey at the Black Rock Manganese Mine facility in Hotazel, Northern Cape province, with the intention to return to the mine facility. The flight was conducted in visual line of sight (VLOS) by day and under the provisions of Part 101 of the Civil Aviation Regulations (CAR) 2011 as amended.</p> <p>The pilot reported that a pre-flight inspection was conducted on the RPA and no anomalies were noted. The pre-flight checks included checking for software updates, ensuring that the Global Positioning System (GPS) satellite was acquired, the home point was set to the take-off location and both batteries were fully charged and correctly installed. The RPA was launched at 1051Z, whereafter it climbed 240 metres (m) above ground level (AGL). However, approximately 9 minutes into the flight, numerous electronic speed control (ESC) related errors appeared on the DJI controller/remote screen. The RPA did not respond to the pilot's inputs; but it started an uncontrolled descent until it impacted the ground at 1100Z. The RPA sustained substantial damages. No damage to property was caused and no people on the ground were injured.</p>

Figure 1: The RPA at the accident site. (Source: Operator)

- vi. The RPA sustained substantial damages during the accident sequence.
- vii. No person was injured on the ground during the accident sequence.
- viii. Photographs showing evidence of bird strike on the RPA structure were not taken before the RPA was disposed as the operator had assumed the occurrence was not a reportable case.

ix. The Certificate of Registration was issued to the present owner on 11 October 2021.
Probable Cause
A possible bird strike caused the RPA to enter an uncontrollable descent and finally impacted terrain; this resulted in the substantial damage to the RPA.
Contributing Factor(s)
None.
Safety Action(s)
None.
Safety Message and/or Safety Recommendation/s
None.
About this Report
<i>A decision to conduct a limited investigation is based on factors including whether the cause is known and the evidence supporting the cause is clear, the level of safety benefit likely to be obtained from an investigation and that will determine the scope of an investigation. For this occurrence, a limited investigation has been conducted, and the Accident and Incident Investigations Division (AIID) has relied on the information submitted by the affected person/s and organisation/s to compile this limited report. The report has been compiled using information supplied in the initial notification, as well as from follow-up desk top enquiries to bring awareness of potential safety issues to the industry in respect of this occurrence, as well as possible safety action/s that the industry might want to consider in preventing a recurrence of a similar occurrence.</i>
