**LIMITED OCCURRENCE INVESTIGATION REPORT – FINAL**

<b>Reference Number</b>	CA18/2/3/10218						
<b>Classification</b>	Accident	<b>Date</b>	9 September 2022	<b>Time</b>	0900Z		
<b>Type of Operation</b>	Private (Part 94)						
<b>Location</b>							
<b>Place of Departure</b>	Lindberg Lodge Airstrip, North West Province		<b>Place of Intended Landing</b>	Eagle's Creek Aerodrome, Gauteng Province			
<b>Place of Occurrence</b>	On the side of the active runway at Carletonville Aerodrome (FACR), Gauteng Province						
<b>GPS Co-ordinates</b>	<b>Latitude</b>	26° 22' 05" S	<b>Longitude</b>	027° 20' 28" E	<b>Elevation</b>	4990 ft	
<b>Aircraft Information</b>							
<b>Registration</b>	ZU-EKI						
<b>Make; Model; S/N</b>	Jora Spol S.R.O; Jora UA2 (Serial Number: C147)						
<b>Damage to Aircraft</b>	Substantial			<b>Total Aircraft Hours</b>	948		
<b>Pilot-in-command</b>							
<b>Licence Type</b>	National Pilot Licence (NPL)		<b>Gender</b>	Male		<b>Age</b>	62
<b>Licence Valid</b>	Yes	<b>Total Hours</b>	1835.5		<b>Total Hours on Type</b>	879

**Accident and Incident Investigations Division  
South African Civil Aviation Authority  
Republic of South Africa**

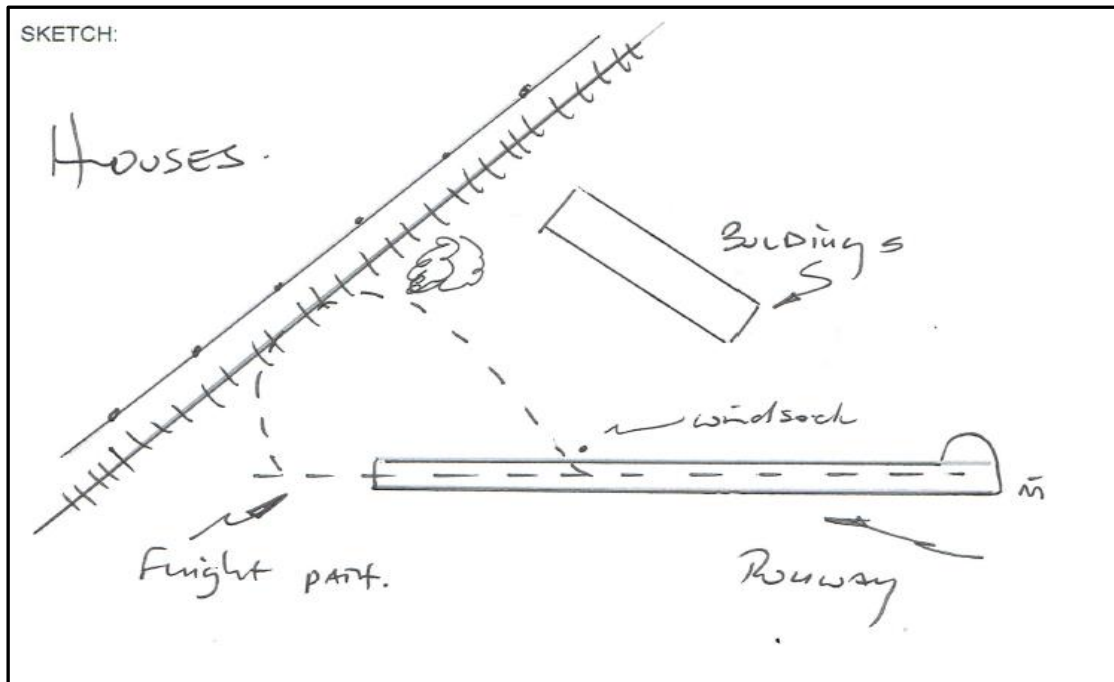
Diagram 1: The pilot's sketch of the return flight path to FACR. (Source: Pilot)

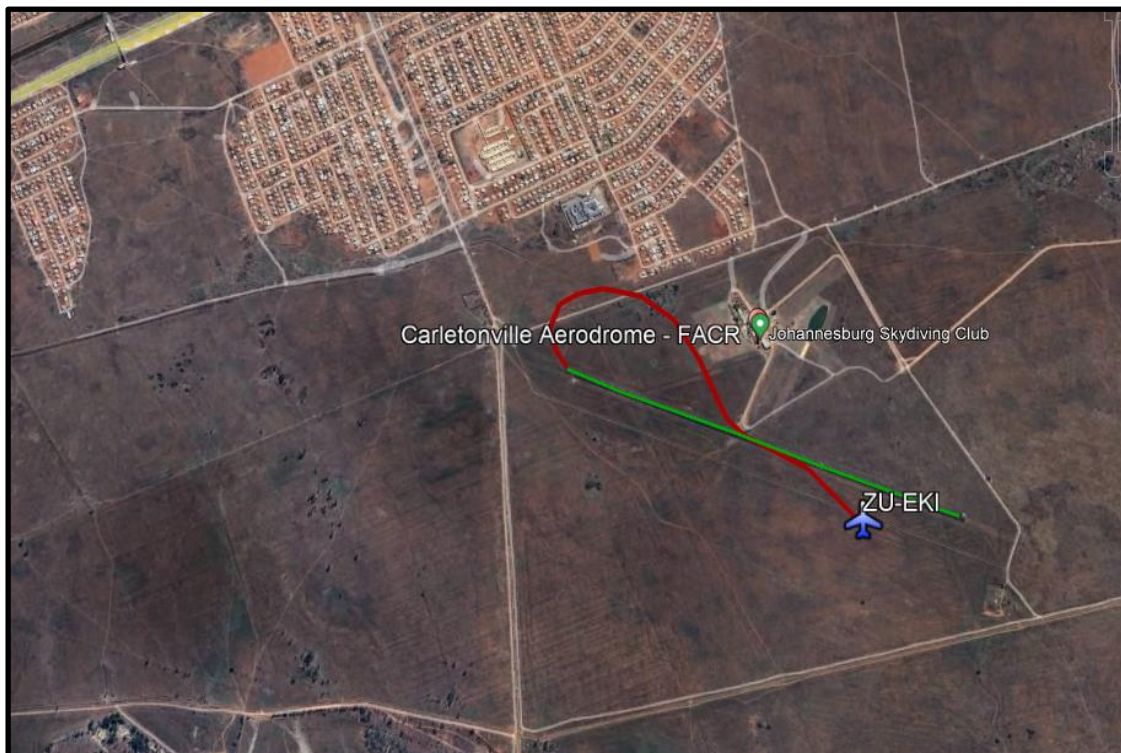
Figure 1: The accident site and the flight path of the aircraft. (Source: Google Earth)

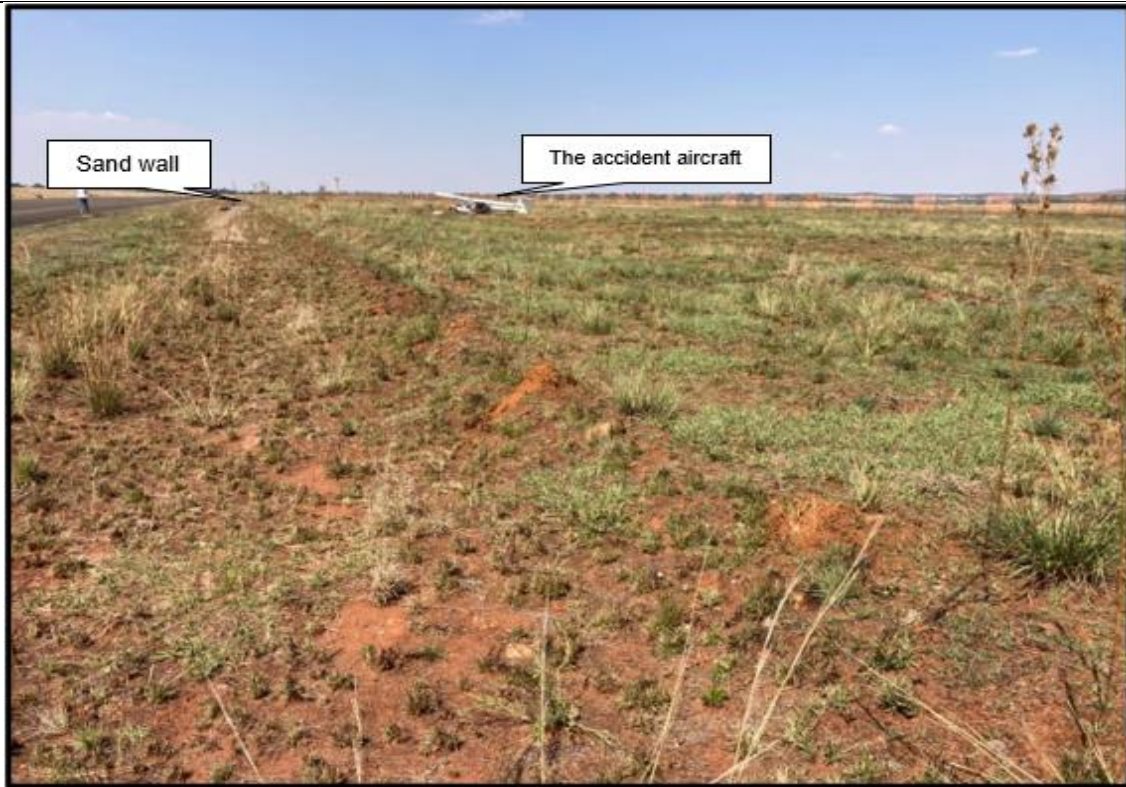
**Figure 2:** The sand wall and the uneven surface at the accident site.

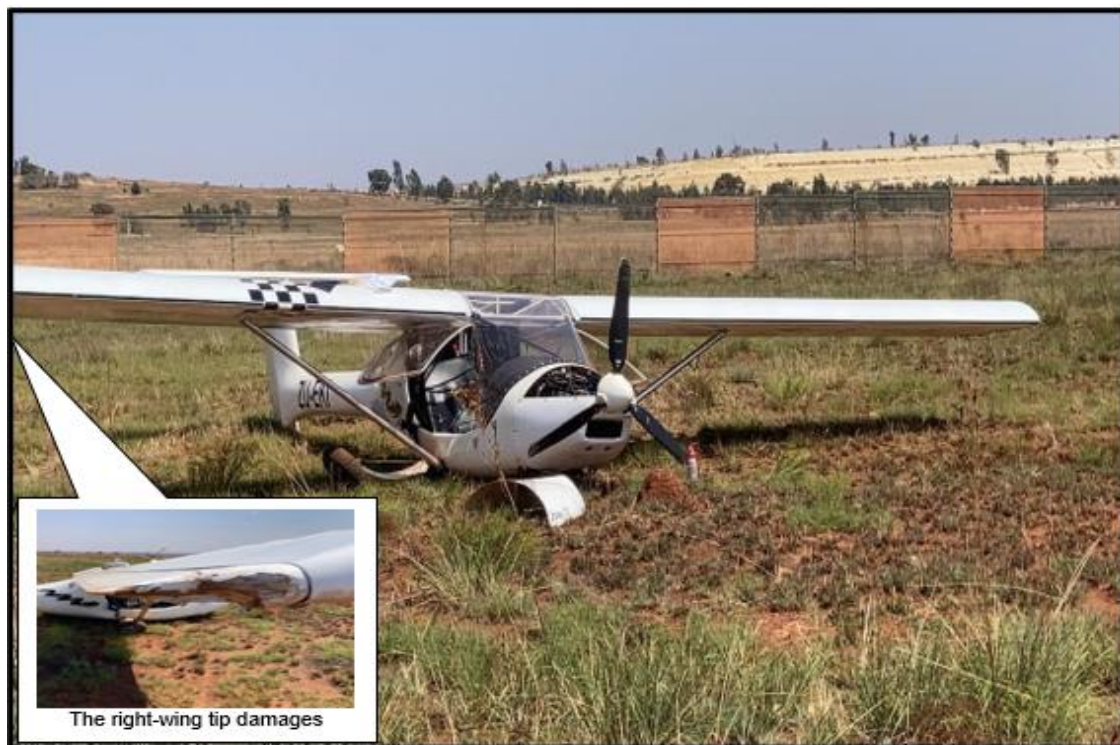
along the runway. The aircraft sustained substantial damage to the nose and main landing gear struts, the propeller blades and the right-wing tip. The aircraft had approximately 40 litres (l) of fuel remaining on-board at the time of the accident. The occupants were not injured.

**Figure 3:** The aircraft at rest. The inset picture shows the damage on the right-wing tip.

- The accident occurred during a precautionary landing on the side of the runway after the engine lost power during take-off.
- The aircraft sustained substantial damage to the nose and main landing gear struts, the propeller blades and the right-wing tip.

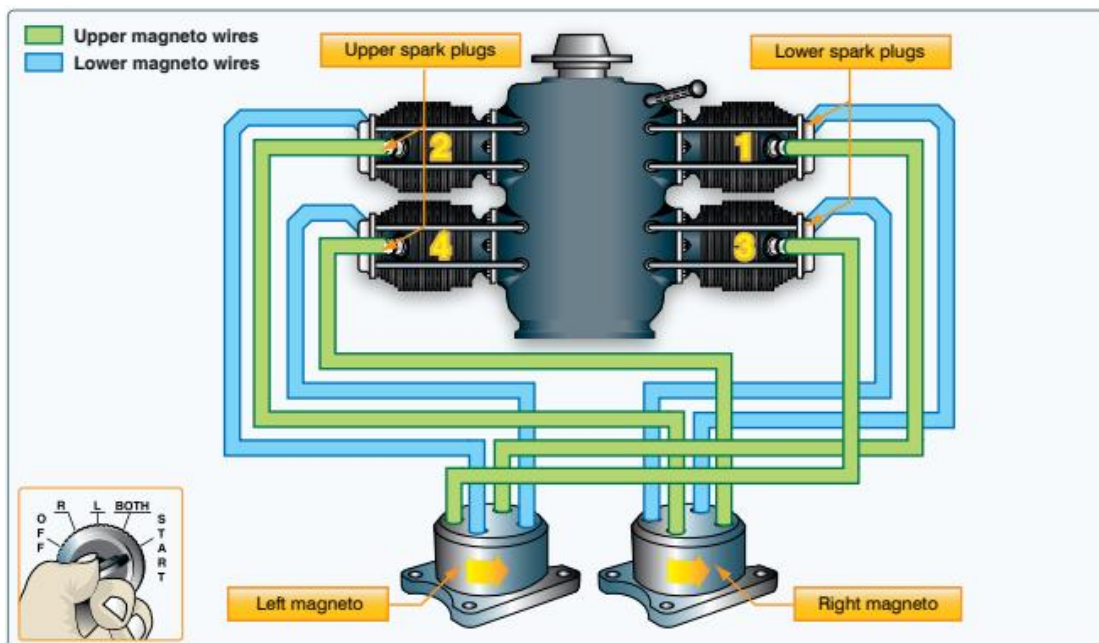
**Diagram 2:** Ignition system. (Source: <https://www.cfinodebook.net/notebook/operation-of-aircraft-systems/ignition>)

The above picture shows an ignition system with a similar starter ignition switch to that of the accident aircraft.

The switch has five positions (Refer to **Diagram 2** bottom left-hand corner)

<ul style="list-style-type: none"> <li>It was determined that the aircraft's starter ignition switch was faulty with the key log springs found off position and loose. This resulted in the key recoiling from position "BOTH" back to the "L" position, which caused one of the magnetos (R) to switch off automatically during flight.</li> </ul>
<b>Probable Cause</b>
A faulty aircraft ignition system caused the engine to lose power, which led to the pilot executing an unsuccessful emergency landing.
<b>Contributing Factor</b>
The starter ignition switch log springs were found off position and loose.
<b>Safety Action(s)</b>
None.
<b>Safety Message and/or Safety Recommendation/s</b>
None.
<b>About this Report</b>
<p><i>The decision to conduct a limited investigation is based on factors, including whether the cause is known and the evidence supporting the cause is clear, the level of safety benefit likely to be obtained from an investigation and that will determine the scope of an investigation. For this occurrence, a limited investigation has been conducted, and the Accident and Incident Investigations Division (AIID) has relied on the information submitted by the affected person/s and organisation/s to compile this limited report. The report has been compiled using information supplied in the initial notification, as well as from follow-up desk top enquiries to bring awareness of potential safety issues to the industry in respect of this occurrence, as well as possible safety action/s that the industry might want to consider in preventing a recurrence of a similar occurrence.</i></p> <p><i>All times given in this report are Co-ordinated Universal Time (UTC) and will be denoted by (Z). South African Standard Time is UTC plus 2 hours.</i></p>
