LIMITED OCCURRENCE INVESTIGATION REPORT – FINAL

| Reference Number | CA18/2/3/10219 | | | | | | |
| Registration | ZU-SVF | | | | | | |
| Make; Model; S/N | Stampe-Vertongen; SV-4C (Serial Number: 373) | | | | | | |

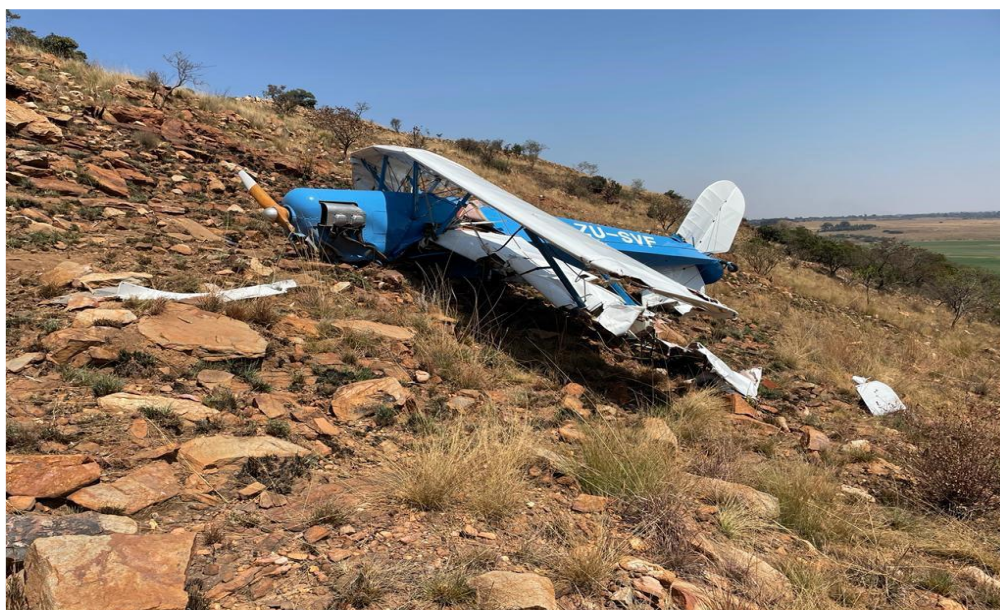
The pilot made numerous attempts to restart the engine, but without success. This led to the pilot force-landing the aircraft on the side of the mountain, approximately 1.36 kilometres (km) north of the threshold of Runway 26. The aircraft sustained substantial damages; however, the occupants were not injured during the accident sequence.

Figure 2: The aircraft as it came to rest on the side of the mountain. (Source: Pilot)

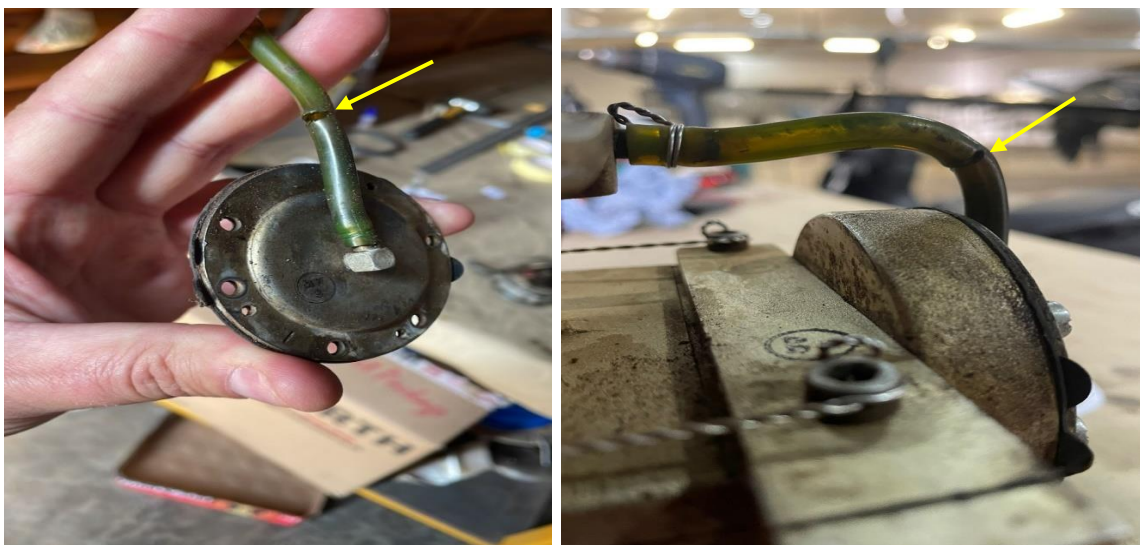
Approximately 58l of fuel remained in the tanks; it was drained by some members of the local community. The wreckage was dismantled and recovered to the maintenance facility at FAKR for further investigation; the engine was removed from the airframe for further examination. A Tygon plastic air hose/pipe connected to the Ellison throttle body, Model EFS-4-5, part number 820718 and serial number 1091 was found damaged. *The plastic air hose supplies pressurised air into the throttle body which would then push open the diaphragm to allow the corresponding amount of fuel into the carburettor for proper combustion.* Because of the damaged plastic air hose, fuel supply into the carburettor was interrupted and, as a result, caused the engine to stop. The plastic air hose is an on-condition item. Scrutiny into the aircraft's logbook indicated no history/record of when it was installed in the engine.

Figures 4 and 5: Pictures of the damaged Tygon plastic air hose/pipe.

| The plastic air hose which supplies pressurised air to operate a throttle body diaphragm to let fuel into the carburettor was damaged, which caused fuel starvation and the subsequent engine stoppage. This led to an unsuccessful forced landing on the side of the mountain. |
| It is possible that the throttle body air hose was used for a prolonged period and had deteriorated unnoticed due to increased operational loads. |
