AIRCRAFT ACCIDENT REPORT AND EXECUTIVE SUMMARY

| | | | | Reference: | | CA18/2/3/10221 | |
| Aircraft Registration | ZU-DYV | Date of Accident | | 30 November 2022 | | Time of Accident | 0800Z |
| Type of Aircraft | Ela 08 Gyroplane | | | Type of Operation | | Training (Part 141) | |

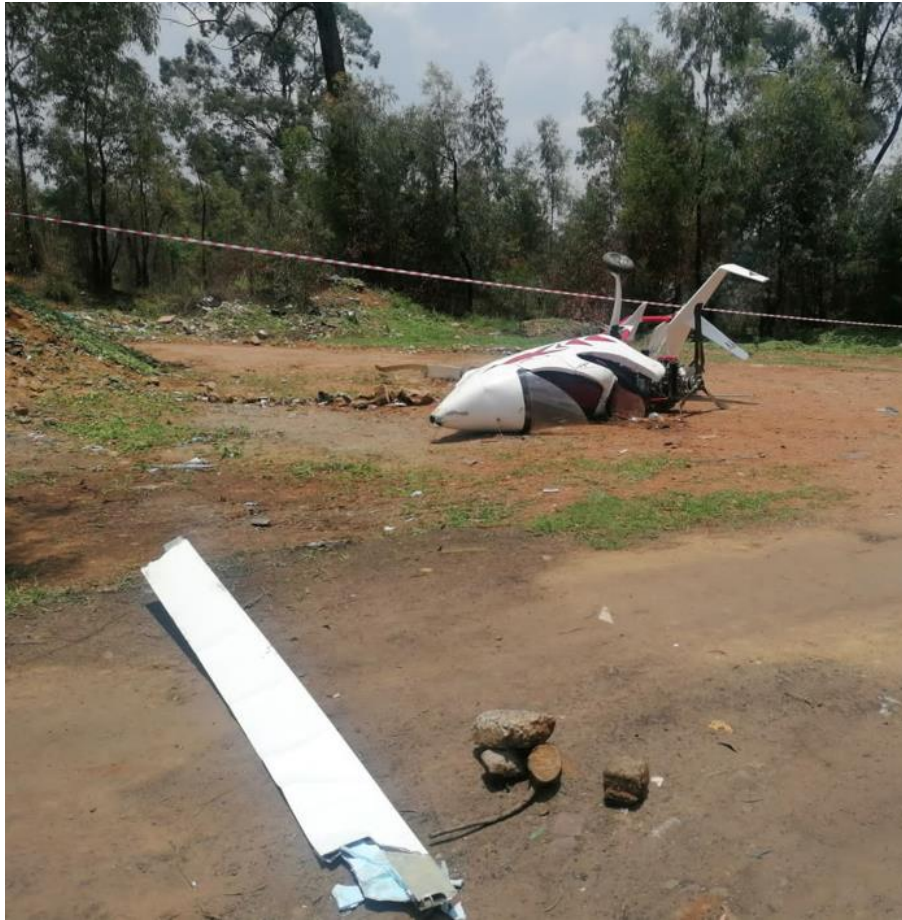
1.3.1 The gyroplane was substantially damaged.

Figure 2: Damage sustained by the gyroplane.

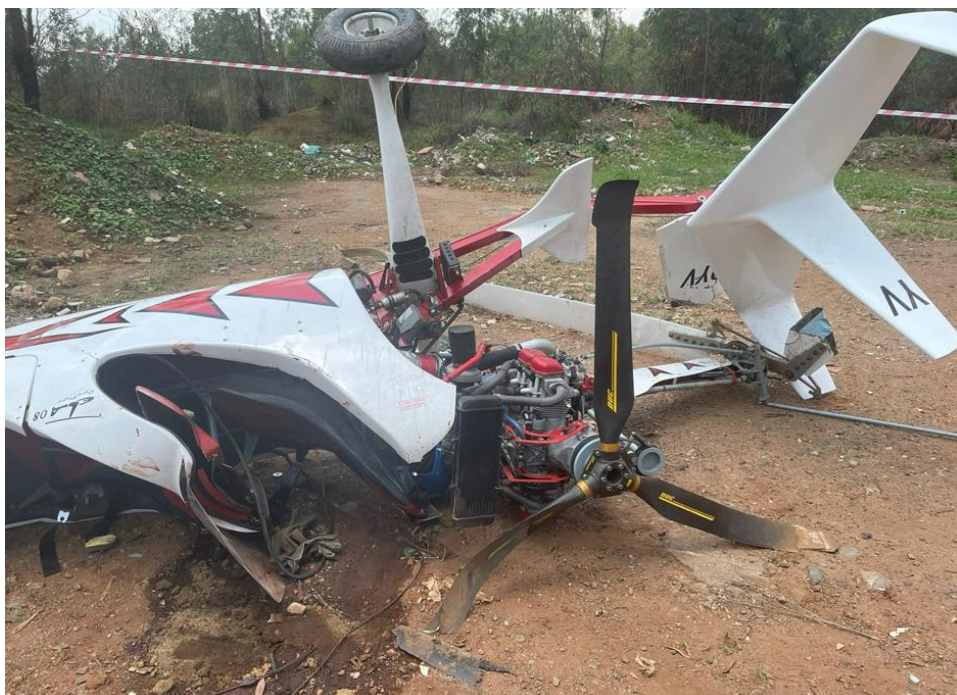
The gyroplane accident occurred near a quarry, and was found lying on its left side with the nose pointing north. The wreckage was contained in a radius of approximately 32m. The embankment located east of the wreckage appeared disturbed, which indicated that the nose cone came in to contact with it prior to the gyroplane's roll. On the ground, there was evidence of fuel leak from the tank breather port because of the manner in which the gyroplane came to rest. The tank was not ruptured, only fuel sipped out. It was estimated that ten (10) litres of fuel remained in the tanks. The fuel pumps were still in their respective position and the fuel filter appeared clean. The fuel pump switch and the master switch were in the "off" position. Fuel piping appeared normal and still connected to the tanks, fuel pumps and the engine. The fuel inside the tanks was green in colour, characterised by its strong smell (automotive fuel). The horizontal stabiliser was still intact; however, the rudder was broken

Figure 4: Final resting position of the aircraft, and stained ground due to fuel spillage.

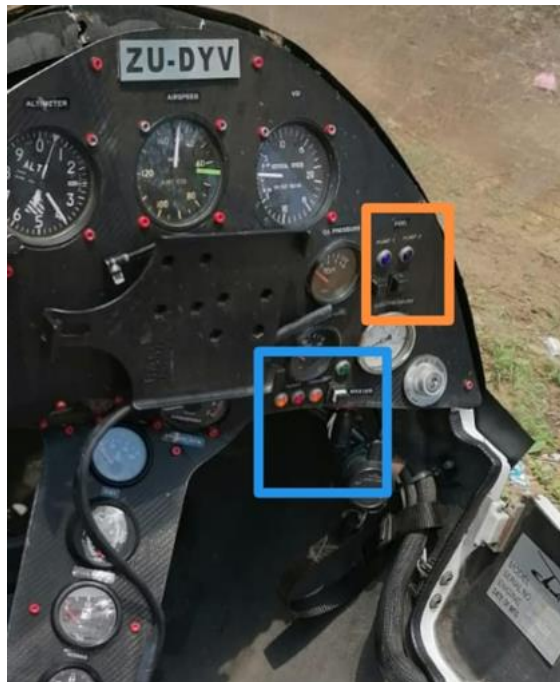
Figure 5: Fuel pumps and master switches in the “off” position at the accident site. (Source: Pilot)

- 3.2.10 The fuel pumps were tested and found serviceable.
- 3.2.11 The engine stopped without warning whilst overhead the quarry in Brakpan during a late right base leg due to fuel starvation, likely due to the fuel pumps being inadvertently switched off.

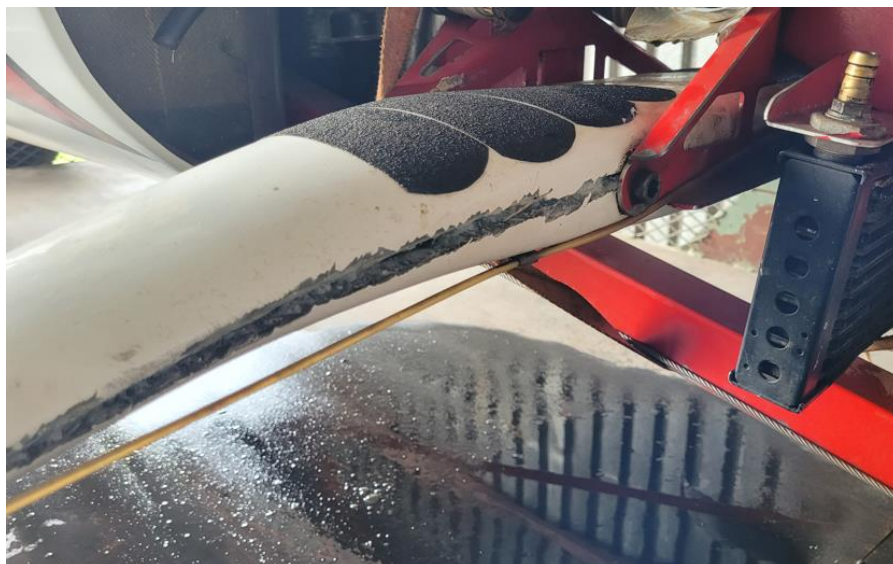
The landing gear strut was still intact; however, evidence of fracture along the middle was visible. Both main tyres were still attached to the axle. The nose gear had collapsed into the wheel well.

Figure 6: Fractured strut.

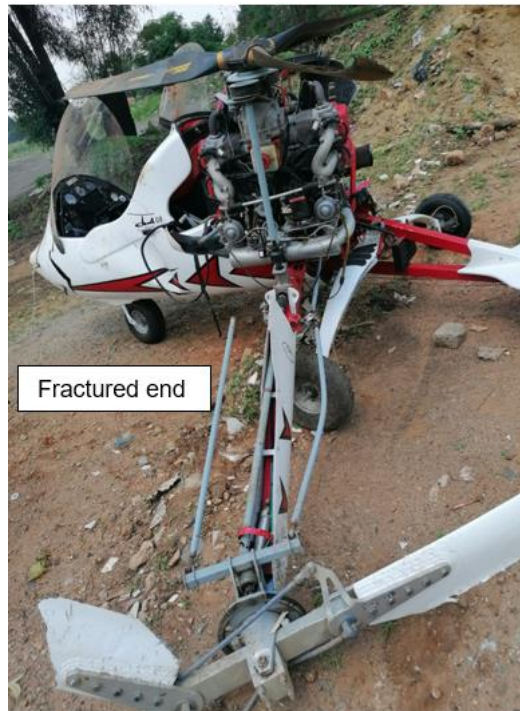
The front seat was in place and secured, whereas the rear seat had dislodged from its attachment point; the front seat safety harness was intact and the rear safety harness was cut (indicative of a cut in which a sharp object was used, in this instant, by the eyewitnesses who helped the crew out of the gyroplane). Both control sticks were still secured in their

respective positions. The throttle arm levers were still in place (found in the “off” position); the cable was checked for functionality, and it corresponded with the movement of the throttle. All instruments in the panel were still secured in their respective receptacles.

Figure 7: The control tubes.

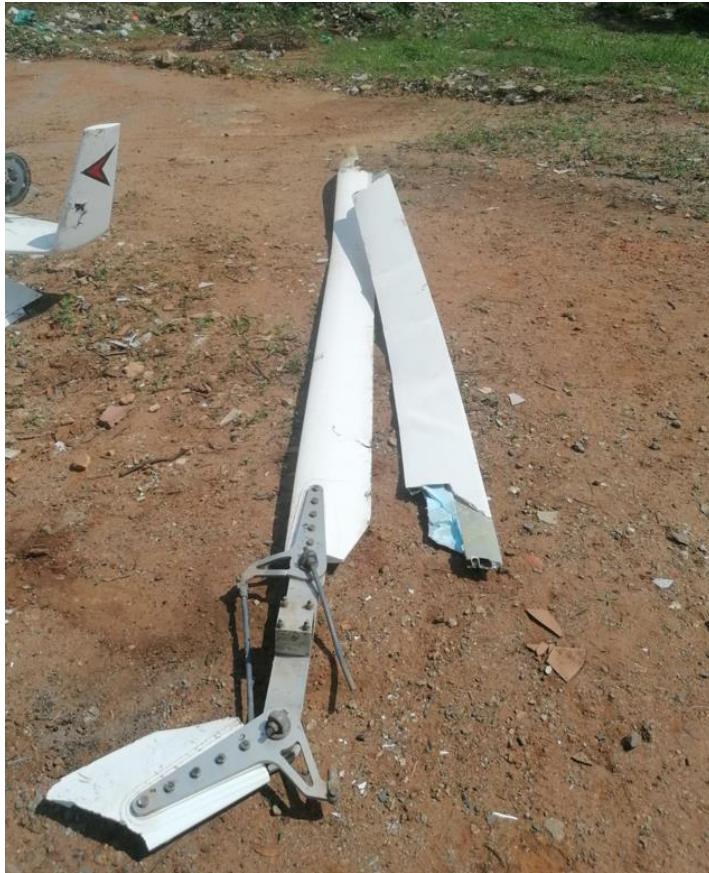
The mast was severed and was found hanging by the wire harness, indicative of impact fracture. Both the control tubes that control disc tilt were severed at the bottom. The pre-rotating gearbox and its associated hardware were still intact. The drivebelt was still attached to the pulley. One of the main rotor blades had detached from the hub and was found 7.8m from the other blades which were still attached to the hub. The detached main rotor blade had evidence of fracture on the tip and in the middle section, indicative of contact with the hard object. This fracture was attributed to impact.

Figure 8: The rotor blade after it was removed from the mast.

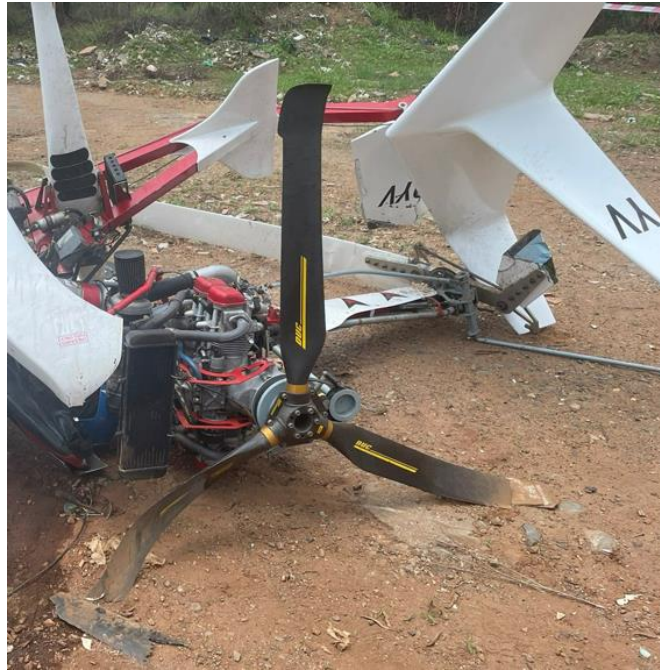
The condition of the exterior of the engine was good. The engine was still attached to the cradle. There were no visible signs of oil or fuel leak. The wiring harness was still intact. All three propeller blades were still attached to the hub, however, one of the blades was damaged and dirt was found on the washout. The exhaust muffler was still intact and there was no visible oil leak on the turbo assembly. The pre-rotator belt was still intact and attached to the gearbox. The pre-rotator piston was still attached to the engine. The engine was fitted with a turbo unit. The exterior condition of the turbo unit was in good condition with no signs of oil leak.

Figure 9: Engine condition with propeller blades still attached.

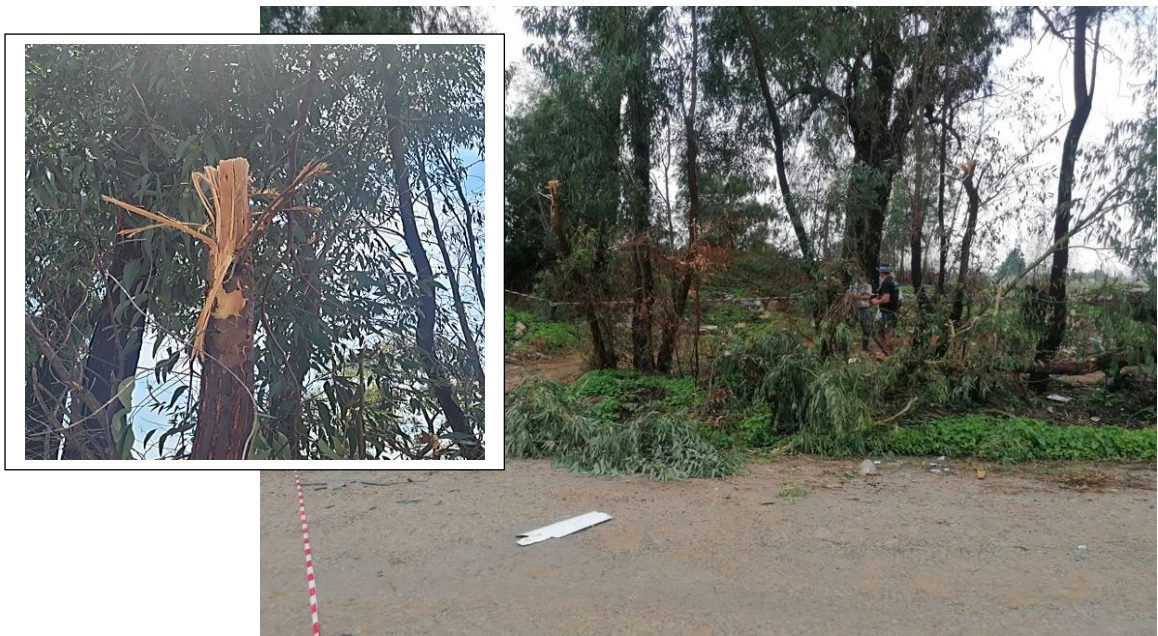
Before the gyroplane made contact with the ground, the rotor blades impacted a tree on the left side of the road. There was a clean cut on one of the trees, an indication of a blade cut. This was evidenced by the blade outboard section which separated and was found at the accident site.

Figure 10: The trees that were severed by the rotor blades. The inset picture shows a close up of the stump.

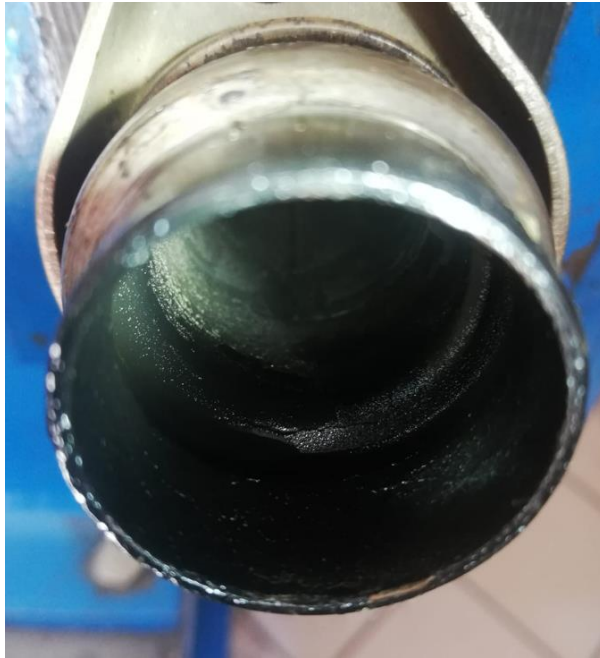
- *The technical report found that there was oil in the combustion chamber exhausts ports and exhaust inlet side,*
- *The rings used were not new, and*
- *The scraper ring was installed upside down, which resulted in the oil being pushed to the top and not down.*

Figure 11: Indication of oil in the intake pipe.

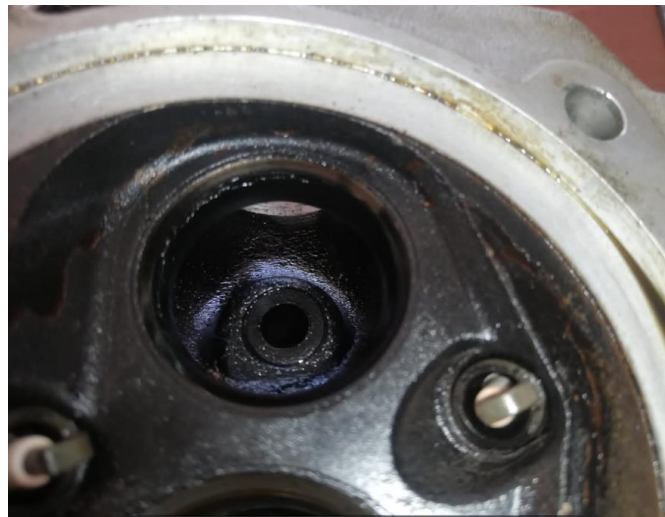
Figure 12: The upper part of the cylinder shows discolouration of the exhaust valve port due to oil in the mouth.

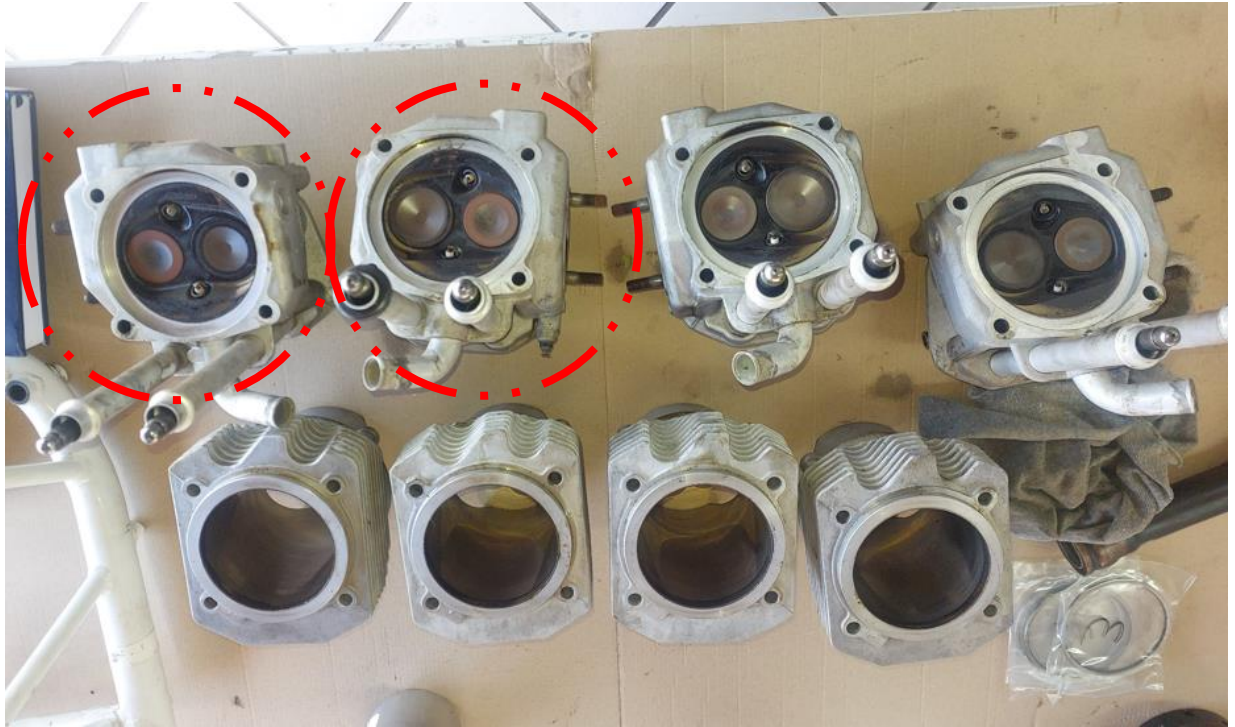
Figure 13: Red circles show cylinder head discolouration as a result of oil.

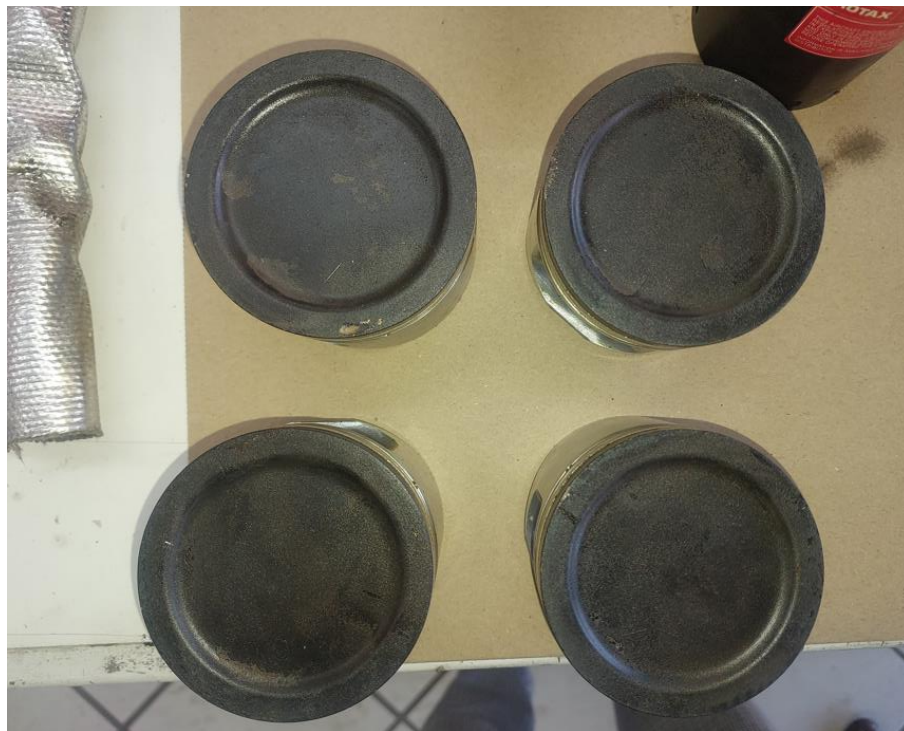
Figure 14: Discolouration on the piston crowns due to oil.

Incorrect installation of the scraper rings during the overhaul would result in improper flow of oil inside the cylinder head and cause smoke emissions during engine operation; this was not reported by the pilot or the AP. Incorrect fitting of the scraper rings was an oversight by the AP who indicated poor workmanship. However, there was no evidence which would suggest that the incorrect installation of the scraper rings caused the engine stoppage.

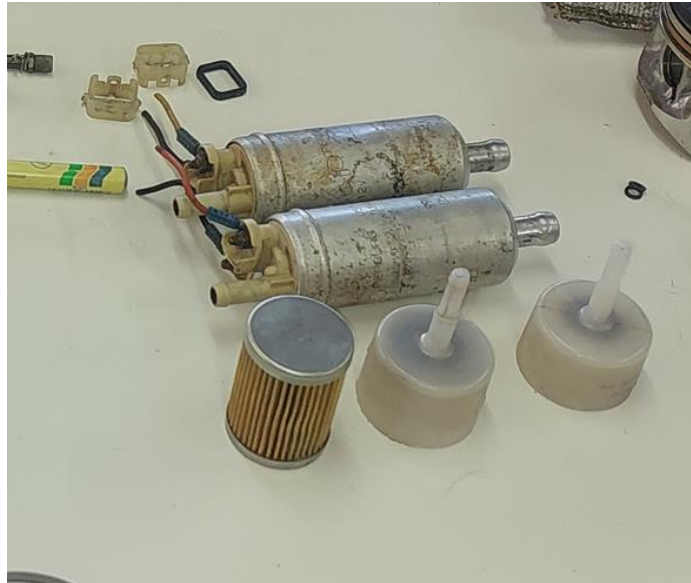
The fuel pumps which were connected in series were recovered and subjected to operational testing at an AMO facility by an AP using an external power supply. When energised, they both operated effectively. The fuel filter did not have evidence of sediments or blockages.

Figure 15: The electrical fuel pumps and filter.

Fuel pumps testing yielded satisfactory result as there were no anomalies found during testing, and fuel filters were clean. Fuel was checked and it was of a correct grade with no evidence of contamination, sediments or presence of water. The fuel pump switches at the accident site were in the “off” position and, thus, the investigation could not confirm with certainty whether or not they were switched off after the accident or were [inadvertently switch off in-flight](#). Fuel piping revealed no anomalies. The carburettor bowls were empty, however, there was no evidence which would suggest fuel restriction during operation.
