LIMITED OCCURRENCE INVESTIGATION REPORT – FINAL

Reference Number	CA18/2/3/10222						
Classification	Accident	Date	03 February 2023		Time	1024Z	
Type of Operation	Training (Part 141)						
Location							
Place of Departure	Beaufort West Aerodrome, (FABW) Western Cape Province		Place of Intended Landing		Beaufort West Aerodrome, (FABW) Western Cape Province		
Place of Occurrence	Runway 08 at Beaufort West Aerodrome (FABW)						
GPS Co-ordinates	Latitude	32°18'00.0"S	Longitude	028°00'00.0"E	Elevation	2929 ft	
Aircraft Information							
Registration	ZS-TBK						
Make; Model; S/N	Cessna, C172S (Serial Number: 172S11301)						
Damage to Aircraft	Substantial			Total Aircraft Hours	5493.2		
Pilot-in-command							
Licence Type	Student Pilot Licence (SPL) Integrated Course (IC)		Gender	Male		Age	22
Licence Valid	Yes	Total Hours	131.0		Total Hours on Type	131.0	
Total Hours 30 Days	78.1		Total Flying on Type Past 90 Days			78.1	
People On-board	1 + 0	Injuries	1	Fatalities	0	Other (on ground)	0

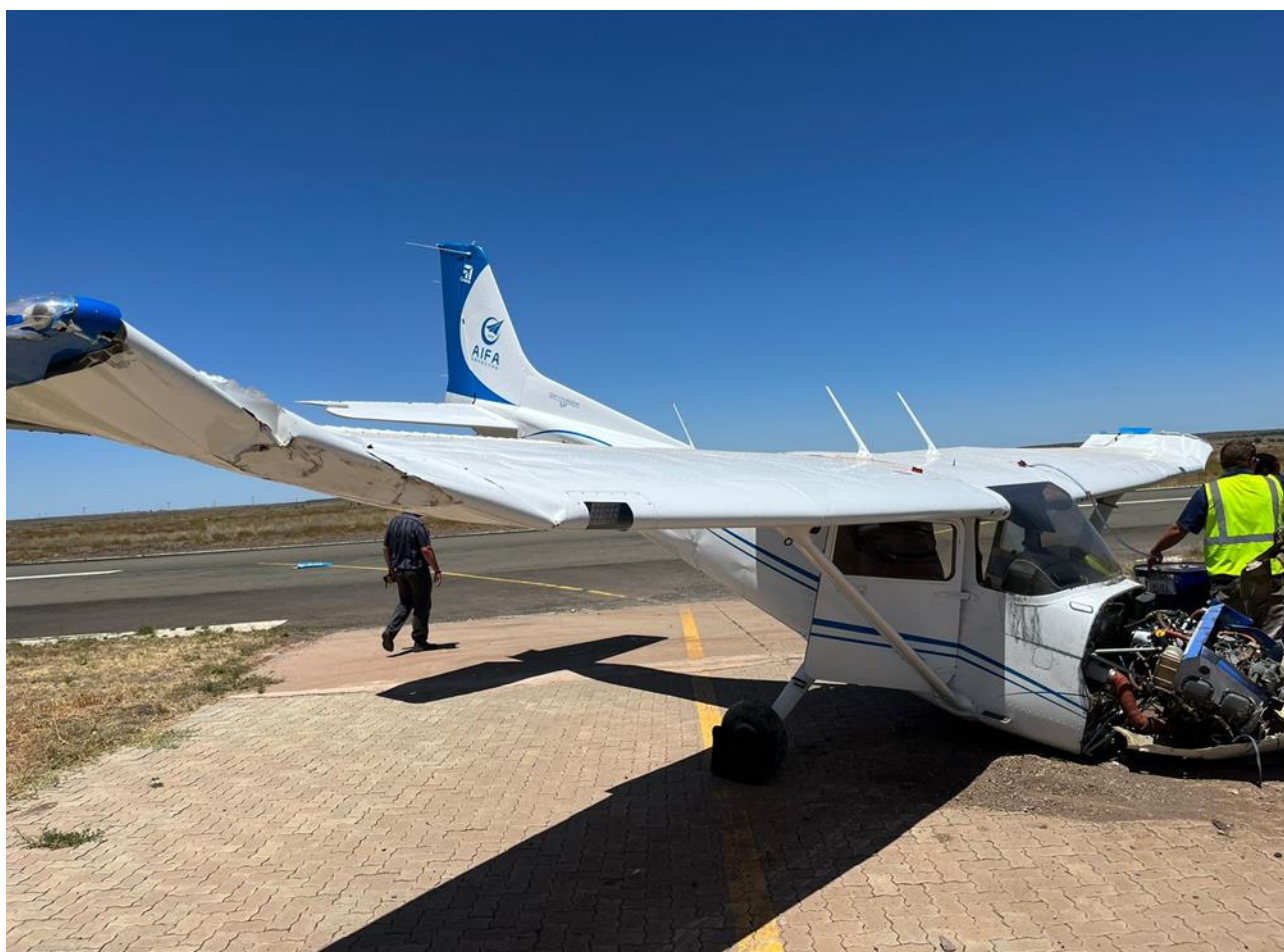
What Happened							
<p>On Friday afternoon, 3 February 2023, a student pilot (SP) on-board a Cessna 172 S Skyhawk aircraft with registration ZS-TBK was on his return flight to Beaufort West Aerodrome (FABW), Western Cape province, after engaging in a solo navigation exercise when the accident occurred. Visual meteorological conditions (VMC) by day prevailed at the time of the flight. The flight was conducted under the provisions of Part 141 of the Civil Aviation Regulations (CAR) 2011 as amended.</p> <p>The SP had conducted a pre-flight check with no anomalies noted prior to the flight. He also filed a visual flight rules (VFR) flight plan with take-off from FABW at 0730Z, routing to Willowmore Aerodrome (FAWO), Aberdeen Aerodrome (FAAE) and back to FABW. Upon his return to FABW, the SP joined overhead the aerodrome at 5000 feet (ft) above ground level (AGL) and, afterwards, joined the circuit on left downwind Runway 08 (RWY08) at an elevation of 3929 ft.</p> <p>The aircraft was unstable on approach and, on round out, it ballooned. Thereafter, it landed hard and bounced. The pilot lost control of the aircraft and, in that process, the wings made contact with the runway surface and the nose gear broke off. The aircraft skidded to the left of the runway before it came to a stop.</p> <p>The aircraft sustained damage to the nose gear, propeller blades, engine cowling, wings and fuselage during the landing sequence. The SP was injured and was rushed to the hospital.</p>

Figure 2: The aircraft at the accident site. (Source: Operator)

<p>Probable Cause</p> <p>The aircraft ballooned during round out following an unstable approach; this led to a hard landing and loss of directional control.</p>
<p>Contributing Factor(s)</p> <p>Crosswind component.</p>
<p>Safety Action(s)</p> <p>None.</p>
<p>Safety Message</p> <p>ATOs must develop procedures to correctly evaluate the students' ability to recover from emergency situations prior to signing them off for solo consolidation training. This accident could have been prevented if the pilot had carried out a go-around. Thus, it is recommended that ATOs emphasise the importance of carrying out a go-around when the aircraft is not stable on approach.</p>
<p>About this Report</p> <p><i>The decision to conduct a limited investigation is based on factors including whether the cause is known and the evidence supporting the cause is clear, the level of safety benefit likely to be obtained from an investigation and that will determine the scope of an investigation. For this occurrence, a limited investigation has been conducted, and the Accident and Incident Investigations Division (AIID) has relied on the information submitted by the affected person/s and organisation/s to compile this limited report. The report has been compiled using information supplied in the initial notification, as well as from follow-up desk top enquiries to bring awareness of potential safety issues to the industry in respect of this occurrence, as well as possible safety action/s that the industry might want to consider in preventing a recurrence of a similar occurrence.</i></p> <p><i>All times given in this report are Co-ordinated Universal Time (UTC) and will be denoted by (Z). South African Standard Time is UTC plus 2 hours.</i></p>
