LIMITED OCCURRENCE INVESTIGATION REPORT – FINAL

Reference Number	CA18/2/3/10223						
Classification	Accident	Date	17 September 2022		Time	0800Z	
Type of Operation	Private (Part 94)						
Location							
Place of Departure	Hoek Van Spruit Se Vloer Pan Airstrip, Northern Cape Province			Place of Intended Landing	Hoek Van Spruit Se Vloer Pan Airstrip, Northern Cape Province		
Place of Occurrence	Hoek Van Spruit Se Vloer Pan gravel airstrip, 5nm north of Verneukpan, Northern Cape Province						
GPS Co-ordinates	Latitude	29° 58' 17" S	Longitude	20° 54' 32" E	Elevation	2 897 feet	
Aircraft Information							
Registration	ZU-IIX						
Make; Model; S/N	SAFARI LSA (Serial Number: 020-02-14 SAF)						
Damage to Aircraft	Substantial			Total Aircraft Hours	625		
Pilot-in-command							
Licence Type	Private Pilot Licence (PPL) Aeroplane		Gender	Female		Age	43
Licence Valid	Yes	Total Hours	144.2		Total Hours on Type	55.5	
Total Hours 30 Days	4.3		Total Flying on Type Past 90 Days	0.5

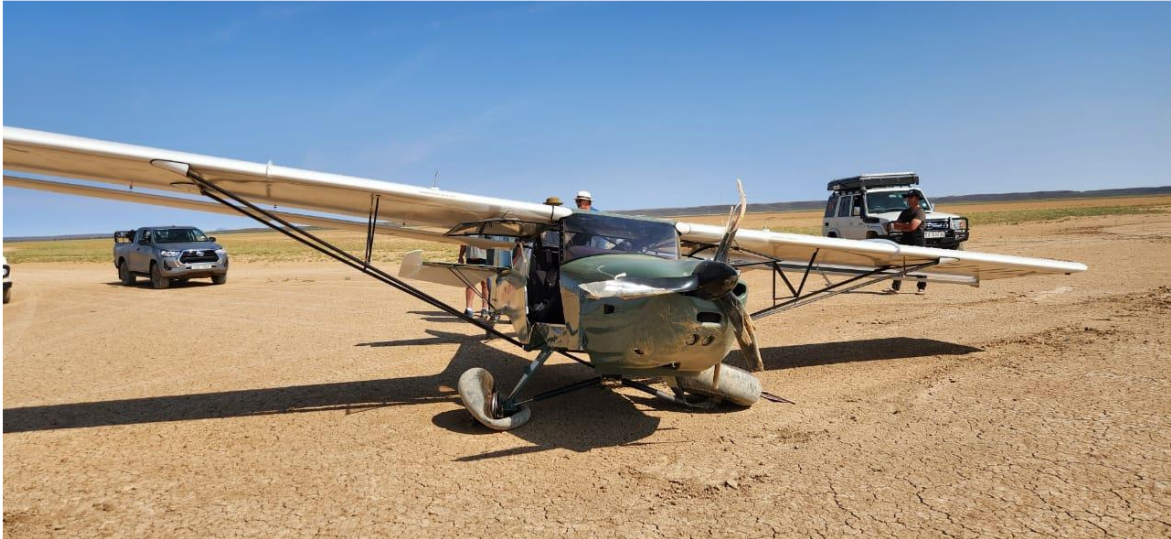
Figure 1: Damaged landing gears and the propeller blades. (Source: Pilot)

6. The aircraft was landed on all three landing gears with full flaps and at a speed of 55 knots, which was in accordance with the POH. However, the pilot lost control of the aircraft. The POH states that, *“At touchdown, HOLD BACK STICK, flaps can be reduced to increase weight on the tail slightly if not 3 points. This will arrest any tendency to bounce. The more flaps used, the more the tendency to bounce but the slower the landing speed.”* The pilot did not reduce the flaps when landing at a high speed and that caused the aircraft to bounce.

The aircraft landed hard and ground looped after touchdown; thereafter, the pilot lost directional control of the aircraft.

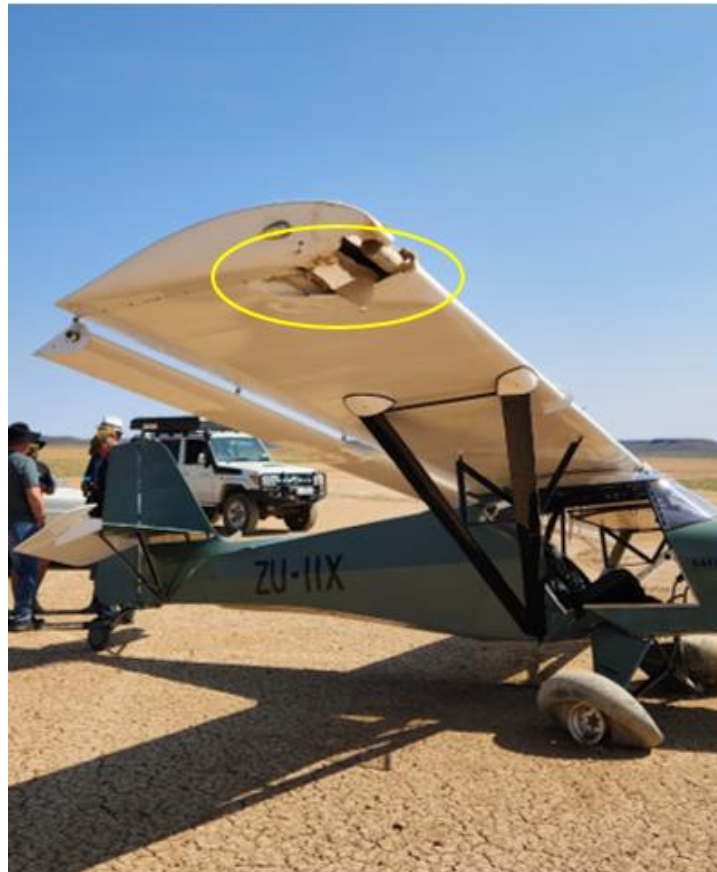
Figure 2: Damaged right-side wingtip. (Source: Pilot)
