AIRCRAFT ACCIDENT REPORT AND EXECUTIVE SUMMARY

Reference:		CA18/2/3/10224		
Helicopter Registration		ZT-RFG	Date of Accident		17 September 2022		Time of Accident	0825Z
Type of Helicopter		Aerospatiale AS350B3e Ecureuil (H125)			Type of Operation		Private (Part 91)	
Pilot-in-command Licence Type		Private Pilot Licence (PPL)		Age	29	Licence Valid	Yes	
Pilot-in-command Flying Experience		Total Flying Hours		129.2		Hours on Type	33	
Last Point of Departure		De Oudekraal Farm, near Bloemfontein, Free State Province						
Next Point of Intended Landing		Karoo Gateway Aerodrome (FABW), Beaufort West, Western Cape Province						
Damage to Helicopter		Substantial						
Location of the accident site with reference to easily defined geographical points (GPS readings if possible)								
Global Positioning System (GPS) co-ordinates determined to be 32° 18.06.31' South 22°39.54.05' East, near the fuel bay at Beaufort West Airport								
Meteorological Information		Wind direction: 200°; Wind speed: 04kts; Temperature: 20°C; Dew point: 02°C; Cloud cover: Nil; Cloud base: Nil; Visibility: 9 999m; QNH: 1015hPa

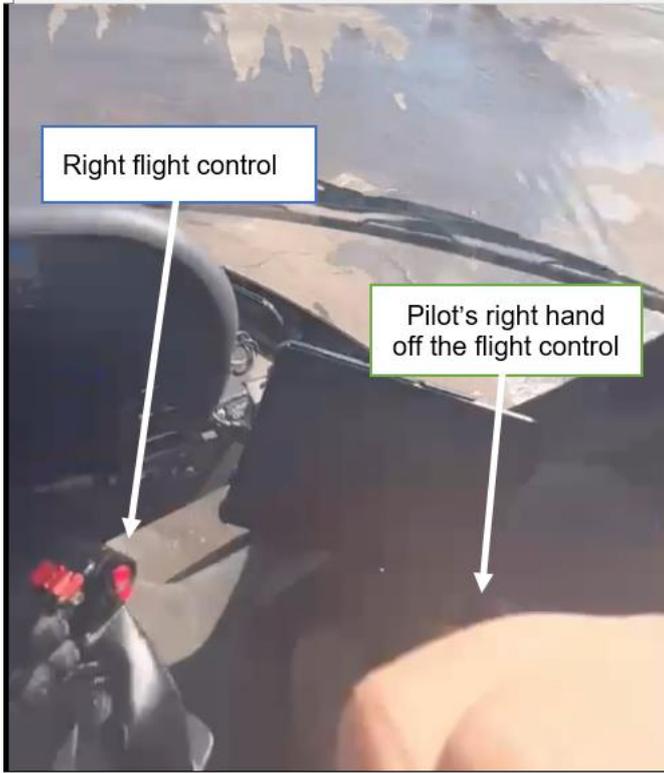
Figure 3: Controls are unattended. (Source: cellular phone video)

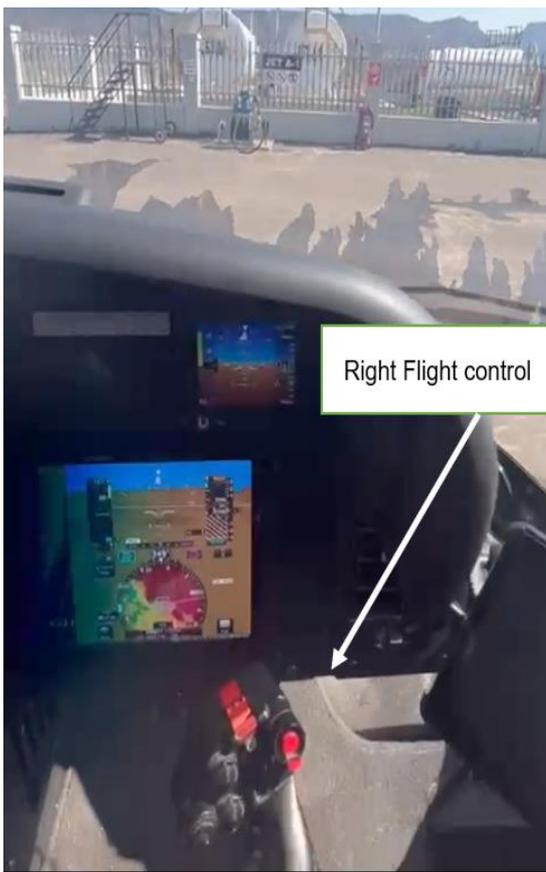
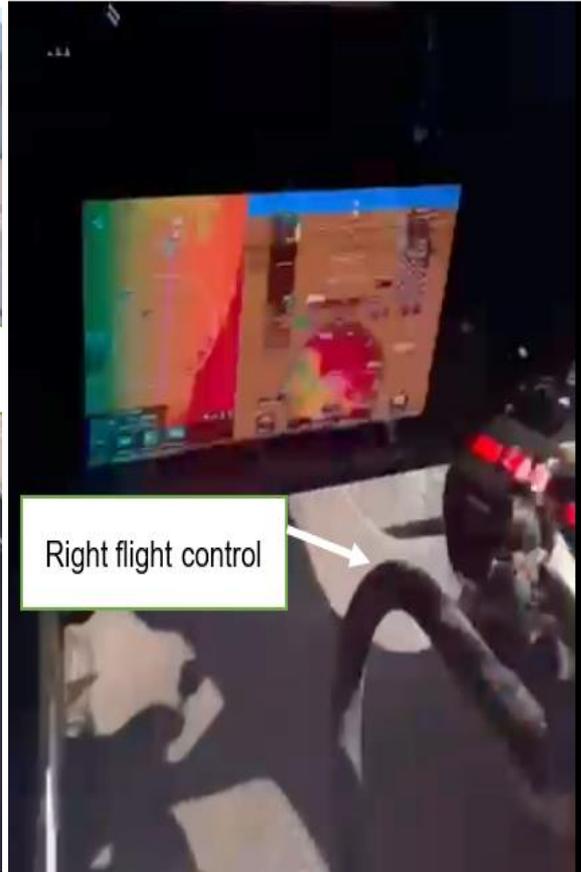
Figures 4 and 5: Still pictures show unattended right flight controls from different angles. (Source: Cellular phone video)

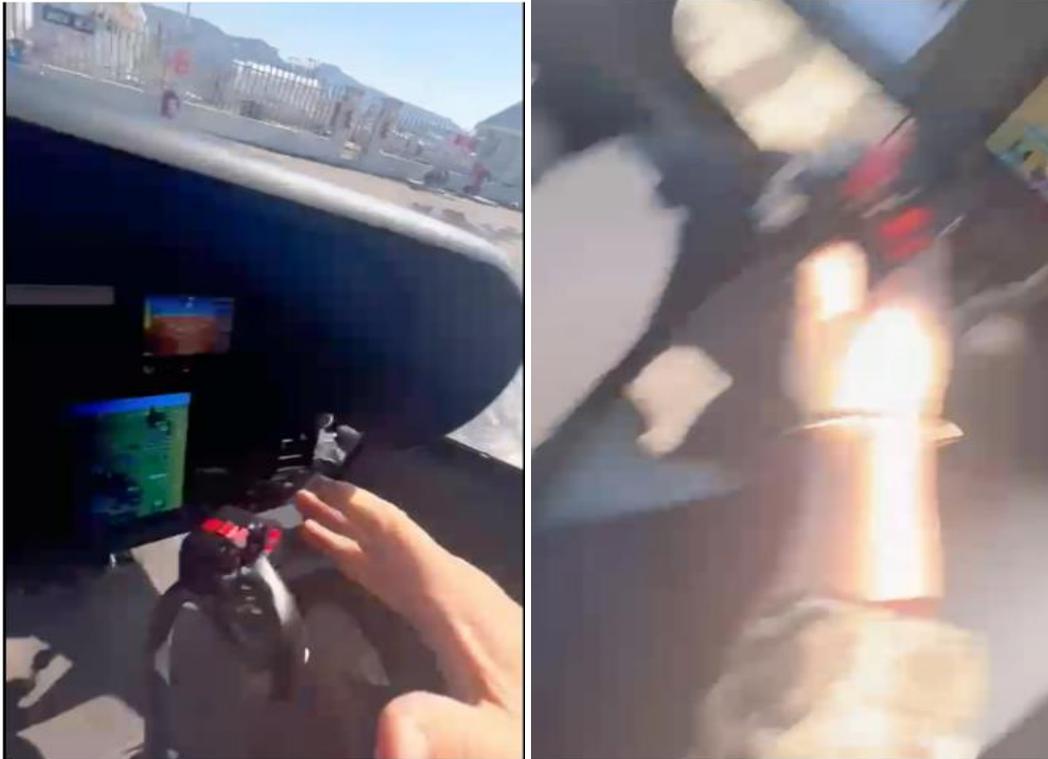
Figures 6 and 7: The pilot reaches for the right flight controls. (Source: cellular phone video)

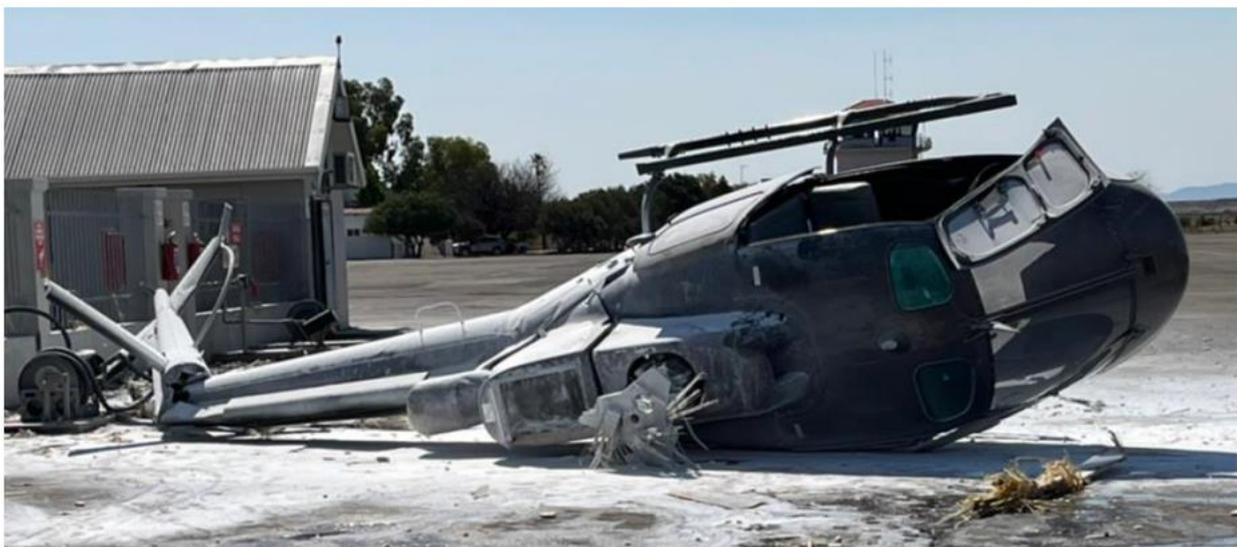
1.3.1. The helicopter was substantially damaged during the accident sequence.

Figure 9: The helicopter’s final resting position at the accident site. (Source: Operator)

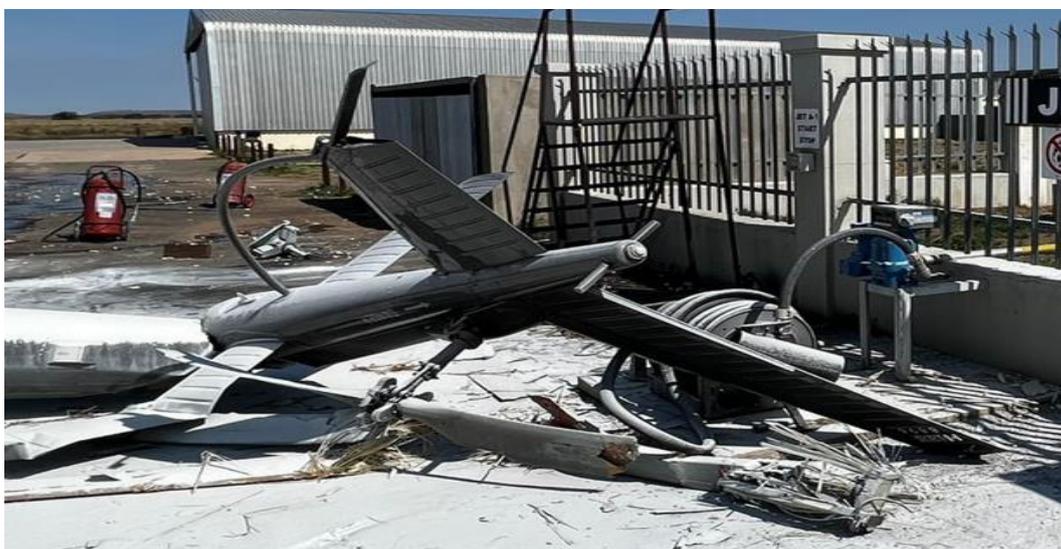
1.12.1 The helicopter was hover-taxiing at a height of 500 ft AGL and at a speed of 20 kts, (definition of hover-taxi in ground effect is presented in 1.12.3) towards the fuel bay. During the landing phase, the helicopter touched down on the ground twice with the skids, bounced, yawed to the left and spun 180° before it flipped and came to rest on its right side. The tail boom and the horizontal stabiliser were severed from the main body by the equipment at the fuel bowser (see Figure 12). The three main rotor blades struck

Figure 12: The separated tail rotor. (Source: Operator)

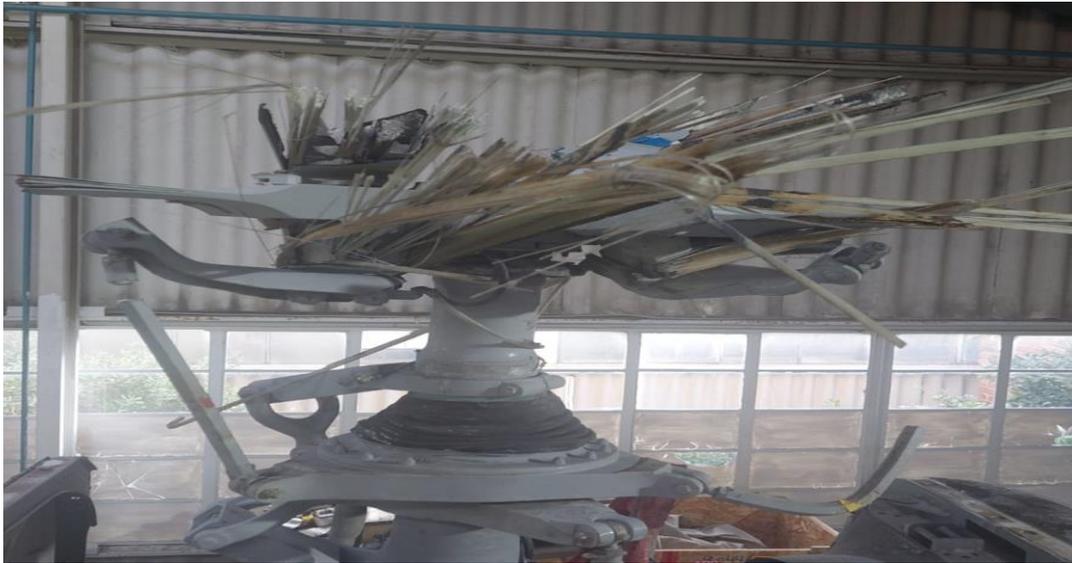
the ground and sheared from the rotor head (see Figure 13). The helicopter was found resting on its right side with the nose pointing south-east (SE), which was the direction of flight. The integrity of the cockpit was not compromised.

Figure 13: The sheared main rotor blades.

- 2.2.6 The main rotor blades and Starflex main rotor head damage were consistent with the blades rotating at high speed when they struck the ground. They were also consistent with the main rotor being driven by the engine when it struck the ground. There were no pre-existing faults found, and the damage sustained by the engine was consistent with the impact sequence.

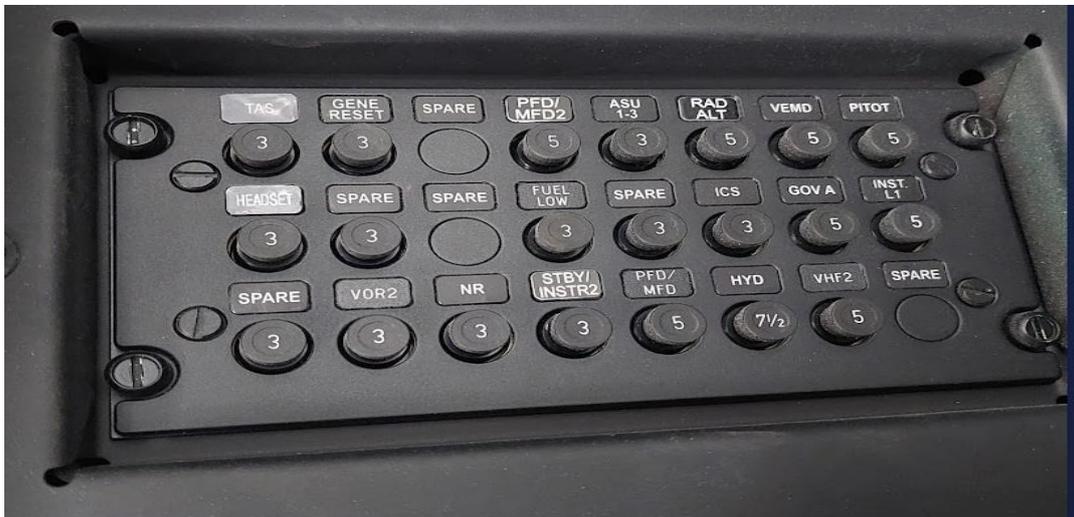
1.12.3 Damage on the main rotor blades indicated that the main rotor was operating at high speed when it struck the ground. The three arms of the Starflex main rotor head displayed rotational damage. The circuit breaker (CB) and the fuse were intact (see Figure 14).

Figure 14: The circuit breakers.

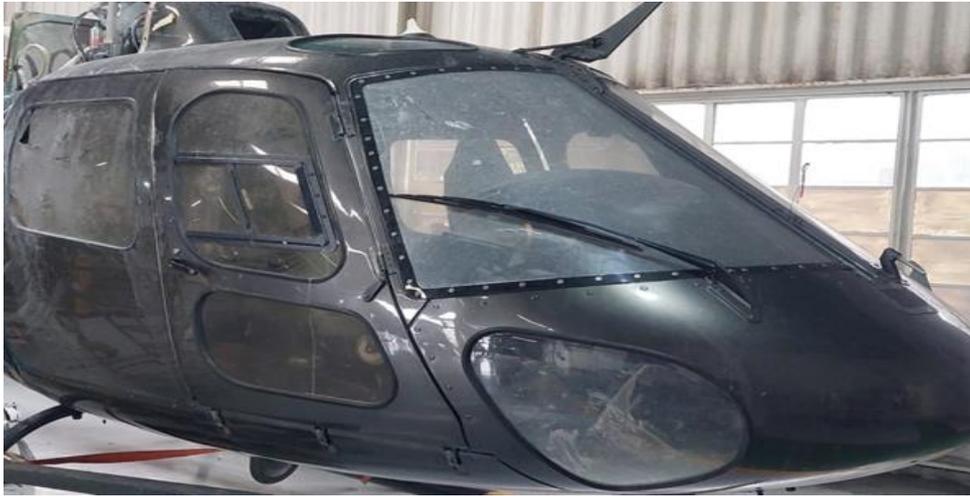
1.15.1 The accident was considered survivable as no damage was caused to the cockpit and cabin structure of the helicopter. The seats and the restraints were intact. There was no fire. The evacuation from the helicopter was prompt.

Figure 15: The intact cabin.

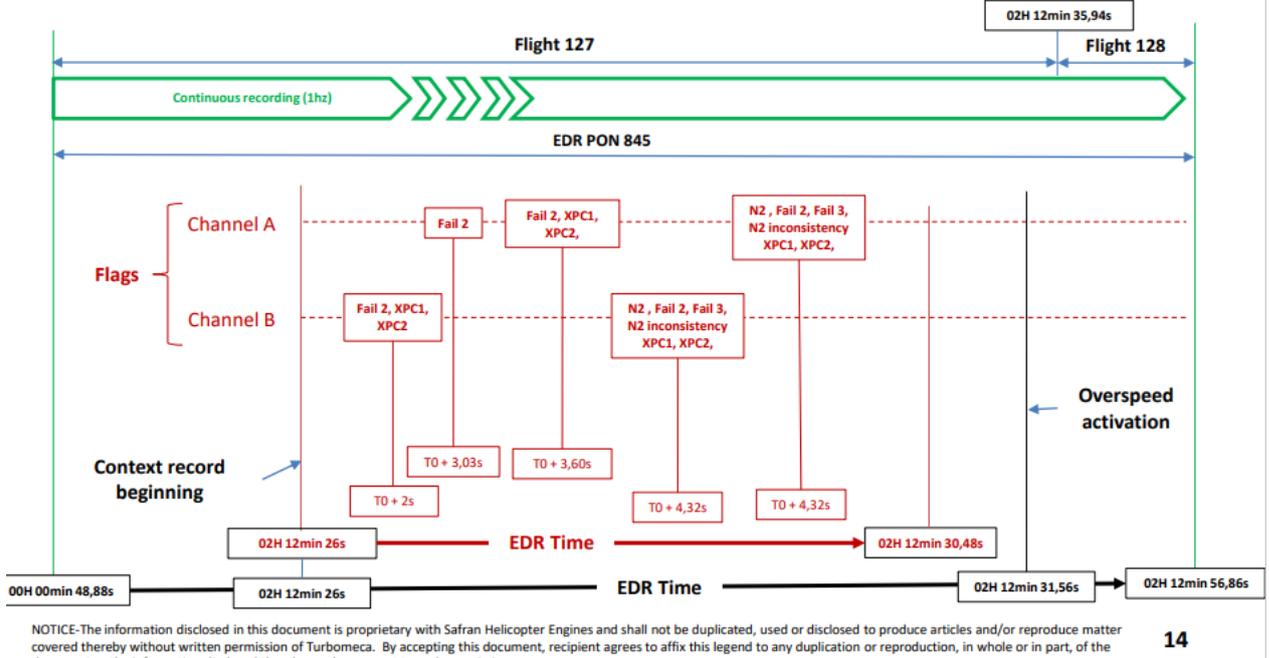
Figure 16: The chronology of the flags with regards to accident timing. (Source: Manufacturer)

- 3.2.6 Evidence showed that the overspeed protection was responsible for shutting down the engine after impact.
- 3.2.7 The helicopter was structurally intact prior to impact, it was damaged by impact forces.
