LIMITED OCCURRENCE INVESTIGATION REPORT – FINAL

Reference Number	CA18/2/3/10225						
Classification	Accident	Date	13 September 2022	Time	0801Z		
Type of Operation	Remotely Piloted Aircraft System, RPAS (Part 101) Mapping						
Location							
Place of Departure	Kolomela Mine Klipbankfontein PIT, Northern Cape Province		Place of Intended Landing	Kolomela Mine, Klipbankfontein PIT, Northern Cape Province			
Place of Occurrence	Kolomela Mine Klipbankfontein PIT, Northern Cape Province						
GPS Co-ordinates	Latitude	28° 24' 7.06" S	Longitude	022° 57' 31.04" E	Elevation	4478 ft	
Aircraft Information							
Registration	ZT-UJX						
Make; Model; S/N	DJI Phantom 4 RTK (Serial Number: P400010)						
Damage to Aircraft	Substantial			Total Aircraft Hours	202.5		
Pilot-in-command							
Licence Type	RPL Multi Rotor		Gender	Male		Age	37
Licence Valid	Yes	Total Hours	84.03		Total Hours on Type	37.39	
Total Hours 30 Days	7.9		Total Flying on Type Past 90 Days	37.39

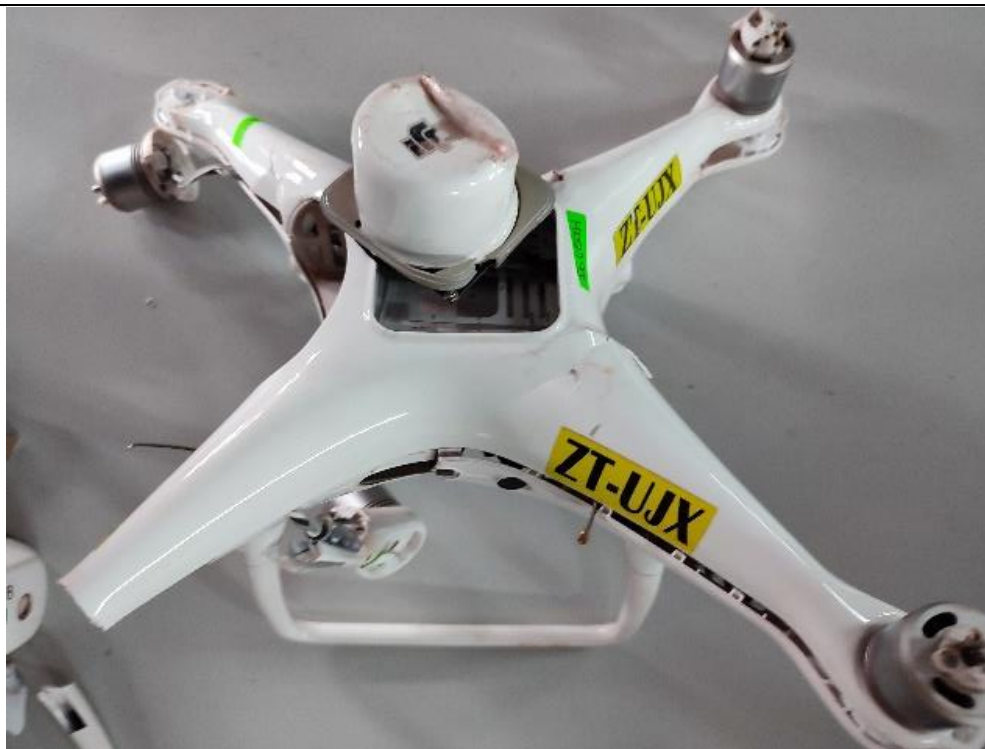
Figure 1: The ZT-UJX after recovery. (Source: Operator)

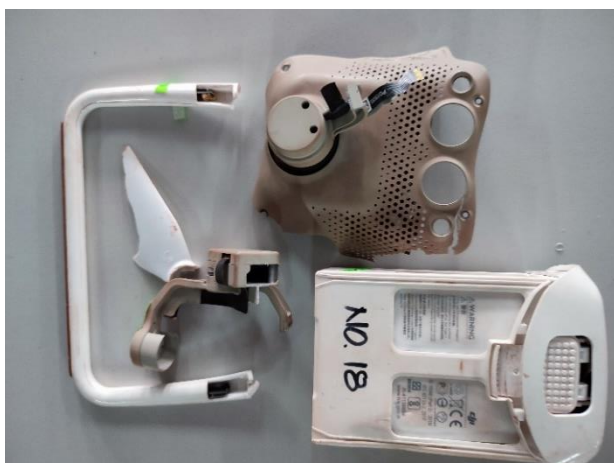
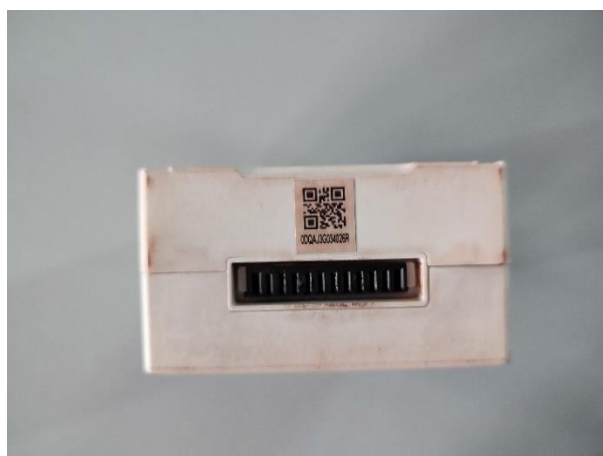
Figures 2 and 3: Damaged battery, propeller blade, gimbal and skid. (Source: Operator)
