LIMITED OCCURRENCE INVESTIGATION REPORT – FINAL

Reference Number	CA18/2/3/10227						
Classification	Accident	Date	4 October 2022		Time	1040Z	
Type of Operation	Training (Part 141)						
Location							
Place of Departure	Cape Winelands Aerodrome, (FAWN) Western Cape Province		Place of Intended Landing		Cape Winelands Aerodrome (FAWN), Western Cape Province		
Place of Occurrence	Cape Winelands Aerodrome (FAWN)						
GPS Co-ordinates	Latitude	S 33°46'17.4"	Longitude	E 018°44'24"	Elevation	400ft	
Aircraft Information							
Registration	ZS-FYY						
Make; Model; S/N	Piper 28R-200 Cherokee Arrow (Serial Number: 28R-35203)						
Damage to Aircraft	Substantial			Total Aircraft Hours	4907.7		
Pilot-in-command							
Licence Type	Airline Transport Pilot Licence (ATPL) Aeroplane		Gender	Male		Age	47
Licence Valid	Yes	Total Hours	3230.5		Total Hours on Type	93.6	
Total Hours 30 Days	2.0		Total Flying on Type Past 90 Days	25.7			
People On-board	2+0	Injuries	0	Fatalities	0	Other (on ground)	0

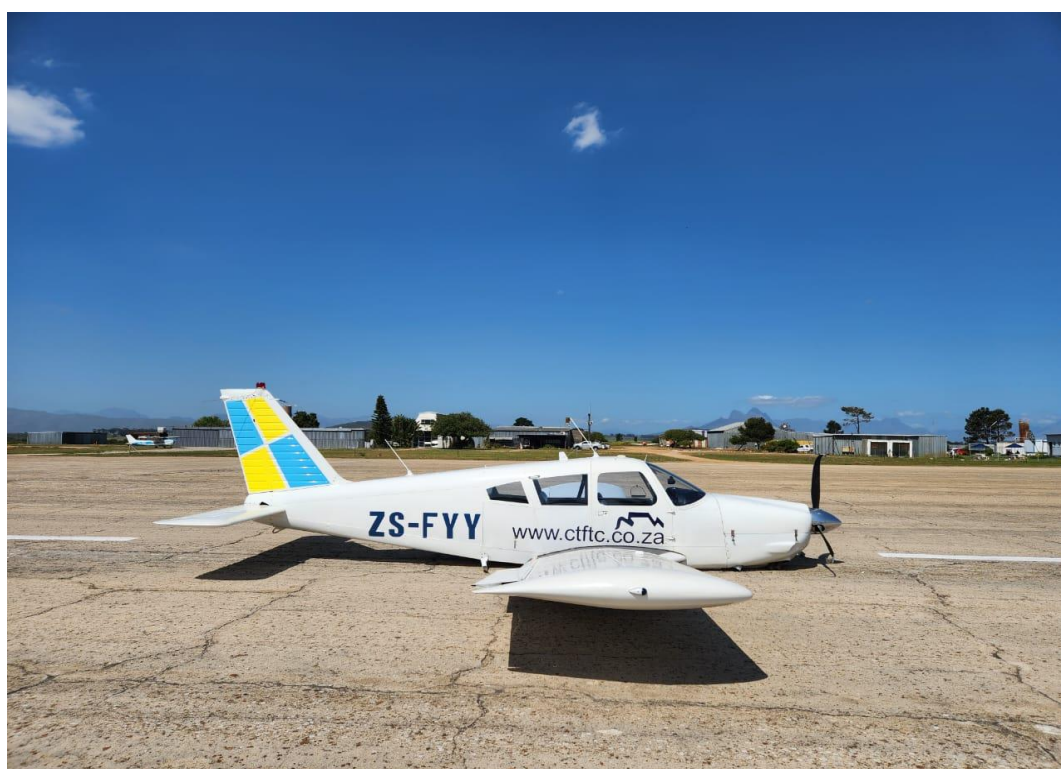
During the downwind leg, the SP failed to extend the flaps and the landing gear as required. The FI stated that the SP did not complete the outstanding downwind checks, and he (FI) did not confirm that the downwind checks were completed as he was looking out for other traffic in the circuit whilst the SP turned base leg for final approach. During the final approach, the FI was focused on the student’s performance because he did not want to repeat the unstable approach scenario, however, they missed the final approach checks which led to a landing with the gear retracted. The aircraft sustained substantial damage to the propeller and the underbelly, however, the FI and the SP were unharmed.

Figure 1: The aircraft as it came to rest. (Source: Pilot)

<ul style="list-style-type: none"> The SP omitted to lower the landing gear during the downwind checks and during the final approach checks, and the FI forgot to check if the gear was lowered. This resulted in the aircraft landing with the undercarriage retracted. The aircraft skidded on its belly, which got damaged together with the propellers.
<p>Probable Cause</p> <p>The FI and the SP omitted to lower the landing gear during the downwind checks and, again, during the final approach checks, which resulted in the aircraft landing with the undercarriage retracted. The aircraft skidded on its belly, which got damaged together with the propellers.</p>
<p>Contributing Factor(s)</p> <ul style="list-style-type: none"> Failure to complete the landing checklist. FI did not monitor the SP during the critical phase of flight (landing).
<p>Safety Action(s)</p> <p>None.</p>
<p>Safety Message and/or Safety Recommendation/s</p> <p>To prevent these types of accidents, pilots are reminded to always be vigilant during the critical stages of flight such as take-offs and landings, and also to opt for a go-around when unsure. The FIs are reminded to check their students during these critical phases of flight.</p>
