LIMITED OCCURRENCE INVESTIGATION REPORT – FINAL
--

Reference Number	CA18/2/3/10228						
Classification	Accident		Date	20 September 2022		Time	1435Z
Type of Operation	Part 93 (Corporate Operations)						
Location							
Place of Departure	Pietermaritzburg Airport (FAPM), KwaZulu-Natal Province			Place of Intended Landing	King Shaka International Airport (FALE), KwaZulu-Natal Province		
Place of Occurrence	On Runway 16 at Pietermaritzburg Airport (FAPM)						
GPS Co-ordinates	Latitude	29°38'48.44" S	Longitude	030°23'51.98" E	Elevation	2 423 feet	
Aircraft Information							
Registration	ZS-PKR						
Make; Model; S/N	Dassault Aviation, Falcon 2000 (Serial Number: 114)						
Damage to Aircraft	Substantial			Total Aircraft Hours	3 482.7		
Pilot-in-command							
Licence Type	Airline Transport Pilot Licence (ATPL)		Gender	Male		Age	70
Licence Valid	Yes	Total Hours	13 860		Total Hours on Type	3 500	
Total Hours Past 30 Days	13.9		Total Flying Hours on Type Past 90 Days			21.4

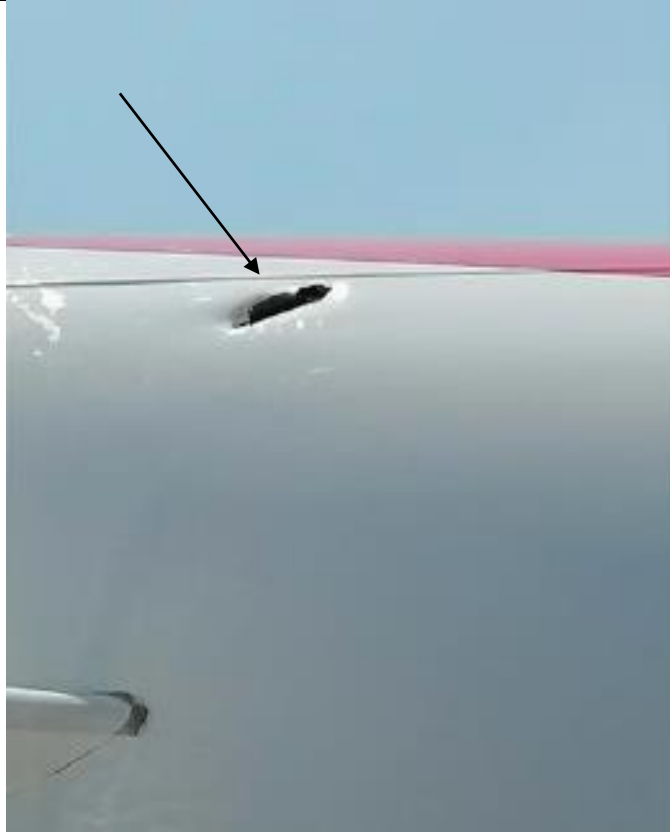
Following an external inspection of the aircraft, it was found that several of the number 2 engine compressor fan blades had been damaged, and that some of the engine hardware (fractured compressor blades) had penetrated the upper right-side of the fuselage, approximately 15 centimetres (cm) in front of the aft pressurised baggage compartment bulkhead. This was due to the bird flying into the engine.

Figure 2: An arrow showing damage to the fuselage. (Source: Operator)

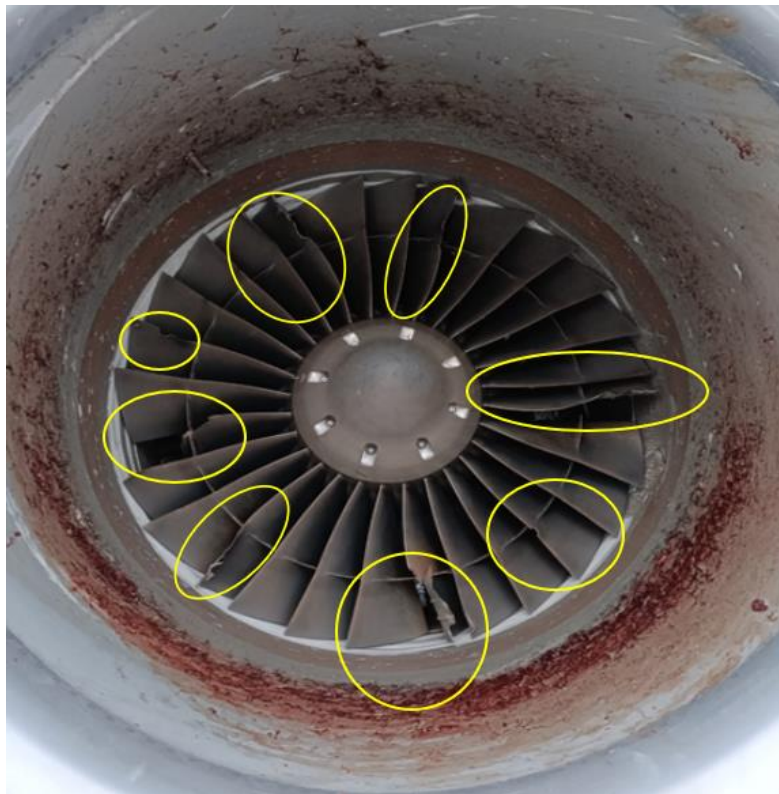
Apart from damage to the No.2 engine and the area where the fuselage was damaged by the fractured engine hardware, no other damage was caused to the aircraft.

Figure 3: The damaged No.2 engine fan blades: (Source: Operator)

During the take-off roll, the No.2 engine spooled down to zero after suffering substantial damage after a bird flew into the engine; the crew conducted a successful RTO.
