LIMITED OCCURRENCE INVESTIGATION REPORT – FINAL

Reference Number	CA18/2/3/10229						
Classification	Accident	Date	15 October 2022		Time	0854Z	
Type of Operation	Aerial Surveillance (Part 101)						
Location							
Place of Departure	Anglo American Mogalakwena Mine in Limpopo Province		Place of Intended Landing		Anglo American Mogalakwena Mine in Limpopo Province		
Place of Occurrence	Anglo American Mogalakwena Platinum Mine						
GPS Co-ordinates	Latitude	25°58'49.03" S	Longitude	028°54'9.73" E	Elevation	4478 ft	
Aircraft Information							
Registration	ZT-XNE						
Make; Model; S/N	DJI MATRICE, 300 RTK (Serial Number: 1ZNBJ7B00C00GL)						
Damage to Aircraft	Substantial			Total Aircraft Hours	68.58		
Pilot-in-command							
Licence Type	RPL Multirotor		Gender	Male		Age	46
Licence Valid	Yes	Total Hours	20.0		Total Hours on Type	17.09	
Total Hours 30 days	07.39		Total Flying on Type Past 90 days		07.39		
People Controlling	1	Injuries	0	Fatalities	0	Other (on ground)	0

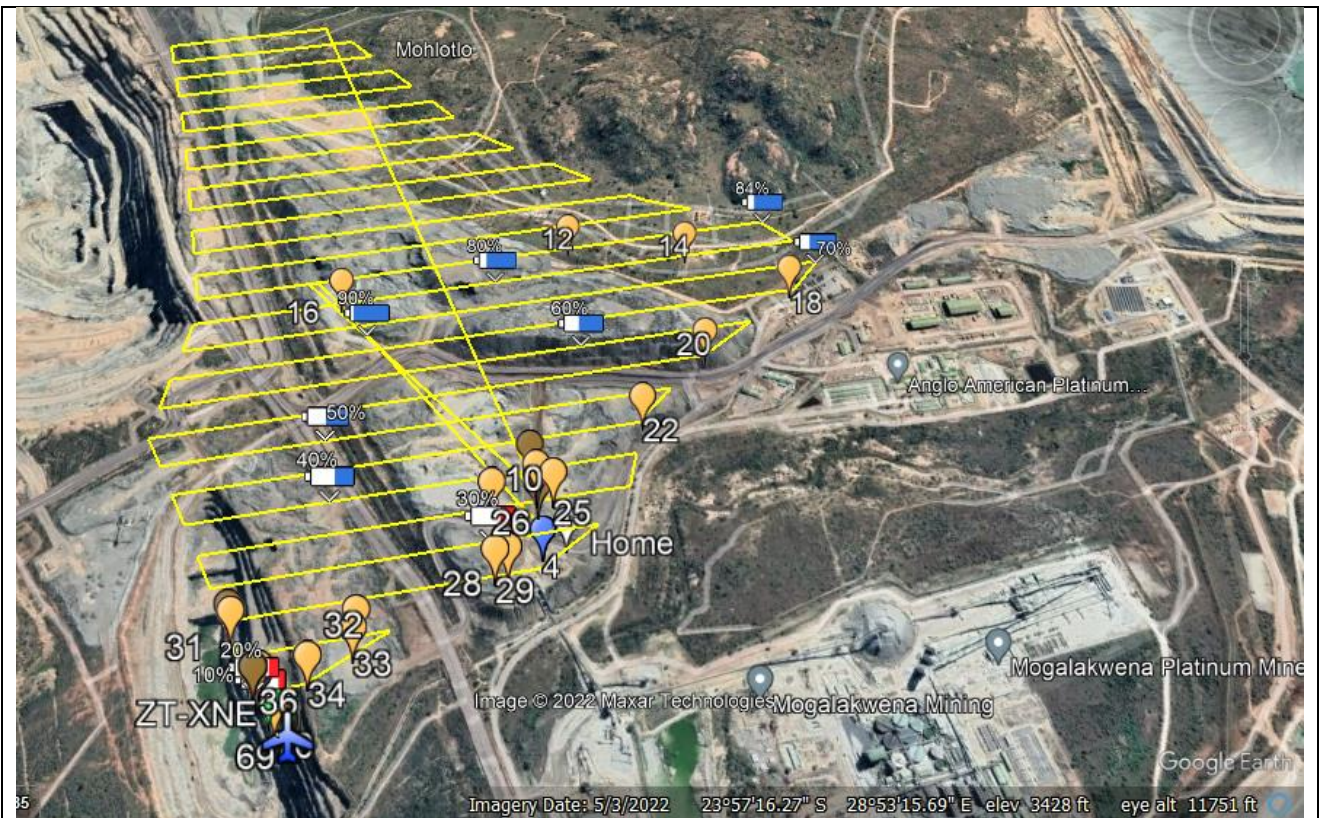
What Happened							
<p>On 15 October 2022 at 0819Z, a pilot operating a remotely piloted aircraft (RPA) with registration ZT-XNE launched the RPA for aerial surveillance from Anglo American Mogalakwena Mine in Limpopo Province. The flight was conducted under visual line of sight (VLOS) by day and under the provisions of Part 101 of the Civil Aviation Regulations (CAR) 2011 as amended.</p> <p>The pilot stated that the RPA was launched with 94% battery power. It flew overhead the 'Big Mike Stockpiles' in the mine and completed the mission at approximately 0848Z with 10% battery power still remaining. The pilot observed the RPA from the controller display indicator returning to home base. However, the RPA then disconnected from the controller. This usually lasts a few seconds before the Command-and-Control link (C2) reconnects again, but this time it remained disconnected. The pilot activated the Return-to-home (RTH) function on the controller, but the RPA did not reconnect.</p> <p>The pilot then radioed the search crew for assistance in locating and recovering the RPA. The RPA was later spotted in the south pit of the mine with the help (use) of another RPA. It was recovered at approximately 1620Z with damage to the antennae, propellers and right front arm.</p>

Figure 1: The view of the accident site. (Source: Pilot)

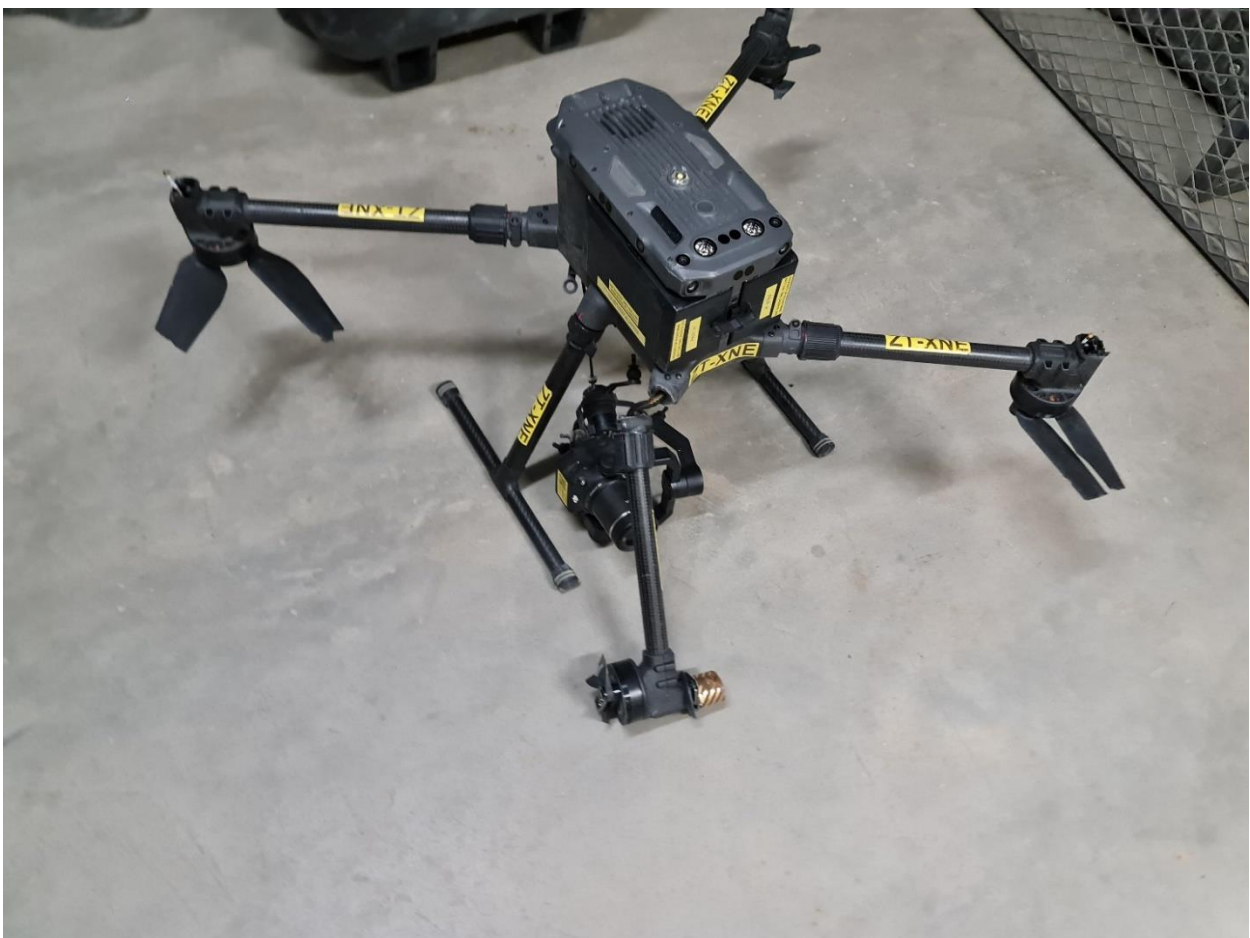
Figure 2: The ZT-XNE after it was recovered. (Source: Operator)

Loss of C2 communication link between the controller and the RPA due to battery power being below 10%.

Contributing Factor
Operating the RPA below the critical battery reserve of 10%.
Safety Action(s)
None.
Safety Message and/or Safety Recommendation/s
Pilots are encouraged to always follow the guidelines as prescribed in the Standard Operating Procedures (SOP) as well as comply with the regulations.
About this Report
<p><i>The decision to conduct a limited investigation is based on factors including whether the cause is known and the evidence supporting the cause is clear, the level of safety benefit likely to be obtained from an investigation and that will determine the scope of an investigation. For this occurrence, a limited investigation has been conducted, and the Accident and Incident Investigations Division (AIID) has relied on the information submitted by the affected person/s and organisation/s to compile this limited report. The report has been compiled using information supplied in the initial notification, as well as from follow-up desk top enquiries to bring awareness of potential safety issues to the industry in respect of this occurrence, as well as possible safety action/s that the industry might want to consider in preventing a recurrence of a similar occurrence.</i></p> <p><i>All times given in this report are Co-ordinated Universal Time (UTC) and will be denoted by (Z). South African Standard Time is UTC plus 2 hours.</i></p>
