LIMITED OCCURRENCE INVESTIGATION REPORT – FINAL

Reference Number	CA18/2/3/10230					
Classification	Accident	Date	19 October 2022	Time	0800Z	
Type of Operation	Game Capture (Part 137)					
Location						
Place of Departure	Ozabeni Game Reserve, KwaZulu-Natal Province	Place of Intended Landing	Ozabeni Game Reserve, KwaZulu-Natal Province			
Place of Occurrence	Ozabeni Game Reserve, KwaZulu-Natal Province					
GPS Co-ordinates	Latitude	27°35'11.45" S	Longitude	32°39'6.42" E	Elevation	102 ft
Aircraft Information						
Registration	ZS-RBM					
Make; Model; S/N	Robinson; R22 Beta (Serial Number: 1895)					
Damage to Aircraft	Substantial			Total Aircraft Hours	5929.6	
Pilot-in-command						
Licence Type	Commercial Pilot Licence (CPL) Helicopter		Gender	Male	Age	40
Licence Valid	Yes	Total Hours	4630.3	Total Hours on Type	397.1	
Total Hours Past 90 Days	162.7		Total Hours on Type Past 90 Days			18.7
People On-board	1 + 0	Injuries	0	Fatalities	0	Other (on ground) 0

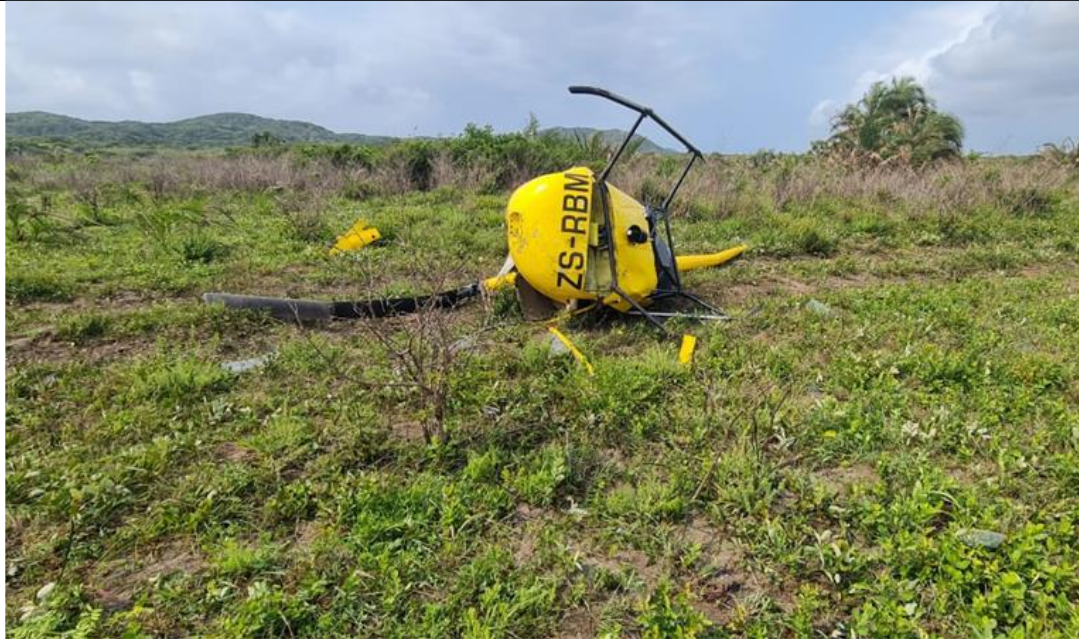
Figure 1: The helicopter resting on its starboard side. (Source: Pilot)

The helicopter was left unattended whilst the engine and the rotors were still running; as a result, the helicopter momentarily lifted off uncommanded before it impacted the ground.

Pilots are advised to adhere to safety notices as stipulated in the Pilot's Operating Handbook, as well as remain in charge of the flight controls whenever the engine is running and the rotors are turning.

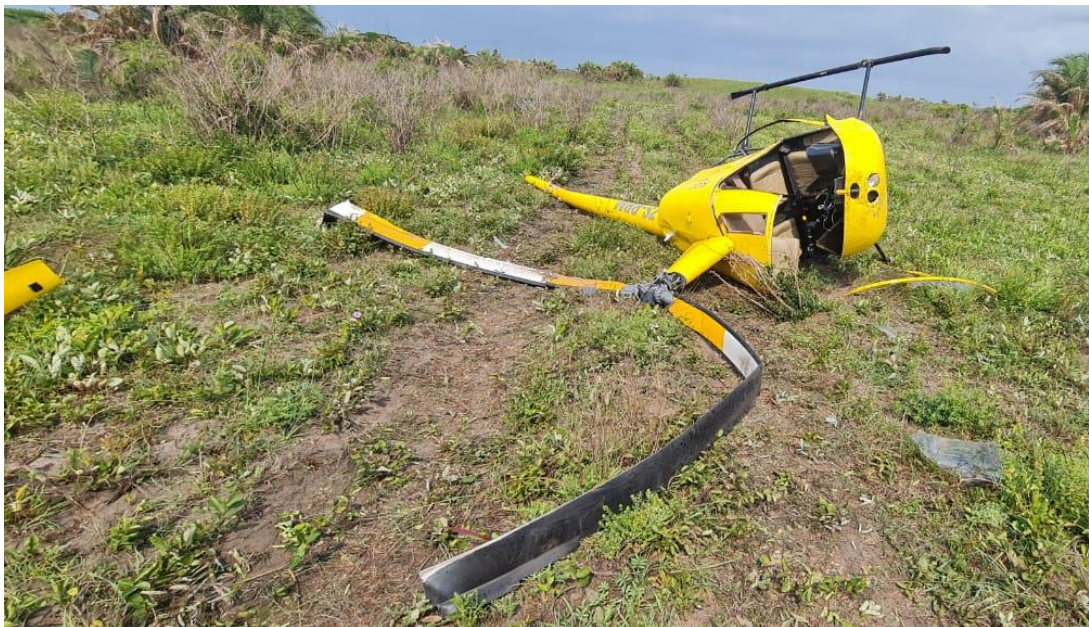
Figure 2: The substantially damaged helicopter post-accident. (Source: Pilot)
