LIMITED OCCURRENCE INVESTIGATION REPORT – FINAL

Reference Number	CA18/2/3/10231						
Classification	Accident	Date	20 October 2022		Time	1208Z	
Type of Operation	Training (Part 141)						
Location							
Place of Departure	Virginia Aerodrome (FAVG), KwaZulu-Natal Province			Place of Intended Landing	Virginia Aerodrome (FAVG), KwaZulu-Natal Province		
Place of Occurrence	During landing on the left-side of Runway 05 at FAVG						
GPS Co-ordinates	Latitude	29° 46' 20.77" S	Longitude	031° 3' 26.19" E	Elevation	28 ft	
Aircraft Information							
Registration	ZS-IEI						
Make; Model; S/N	Piper Cherokee PA-28 -140; Piper Aircraft Corporation (Serial Number: 28-26628)						
Damage to Aircraft	Substantial			Total Aircraft Hours	11 527.83		
Pilot-in-command							
Licence Type	Student Pilot Licence		Gender	Male		Age	19
Licence Valid	Yes	Total Hours	30.7		Total Hours on Type	30.7	
Total Hours 30 Days	12.8		Total Flying on Type Past 90 Days	12.8			
People On-board	1+0	Injuries	0	Fatalities	0	Other (on ground)	0

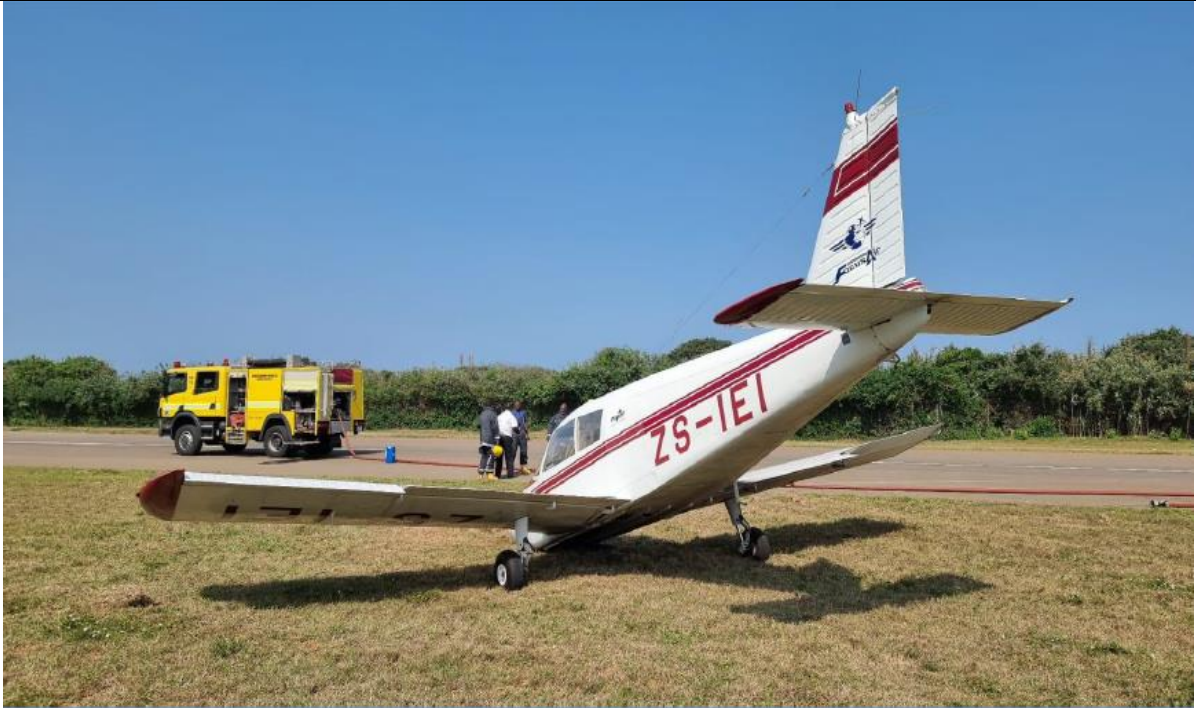
Figure 1: The aircraft after the accident. (Source: Operator)

<p>Probable Cause</p> <p>The aircraft was unstable on approach which led to a hard landing and a bounce. As a result, the pilot lost control of the aircraft which veered off to the left-side of the runway. The nose gear failed before the aircraft came to a stop.</p>
<p>Contributing Factor(s)</p> <p>The gusty weather conditions that prevailed at the time of landing contributed to the bounced landing.</p>
<p>Safety Action(s)</p> <p>None.</p>
<p>Safety Message</p> <p>To prevent these types of accidents, pilots are reminded to always be vigilant during the critical stages of the flight such as take-offs and landings, and to carry out a go-around when unsure.</p>

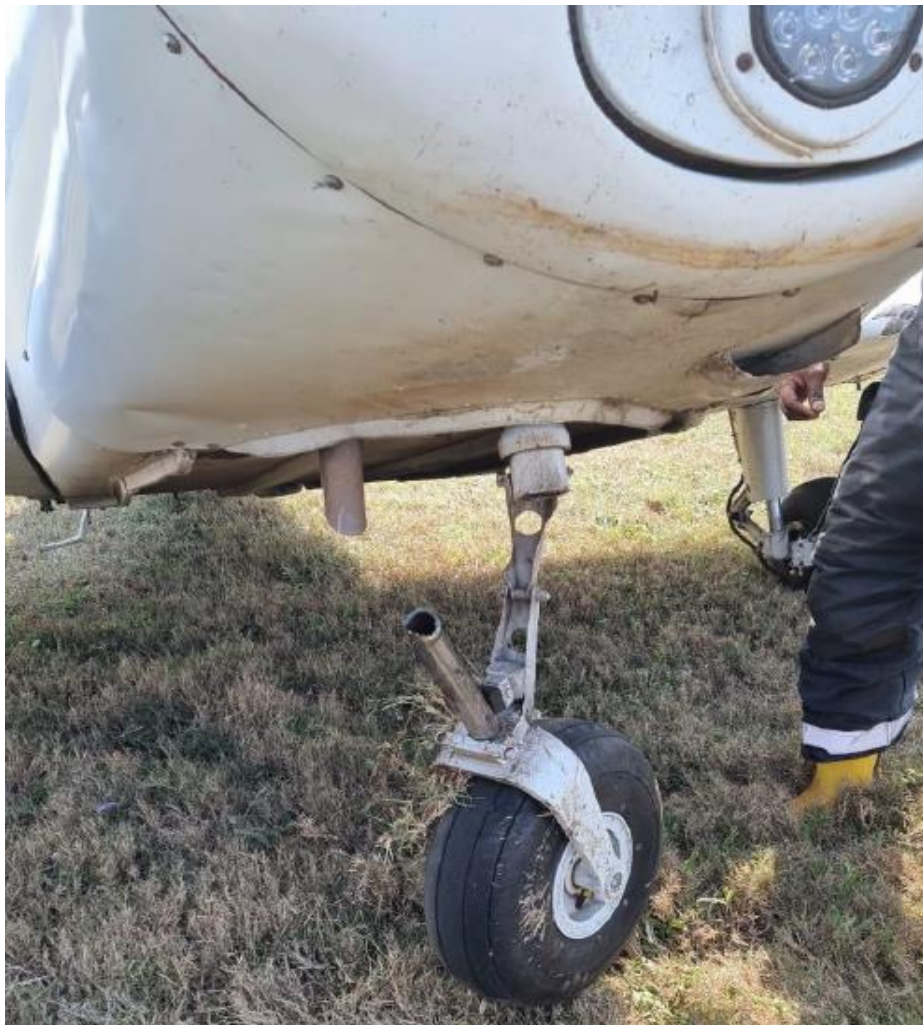
Figure 2: The damaged nose landing gear. (Source: Operator)
