LIMITED OCCURRENCE INVESTIGATION REPORT – FINAL

Reference Number	CA18/2/3/10233				
Classification	Accident	Date	19 November 2022	Time	0502Z
Type of Operation	Private (Part 91)				
Location					
Place of Departure	Vereeniging Airport (FAVV), Gauteng Province		Place of Intended Landing	Vereeniging Airport (FAVV), Gauteng Province	
Place of Occurrence	710m north-west of Runway 21 threshold at FAVV				
GPS Co-ordinates	Latitude	26° 33' 25.9" S	Longitude	27° 57' 35.9" E	Elevation 4893 ft
Aircraft Information					
Registration	ZS-DUR				
Make; Model; S/N	Cessna 172E (172-51496)				
Damage to Aircraft	Substantial		Total Aircraft Hours	4001.6	
Pilot-in-command					
Licence Type	Commercial Pilot Licence (CPL) Aeroplane		Gender	Male	Age 22
Licence Valid	Yes	Total Hours	205.6	Total Hours on Type	29.5
Total Hours Past 90 Days	3.4		Total Hours on Type Past 90 Days		0.1
People On-Board	1 + 2	Injuries	0	Fatalities	0
Other (on ground) 0					
What Happened					
<p>On 19 November 2022, a pilot and two passengers on-board a Cessna 172E aircraft with registration ZS-DUR took off on a private flight from Vereeniging Airport (FAVV) in Gauteng province with the intention to land back at the same airpor

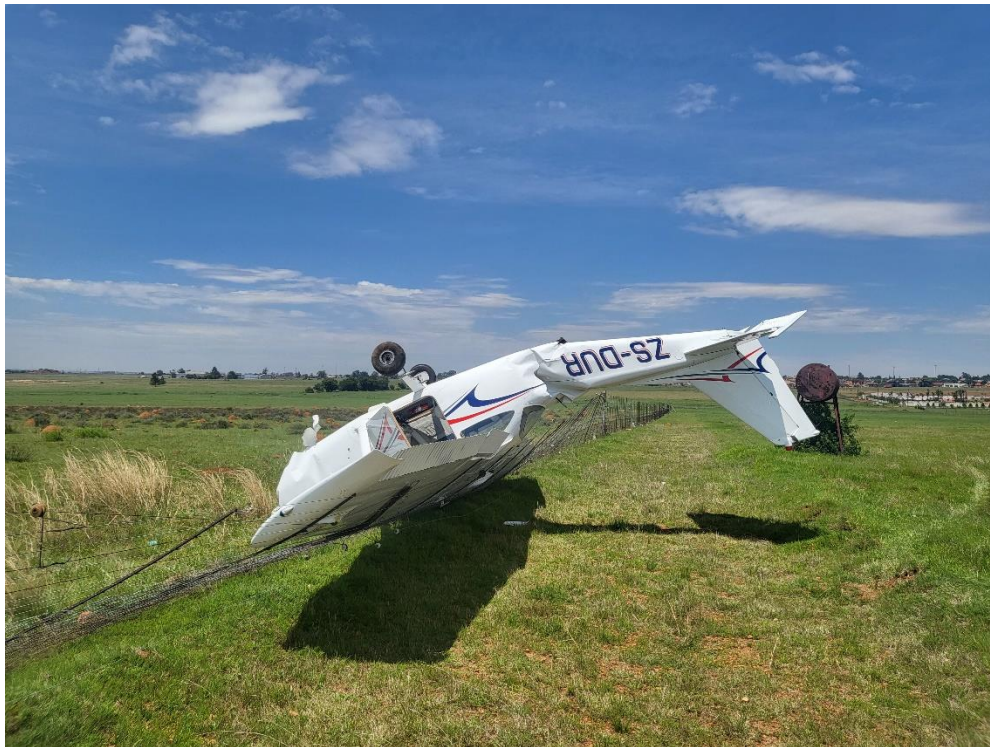
The aircraft sustained substantial damage to the nose landing gear strut, both propeller blades, both wing tips and the empennage structure. The pilot and both passengers were not injured during the accident sequence.

Figure 1: The ZS-DUR aircraft as it came to rest on the electrically charged perimeter fence.

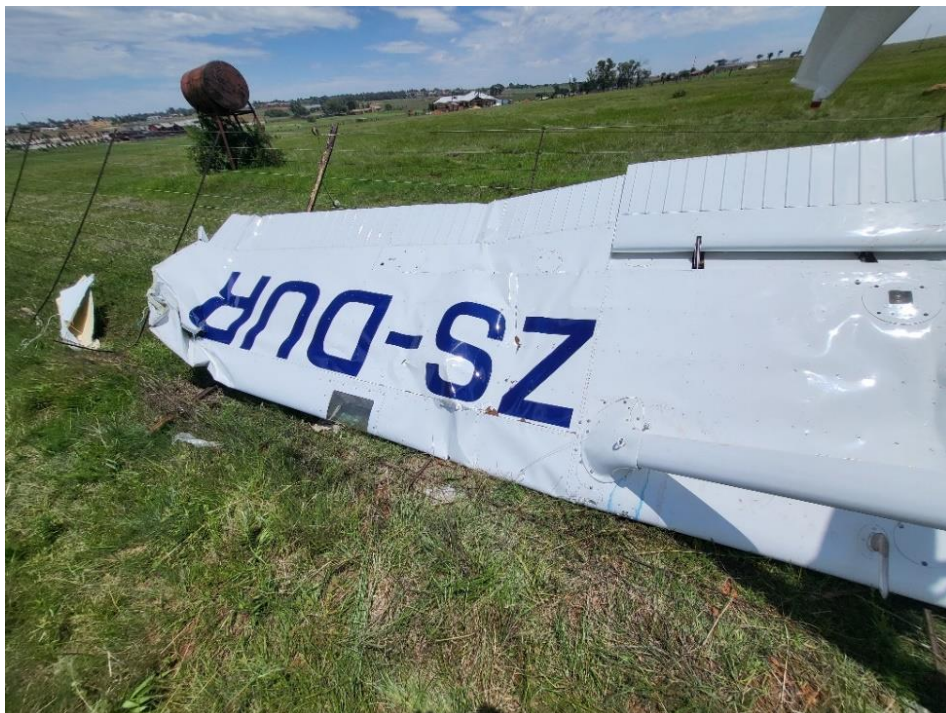
Wreckage examination revealed that the left wing was buckled with bent and compression load damage. The left wing tip was severed, which correlates with the aircraft impacting the ground with the left wing tip first as evidenced by dirt and grass on the wing tip skin. The nose undercarriage broke off from the attachment points and both propeller blades bent backwards, an indication that the aircraft experienced power loss which contributed to the stall shortly after take-off. The engine was intact and still secured to the cradle; it had signs of minor damage due to impact. The flight control

Figure 3: The damaged wing with the severed left wing tip.

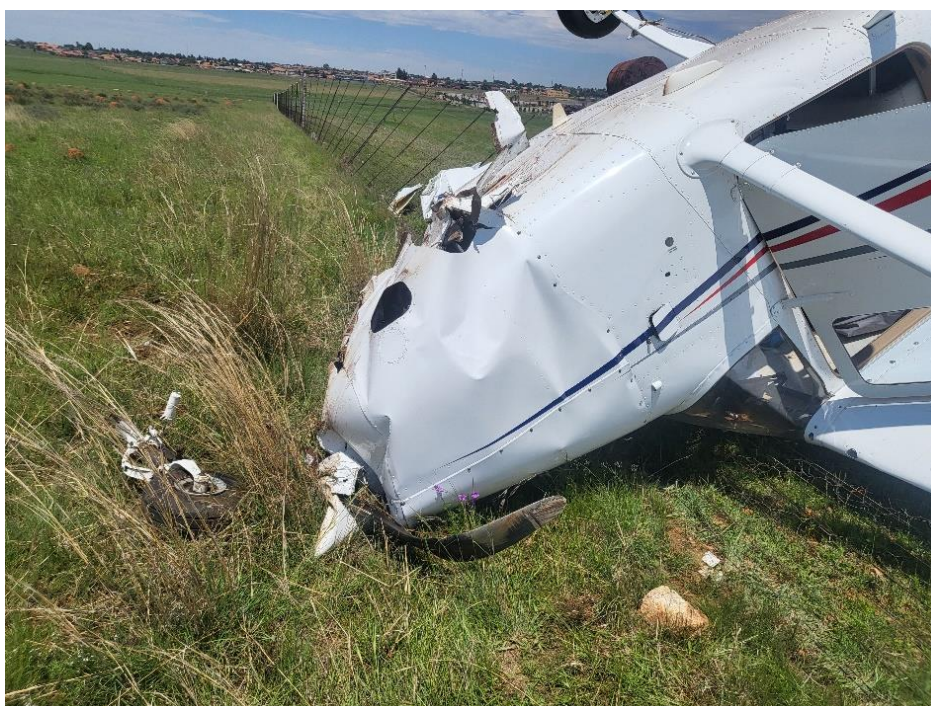
Figure 4: The severed nose undercarriage and bent propeller blades.
