LIMITED OCCURRENCE INVESTIGATION REPORT – FINAL

Reference Number	CA18/2/3/10234						
Classification	Accident	Date	20 September 2022		Time	0536Z	
Type of Operation	Aerial Survey (Part 101)						
Location							
Place of Departure	Wonderfontien Colliery, Mpumalanga Province		Place of Intended Landing	Wonderfontien Colliery, Mpumalanga Province			
Place of Occurrence	Wonderfontien Colliery, Mpumalanga Province						
GPS Co-ordinates	Latitude	25° 49' 54.56" S	Longitude	029° 52' 56.63" E	Elevation	57211ft	
Aircraft Information							
Registration	ZT-XNG						
Make; Model; S/N	DJI Mavic 2 Pro (Serial Number: 163CHATR0A56BY)						
Damage to Aircraft	Not found			Total Aircraft Hours	61		
Pilot-in-command							
Licence Type	Remote Pilot Licence (RPL)		Gender	Female		Age	33
Licence Valid	Yes	Total Hours	334.09		Total Hours on Type	334.09	
Total Hours 30 Days	40		Total Flying on Type Past 90 Days	40			
People On-board	0	Injuries	0	Fatalities	0	Other (on ground)	0

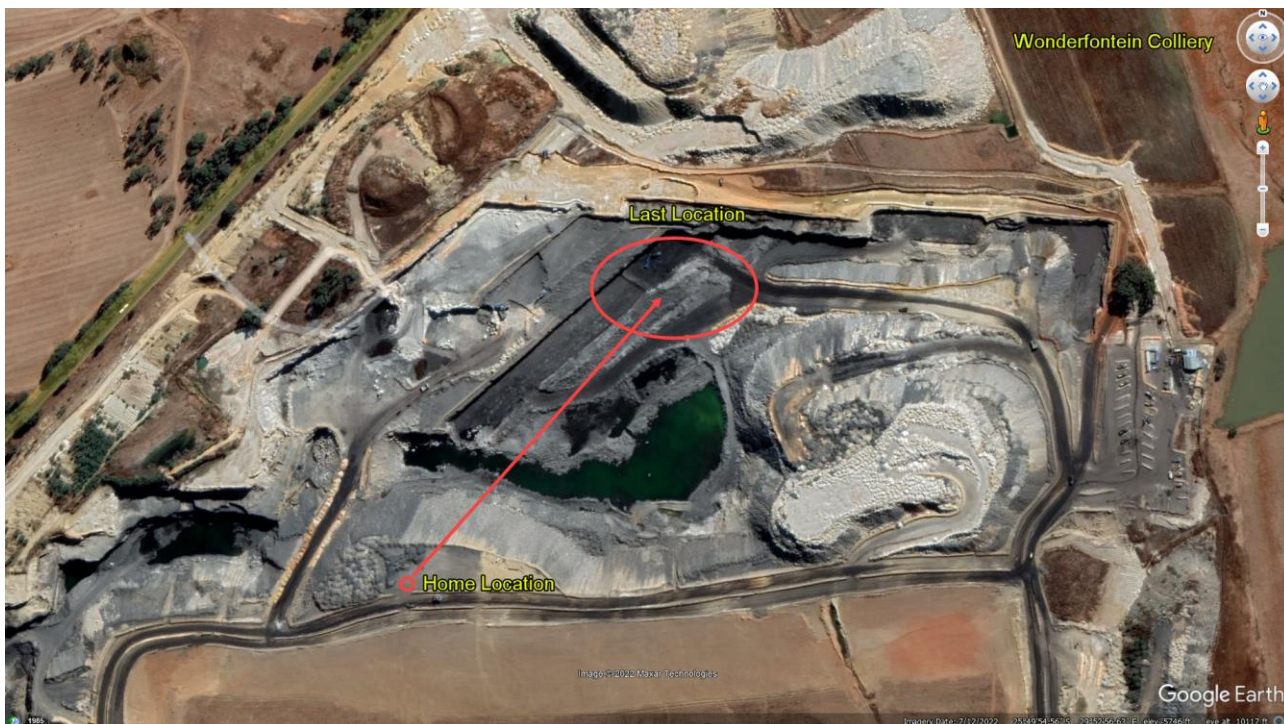
What Happened							
<p>On 20 September 2022, a pilot operating a DJI Mavic 2 Pro remotely piloted aircraft (RPA) with registration ZT-XNG took off on a surveillance flight from Wonderfontein Colliery in Gauteng province with the intention to land back at the same colliery. The flight was conducted in visual line of sight (VLOS) by day and under the provisions of Part 101 of the Civil Aviation Regulations (CAR) 2011 as amended.</p> <p>The pilot stated that she carried out all the required checks before launching the RPA. She also carried out all the checks required by the survey application DroneDeploy; all system checks were in order. She then launched the RPA to the first check point over the mine as prescribed in the DroneDeploy application. Shortly after launching the RPA, the pilot's controller unit shut off (the screen became dark) and the RPA disconnected. The pilot tried to re-establish connection but was unsuccessful.</p> <p>She then set out to the check point where the surveillance was to be carried out, but was unable to locate the RPA. The RPA is suspected to have been buried under the rocks, possibly after a blast in the mine. The RPA has not been recovered. The operator stated that it is likely that the RPA was</p>

involved in a bird strike moments before the mine blast, however, there was no evidence to support this theory.

Figure 1: The area where the RPA was last tracked. (Source: Operator)

- There were no injuries reported.
- The RPA is likely buried under the rocks following the mine blast.

It is likely that the RPA lost Command and Control (C2) connection, which resulted in the loss of control of the RPA. The loss of C2 connection is undetermined.
