LIMITED OCCURRENCE INVESTIGATION REPORT – FINAL

| Reference Number | CA18/2/3/10235 | | | | | | |
| Registration | ZT-XSZ | | | | | | |
| Make; Model; S/N | DJI Mavic 2, Enterprise Advanced (Serial Number: MAV0096) | | | | | | |

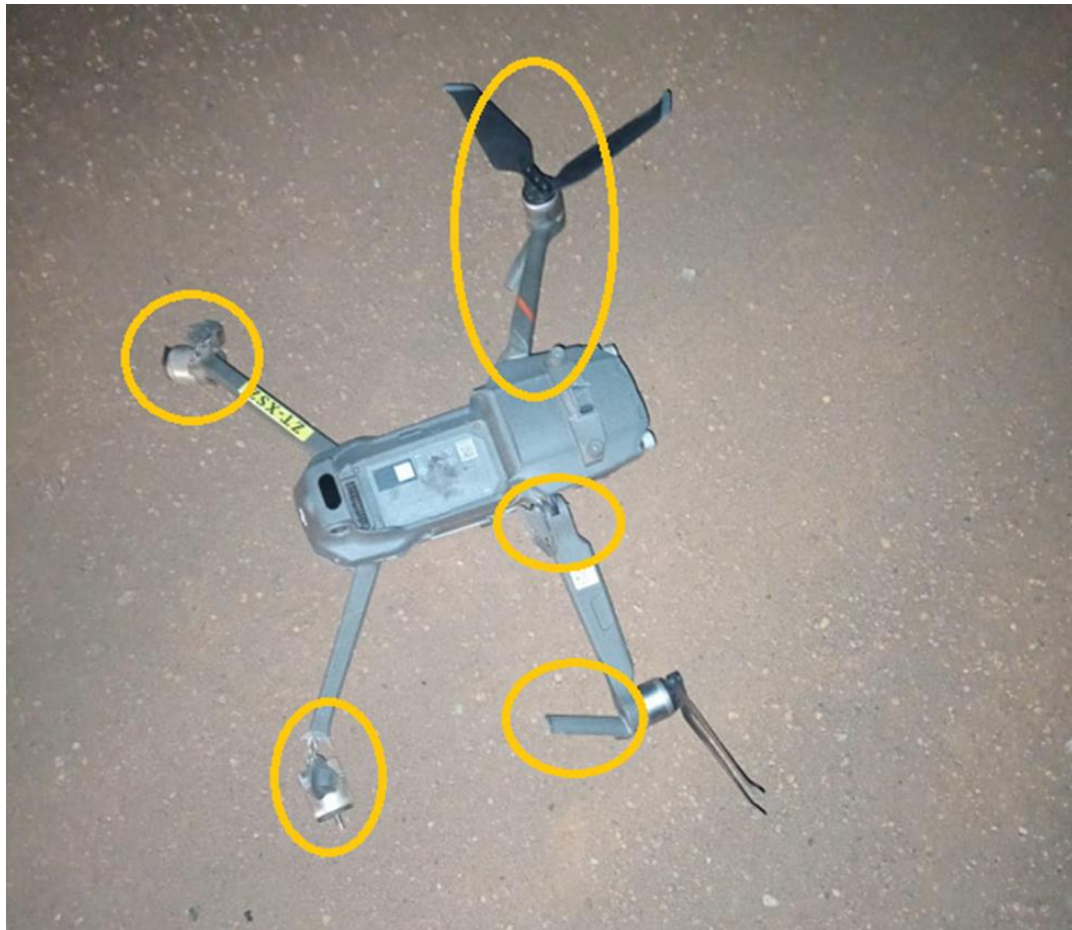
| <p>On 6 October 2022, a pilot operating a remotely piloted aircraft (RPA) with registration ZT-XSZ launched the aircraft on an aerial surveillance of a railway line, approximately 9 nautical miles (nm) south-west of Emalahleni in Mpumalanga province. The flight was conducted beyond visual line of sight (BVLOS) by night and under the provisions of Part 101 of the Civil Aviation Regulations (CAR) 2011 as amended.</p> <p>The pilot stated that he conducted pre-flight checks, and no anomalies were observed on the RPA. The pilot completed a flight mission and landed the RPA back at home base to change the batteries before resuming the next flight mission at 1919Z with a 91% battery power indication on the control screen. Approximately six minutes after launch, the RPA disconnected from the pilot's controller unit and crashed to the ground. The pilot made his way to the crash site to recover the substantially damaged RPA, approximately 200 metres (m) from the launch site.</p> <p>Post-inspection of the RPA revealed the burnt battery terminals, which led to loss of C2 communication link between the pilot's controller unit and the RPA. This resulted in the RPA disconnecting from the pilot's controller unit. There were no reported injuries during the occurrence and the RPA sustained damage to the propellers and arms.</p> | | | | | | | |

Figure 2: The damage sustained by the ZT-XSZ. (Source: Pilot)

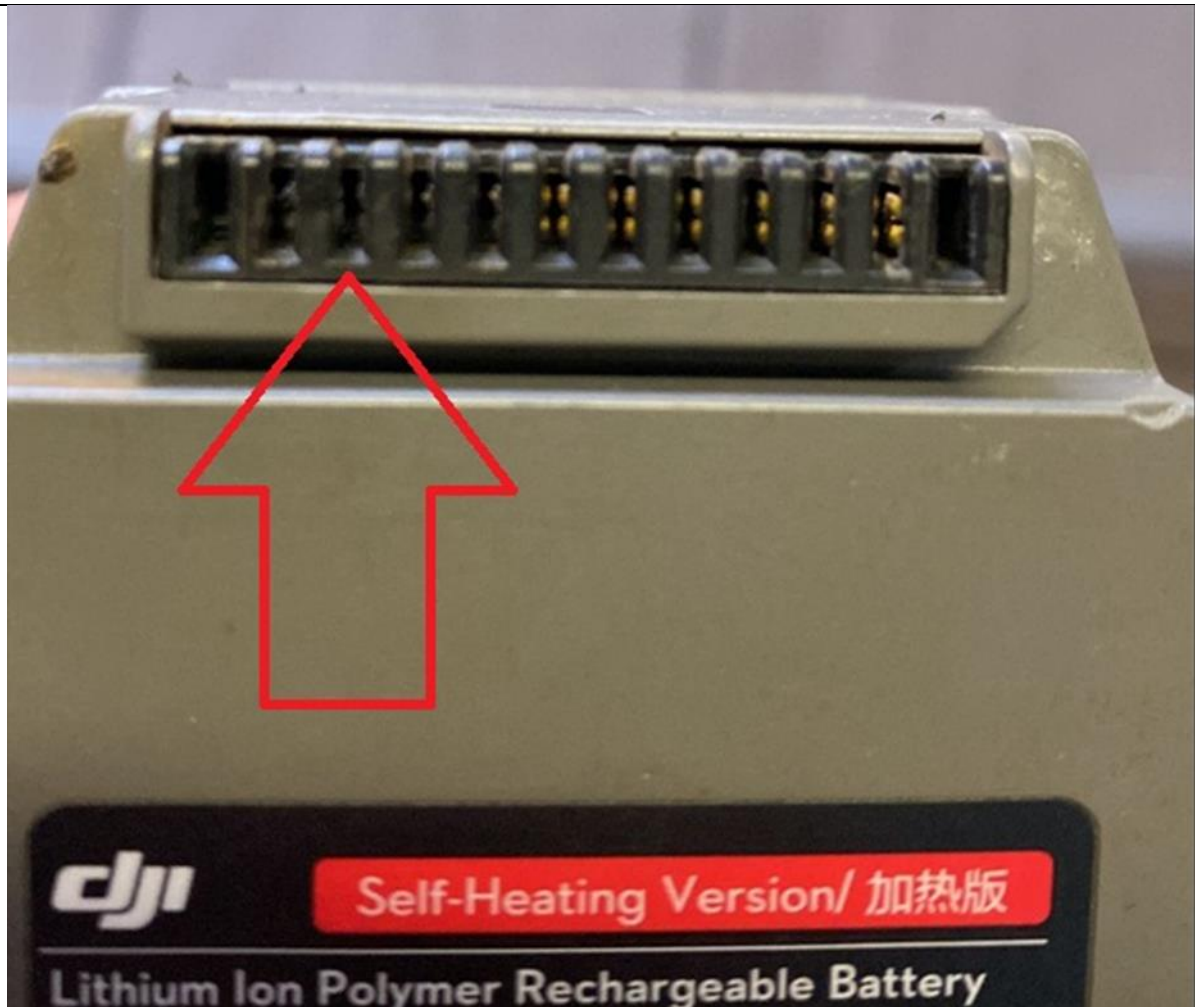
Figure 3: The damaged battery terminals. (Source: Operator)

Figure 3 shows five damaged battery terminals on the left-side and one damaged terminal on the right-side. The six terminals in the middle were still serviceable.

| <ul style="list-style-type: none"> • The last scheduled maintenance inspection prior to the accident flight was conducted on 2 September 2022 at 235.0 airframe hours. The aircraft flew a further 55.0 hours since the last scheduled maintenance inspection was conducted. • The operator had a Remotely Piloted Aircraft Operating Certificate (ROC) that was issued by the Regulator on 31 October 2021 with an expiry date of 31 October 2022. • During recovery of the aircraft, the pilot discovered that the battery terminals (Serial Number: MAV1263) were burnt. |
| Burnt battery terminals led to loss of C2 communication link between the pilot's controller unit and the RPA after take-off. |
| Battery connector terminal failure. |
