**LIMITED OCCURRENCE INVESTIGATION REPORT – FINAL**

<b>Reference Number</b>	CA18/2/3/10236						
<b>Classification</b>	Accident	<b>Date</b>	24 October 2022		<b>Time</b>	1510Z	
<b>Type of Operation</b>	Surveillance (Part 101)						
<b>Location</b>							
Place of Departure	Sun City, North West Province		Place of Intended Landing	Sun City, North West Province			
Place of Occurrence	Sun City, North West Province						
GPS Co-ordinates	Latitude	25° 20'49.05" S	Longitude	027° 06'15.77" E	Elevation	3626 ft	
<b>Aircraft Information</b>							
Registration	ZT-XWX						
Make; Model; S/N	DJI Mavic 2 (Serial Number: MAV0082)						
Damage to Aircraft	Substantial			Total Aircraft Hours	183		
<b>Pilot-in-command</b>							
Licence Type	Remote Pilot Licence (RPL) Multi Rotor		Gender	Male		Age	24
Licence Valid	Yes	Total Hours	553		Total Hours on Type	433	
Total Hours 30 Days	87		Total Flying on Type Past 90 Days	180			
<b>People Controlling</b>	1	<b>Injuries</b>	0	<b>Fatalities</b>	0	<b>Other (on ground)</b>	0

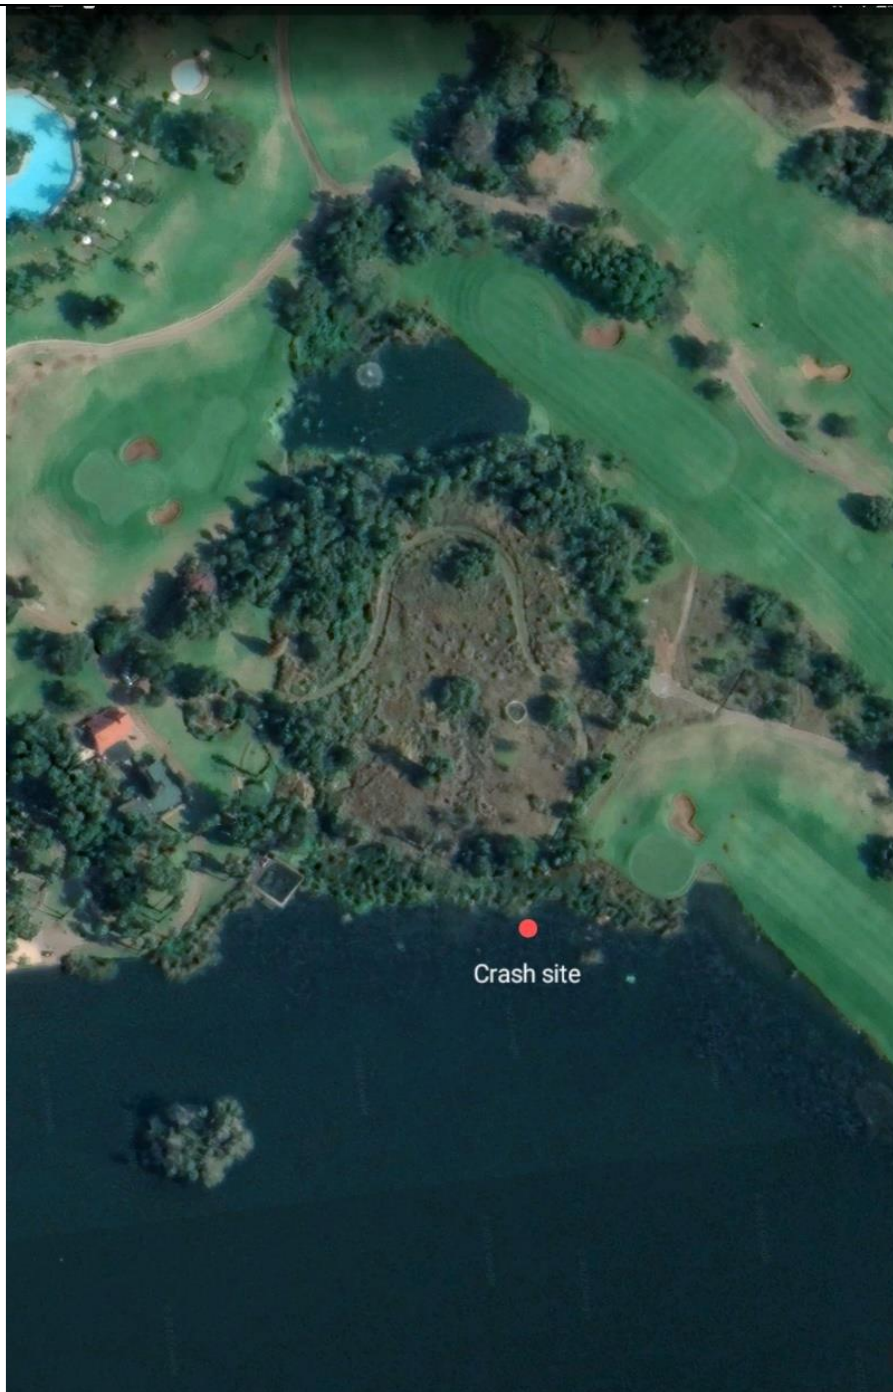
**Figure 1:** The crash site. (Source: Google Maps)
