**LIMITED OCCURRENCE INVESTIGATION REPORT – FINAL**

<b>Reference Number</b>	CA18/2/3/10237						
<b>Classification</b>	Accident		<b>Date</b>	2 December 2022		<b>Time</b>	0630Z
<b>Type of Operation</b>	Training (Part 141)						
<b>Location</b>							
<b>Place of Departure</b>	Rand Airport (FAGM), Gauteng Province		<b>Place of Intended Landing</b>	Rand Airport (FAGM), Gauteng Province			
<b>Place of Occurrence</b>	Helipad in front of Hangar Number 6, Rand Airport (FAGM), Gauteng Province						
<b>GPS Co-ordinates</b>	<b>Latitude</b>	26° 14' 17.58" S	<b>Longitude</b>	28° 09' 1.71" E	<b>Elevation</b>	5 465 ft	
<b>Helicopter Information</b>							
<b>Registration</b>	ZS-RYX						
<b>Make; Model; S/N</b>	Robinson Helicopter Company; R44 Raven II (Serial Number: 12498)						
<b>Damage to Helicopter</b>	Substantial			<b>Total Helicopter Hours</b>	2 596.1		
<b>Pilot-in-command</b>							
<b>Licence Type</b>	Student Pilot Licence (SPL) Helicopter (H)			<b>Gender</b>	Male	<b>Age</b>	46

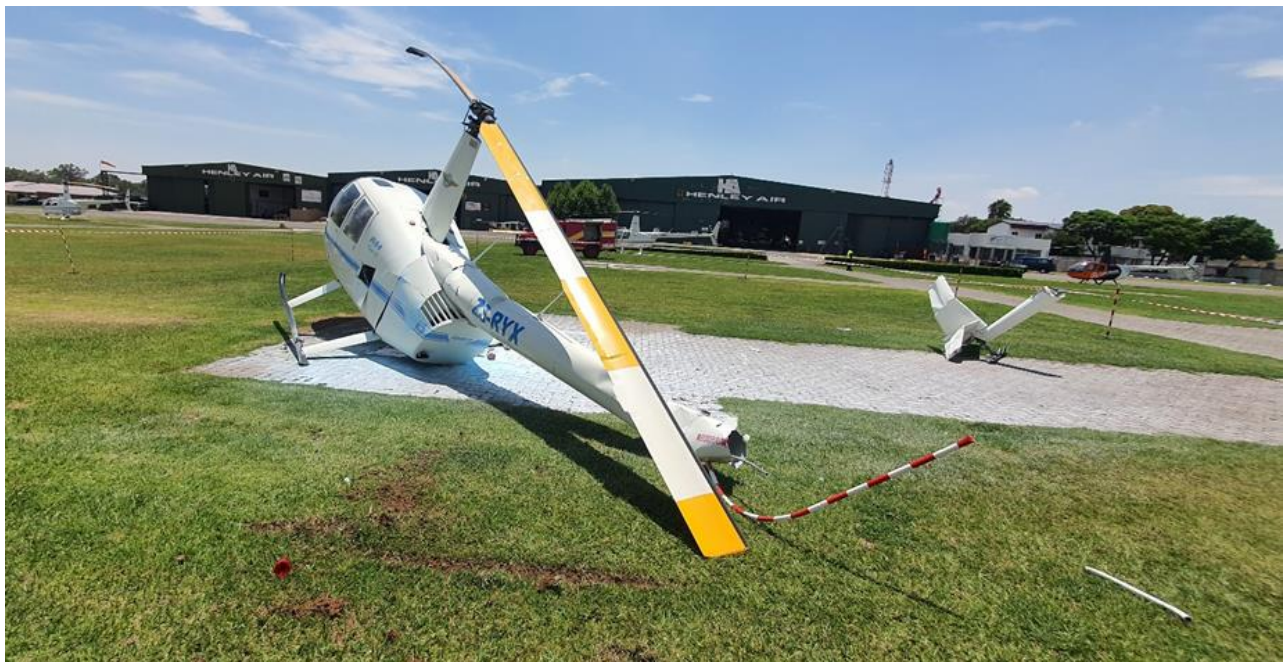
The helicopter was substantially damaged; however, the pilot was uninjured during the accident.

**Figure 1:** The helicopter as it came to rest.

The helicopter landed hard on the right skid rear portion, which resulted in loss of control. The helicopter then yawed to the left; to correct this, the SP made abrupt control inputs which caused one of the main rotor blades to strike the tail boom before the helicopter came to rest.
