LIMITED OCCURRENCE INVESTIGATION REPORT – FINAL

Reference Number	CA18/2/3/10238						
Classification	Accident	Date	10 November 2022		Time	1230Z	
Type of Operation	Multispectral Scan of Yacht (Part 101)						
Location							
Place of Departure	Support Boat, 2nm North of Granger Bay, Western Cape Province			Place of Intended Landing	Support Boat, 2nm North of Granger Bay, Western Cape Province		
Place of Occurrence	2.3nm North of Granger Bay (South Atlantic Ocean), Western Cape Province						
GPS Co-ordinates	Latitude	33° 51' 50.11" S	Longitude	18° 25' 41.25" E	Elevation	-76 ft	
Aircraft Information							
Registration	ZT-WKE						
Make; Model; S/N	DJI; Matrice 210 (171DGCMR13JTE7)						
Damage to Aircraft	Unknown (Lost)			Total Aircraft Hours	119.0		
Pilot-in-command							
Licence Type	Remote Pilot Licence (RPL)		Gender	Male		Age	38
Licence Valid	Yes	Total Hours	745.5		Total Hours on Type	0.3	
Total Hours Past 90 Days	32.0		Total Flying Past 90 Days on Type	0.3

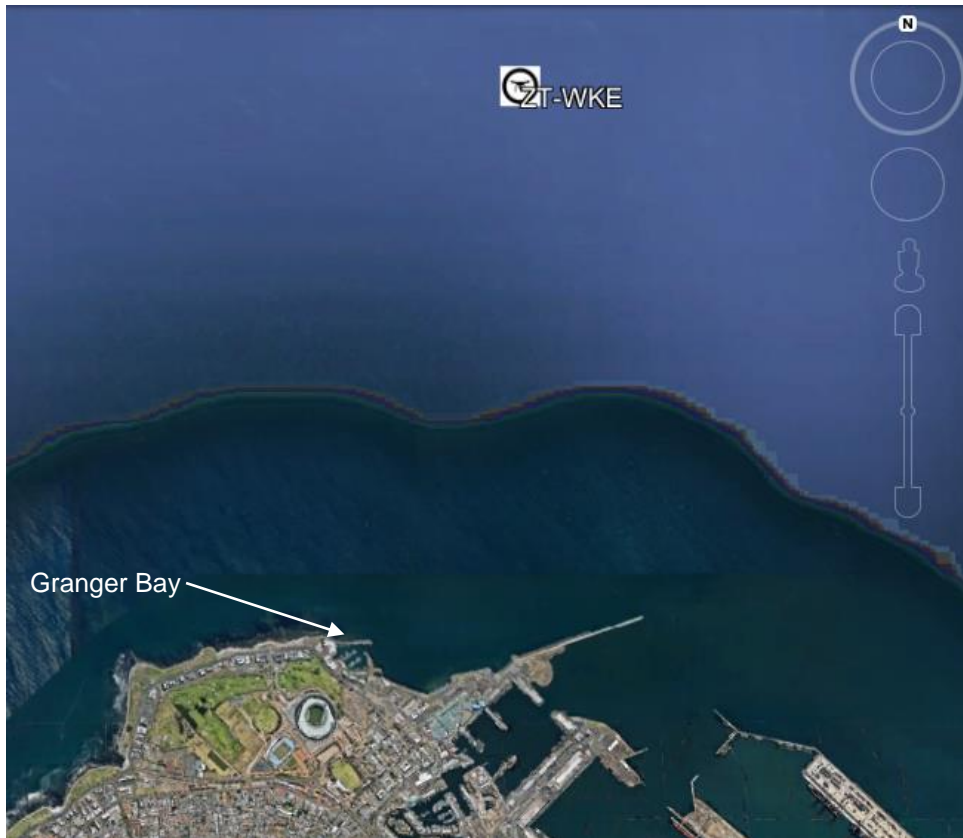
Figure 2: Last place where RPA submerged into the ocean. (Source: Google Earth)

One of the RPA's propeller blades detached in-flight, which led to the loss of control and the rapid descent into the ocean. The cause of the propeller blade detaching from the RPA could not be determined.
