LIMITED OCCURRENCE INVESTIGATION REPORT – FINAL
--

Reference Number	CA18/2/3/10239						
Classification	Accident	Date	3 December 2022		Time	0900Z	
Type of Operation	Skydiving (Part 96)						
Location							
Place of Departure	Skydive the Ranch Airfield, Mpumalanga Province		Place of Intended Landing	Wonderboom Aerodrome (FAWB), Gauteng Province			
Place of Occurrence	Skydive the Ranch Airfield, near Delmas Mpumalanga Province						
GPS Co-ordinates	Latitude	26° 02' 44.31" S	Longitude	028° 48' 18.39" E	Elevation	5015ft	
Aircraft Information							
Registration	ZS-WZP						
Make; Model; S/N	Atlas Angel AL-60C4M KUDU (Serial Number: 967)						
Damage to Aircraft	Substantial		Total Aircraft Hours	6443.1			
Pilot-in-command							
Licence Type	Private Pilot Licence (PPL)		Gender	Male		Age	40
Licence Valid	Yes	Total Hours	352		Total Hours on Type	4.8	
Total Hours 30 Days	11.5		Total Flying on Type Past 90 Days	4.8			
People On-board	1+9	Injuries	0	Fatalities	0	Other (on ground)	0

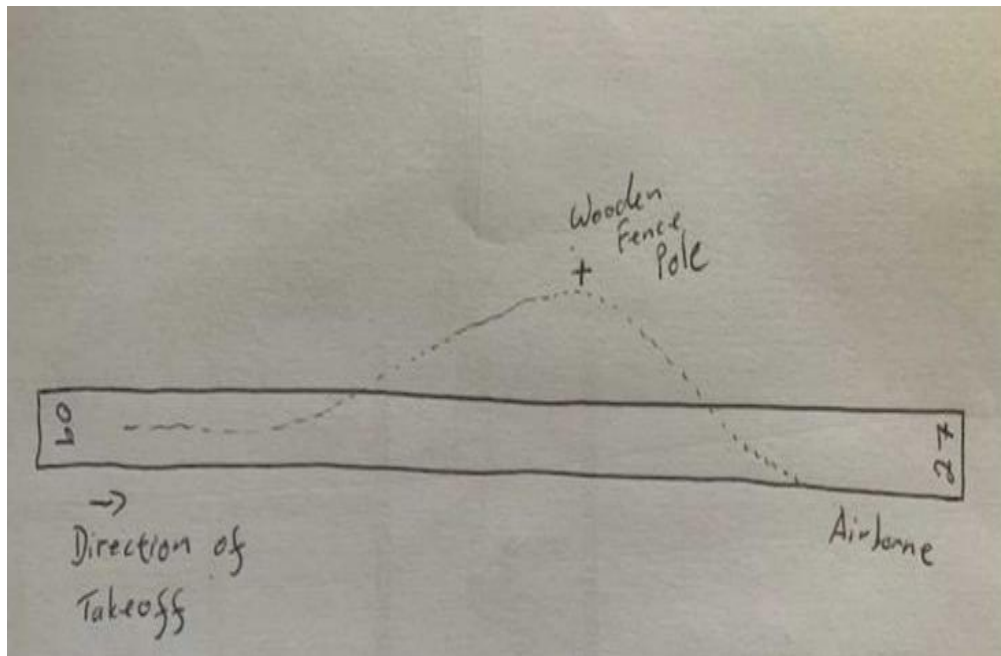
Figure 2: A pilot's sketch of the take-off path. (Source: Pilot)

8. The POH states that there is a tendency for the aircraft to swing to the left which is most pronounced at the start of the take-off run. The pilot stated that it is possible that he may have over corrected for the crosswind and that there could have been a gust of wind at the same time, resulting in loss of directional control.

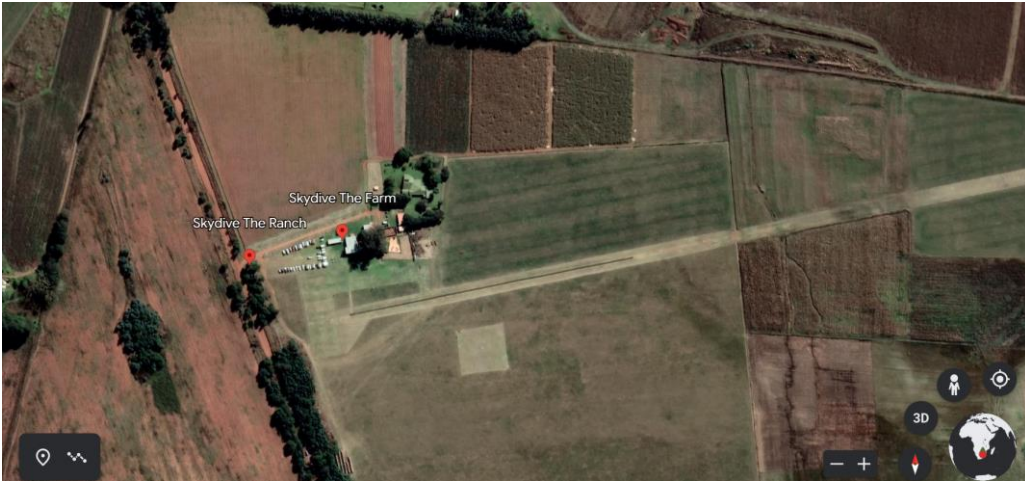
Figure 3: Skydive the Ranch Airfield layout. (Source: Google Earth)

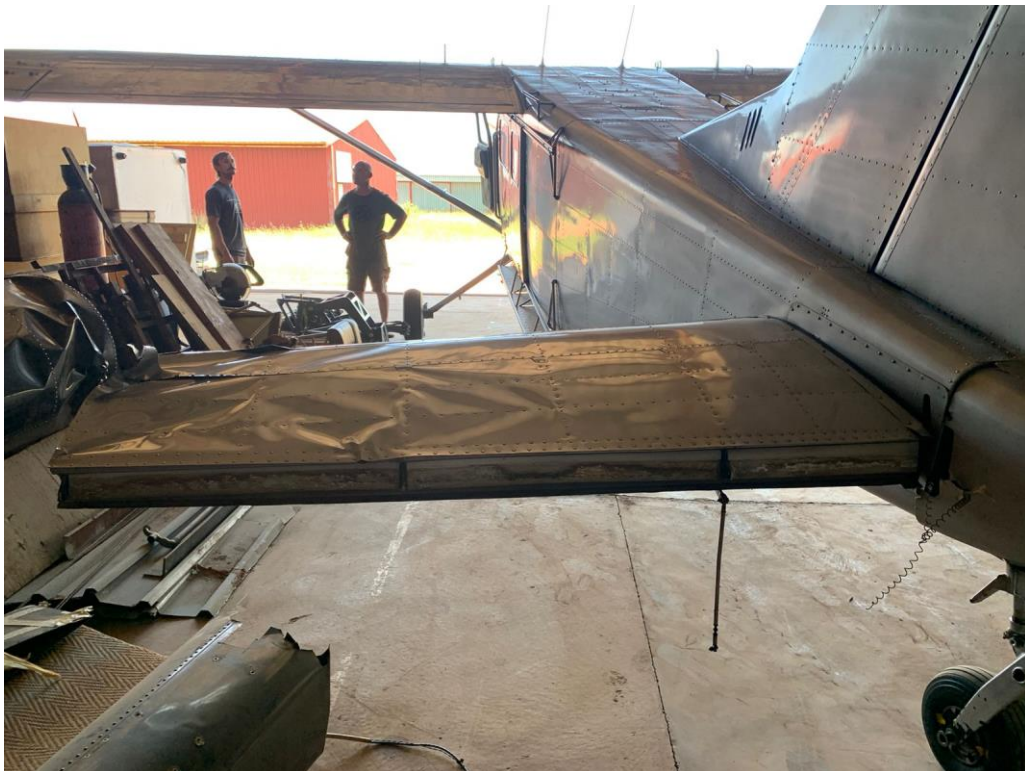
Figure 4: Rearview of the damaged horizontal stabiliser. (Source: Pilot)

6. The pilot lost directional control during the take-off roll and, just before rotation/take-off, the aircraft's left stabiliser impacted a fence post.

Probable Cause(s)
The pilot lost directional control during take-off and the aircraft impacted a fence post with the left horizontal stabiliser shortly before rotation.
Contributing Factor
None.
Safety Action(s)
None.
Safety Message and/or Safety Recommendation/s
Pilots are encouraged to abort take-off when there is loss of directional control or after colliding with objects as it is unsafe to continue flying without assessing damage after an occurrence.
About this Report
<i>The decision to conduct a limited investigation is based on factors including whether the cause is known and the evidence supporting the cause is clear, the level of safety benefit likely to be obtained from an investigation and that will determine the scope of an investigation. For this occurrence, a limited investigation has been conducted, and the Accident and Incident Investigations Division (AIID) has relied on the information submitted by the affected person/s and organisation/s to compile this limited report. The report has been compiled using information supplied in the initial notification, as well as from follow-up desk top enquiries to bring awareness</i>

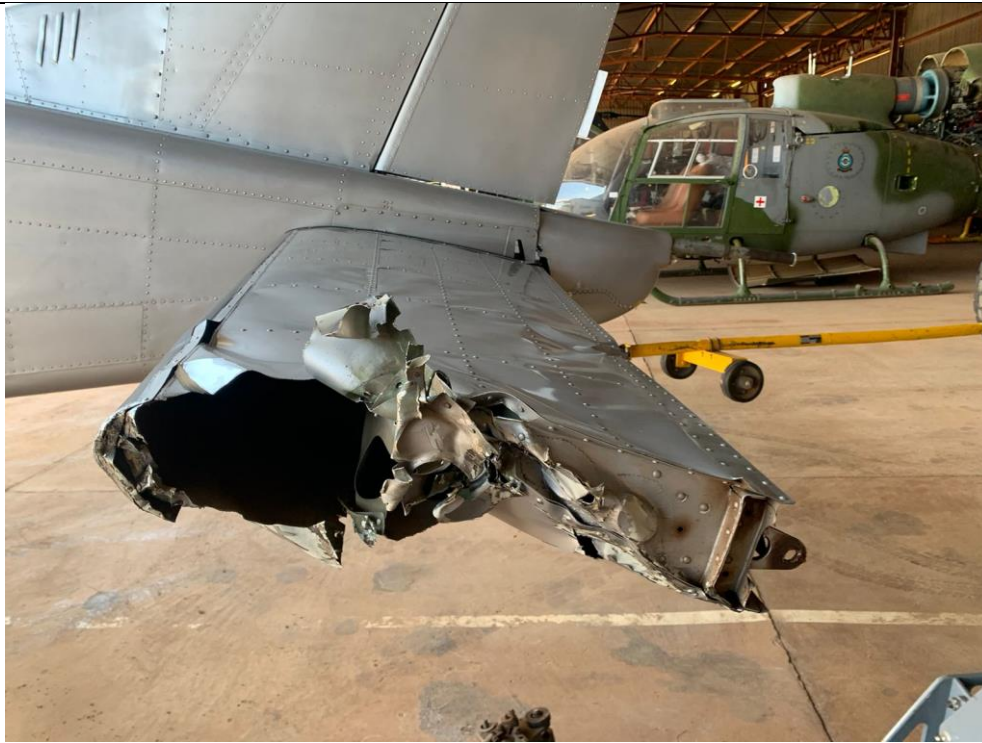
Figure 5: Side view of the damaged left horizontal stabiliser. (Source: Pilot)
