<b>LIMITED OCCURRENCE INVESTIGATION REPORT – FINAL</b>
--

<b>Reference Number</b>	CA18/2/3/10240						
<b>Classification</b>	Accident		<b>Date</b>	30 November 2022		<b>Time</b>	1712Z
<b>Type of Operation</b>	Remotely Piloted Aircraft System Aerial Surveillance (Part 101)						
<b>Location</b>							
Place of Departure	Simunye Colliery Secunda, Mpumalanga Province		Place of Intended Landing	Simunye Colliery Secunda, Mpumalanga Province			
Place of Occurrence	At Simunye Colliery Secunda whilst hovering at 394 feet above ground level following launch						
GPS Co-ordinates	Latitude	26° 34' 37.23" S	Longitude	29° 11' 09.10" E	Elevation	5 331 ft	
<b>Aircraft Information</b>							
Registration	ZT-WWH						
Make; Model; S/N	DJI; Matrice 300 RTK (Serial Number: 1ZNDHAL00C2569)						
Damage to Aircraft	Destroyed		Total Aircraft Hours	832.11			
<b>Pilot-in-command</b>							
Licence Type	Remote Pilot Licence (RPL)		Gender	Male		Age	33
Licence Valid	Yes	Total Hours	501.02		Total Hours on Type	501.02

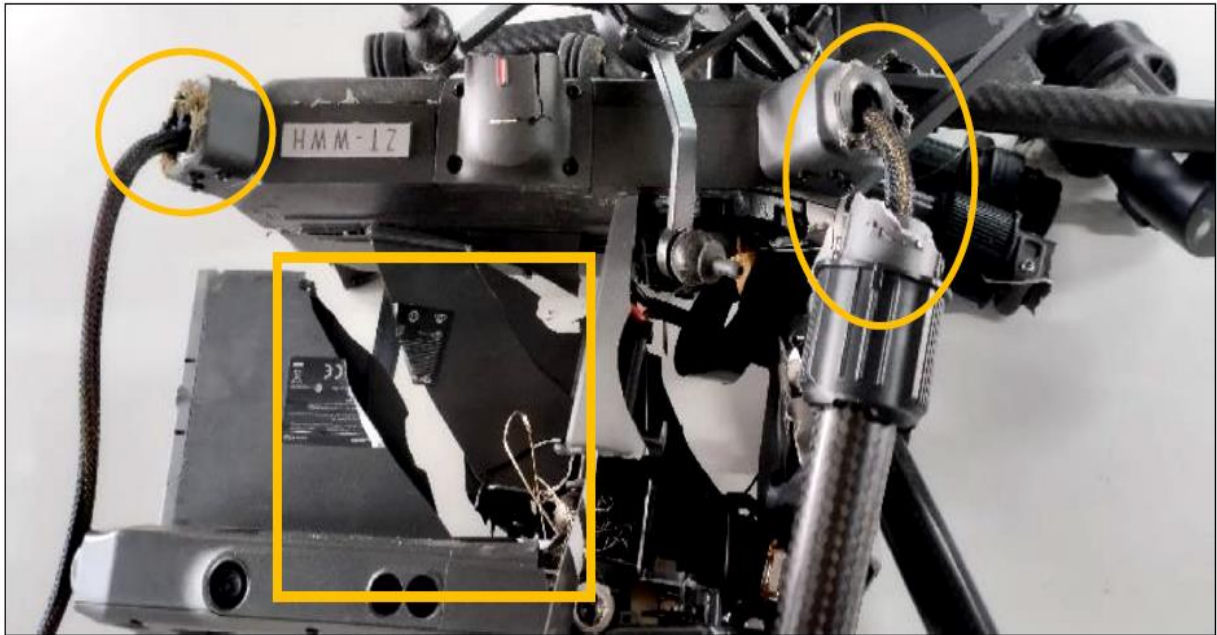
Total Hours 30 days	64.48		Total Flying on Type Past 90 days		177.55		
<b>People Controlling</b>	1	<b>Injuries</b>	0	<b>Fatalities</b>	0	<b>Other (on ground)</b>	0
<b>What Happened</b>							
<p>On Wednesday, 30 November 2022, a pilot launched a DJI Matrice 300 RTK remotely piloted aircraft (RPA) with registration ZT-WWH to perform a night aerial surveillance flight at Simunye Colliery Mine in Secunda, Mpumalanga province. The flight was conducted in visual line of sight (VLOS) at dusk under the provisions of Part 101 of the Civil Aviation Regulations (CAR) 2011 as amended.</p> <p>The pilot reported that a pre-flight inspection was conducted on the RPA and no anomalies were noted. At approximately 1710Z, the RPA was manually launched for a pre-flight test with 94% battery power. The pre-flight test was carried out at approximately 5 metres (m) above ground level (AGL) to establish if the controls were responding as expected (that is, forward and backward flight, left and right roll, left and right yaw). Also, checks on the gimbal for the payload (H20T) were carried out and all the units were in good working condition.</p> <p>After the tests, the RPA climbed to 120m (394 feet [ft]) AGL and it hovered for a few seconds before proceeding with the surveillance flight. At approximately 1712Z, the pilot and the ground crew heard a screeching sound coming from the RPA, which was immediately followed by a total loss of control. The RPA entered an uncontrolled descent until it impacted the ground.</p> <p>The RPA was recovered after a brief search by the ground crew; it had sustained substantial damage. There was no damage to property during the accident and no person on the ground was injured.</p> <p>Post-accident Investigation Report:</p> <ul style="list-style-type: none"> <li>The wreckage distribution indicated that the RPA was substantially damaged beyond economical repair during the accident sequence.</li> </ul>

**Figure 1:** Damaged arms and camera. (Source: Operator)

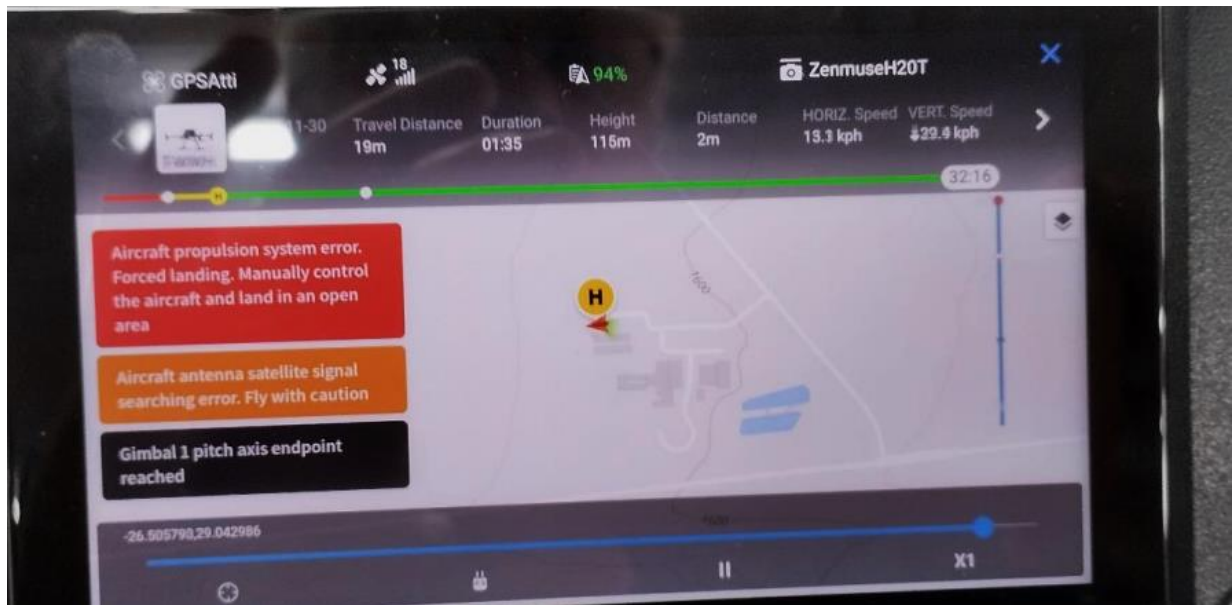
- A screenshot from the RPA's flight log indicated that it experienced a propulsion error at 120m (394 ft) AGL which seemed to have been caused by either a motor or an Electronic Speed Control (ESC) malfunction.

**Figure 2:** The screen showing the propulsion error. (Source: Operator)

- The picture above shows the results of the diagnoses which indicate that the malfunction was either the RPA motor and/or the ESC. A further indication was that the RPA attempted to maintain stability whilst in a tumble following the propulsion error at a vertical speed of 22.4 kilometres per hour (kph) in a downward direction.
- The operator's investigation determined that it was not the pilot's inputs that led to the accident.

<b>Probable Cause(s)</b>
The RPA experienced a propulsion error which was likely caused by an over speeding motor or malfunctioning of the ESC.
<b>Contributing Factor(s)</b>
None.
<b>Safety Action(s)</b>
None.
<b>Safety Message and/or Safety Recommendation/s</b>
None.
<b>About this Report</b>
<p><i>The decision to conduct a limited investigation is based on factors including whether the cause is known and the evidence supporting the cause is clear, the level of safety benefit likely to be obtained from an investigation and that will determine the scope of an investigation. For this occurrence, a limited investigation has been conducted, and the Accident and Incident Investigations Division (AIID) has relied on the information submitted by the affected person/s and organisation/s to compile this limited report. The report has been compiled using information supplied in the initial notification, as well as from follow-up desk top enquiries to bring awareness of potential safety issues to the industry in respect of this occurrence, as well as possible safety action/s that the industry might want to consider in preventing a recurrence of a similar occurrence.</i></p> <p><i>All times given in this report are Co-ordinated Universal Time (UTC) and will be denoted by (Z). South African Standard Time is UTC plus 2 hours.</i></p>
