LIMITED OCCURRENCE INVESTIGATION REPORT – FINAL

Reference Number	CA18/2/3/10241						
Classification	Accident	Date	19 December 2022		Time	1200Z	
Type of Operation	Training (Part 141)						
Location							
Place of Departure	Brakpan Aerodrome (FABB), Gauteng Province		Place of Intended Landing		Brakpan Aerodrome (FABB), Gauteng Province		
Place of Occurrence	Runway 36 at Brakpan Aerodrome						
GPS Co-ordinates	Latitude	26°14'28.60" S	Longitude	028°18'15.14" E	Elevation	5 340 ft	
Aircraft Information							
Registration	ZS-OGG						
Make; Model; S/N	Piper PA-23-250 Aztec (Serial Number: 27-4510)						
Damage to Aircraft	Substantial			Total Aircraft Hours	6259.81		
Pilot-in-command							
Licence Type	Airline Transport Pilot Licence (ATPL)		Gender	Male		Age	73
Licence Valid	Yes	Total Hours	24 700		Total Hours on Type	700	
Total Hours Past 30 Days	20		Total Flying Hours on Type Past 90 Days			20	
People On-board	2 + 0	Injuries	0	Fatalities	0	Other (on ground)	0

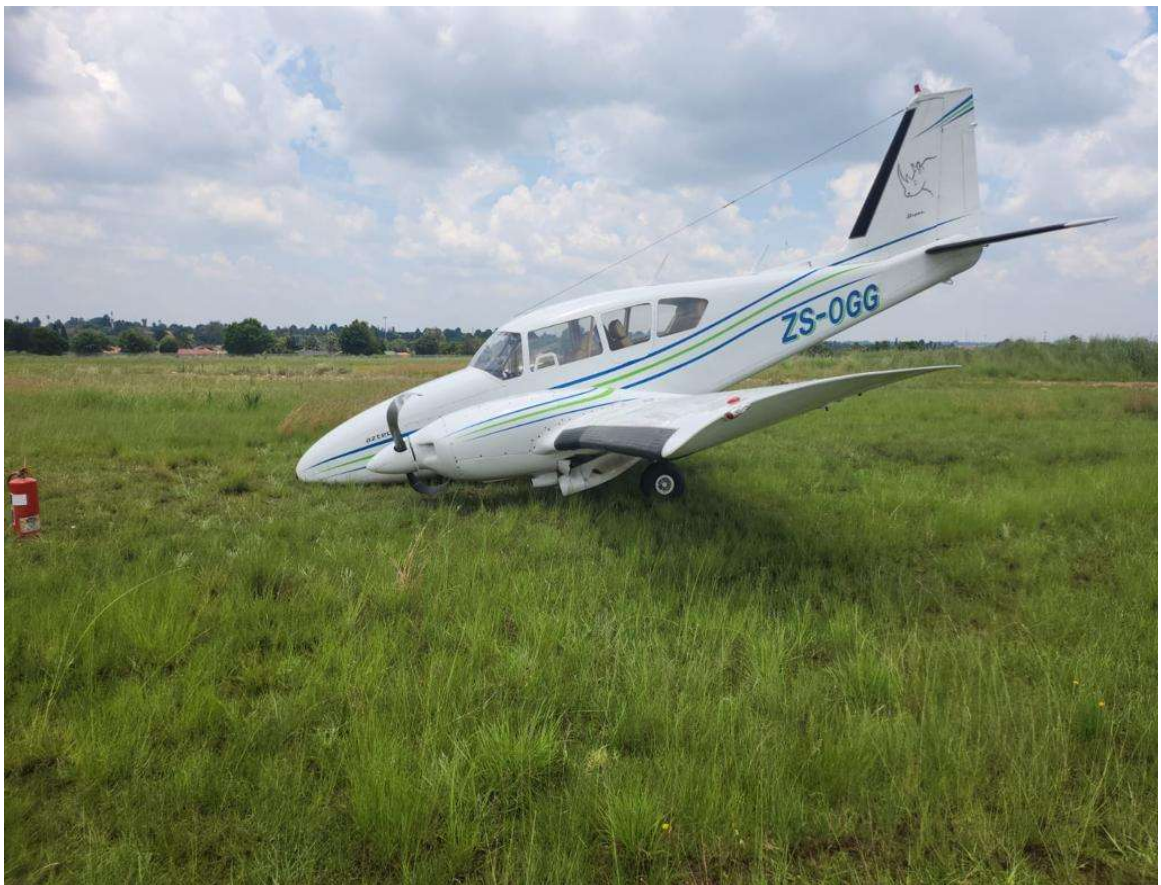
Figure 2: The aircraft as it came to rest post-accident. (Source: Pilot)

It is likely that the aircraft was flared too early which resulted in the high rate of descent and a hard landing. Consequently, the nose gear collapsed, and the aircraft veered off to the right-side of the runway.

Pilots should be more attentive during the critical phases of flight such as take-off and landings, and in particular, during training of new and inexperienced pilots.
