LIMITED OCCURRENCE INVESTIGATION REPORT – FINAL

Reference Number	CA18/2/3/10243						
Classification	Accident	Date	23 December 2022		Time	1235Z	
Type of Operation	Private (Part) 91						
Location							
Place of Departure	El Mirador Airfield (FALQ), KwaZulu-Natal Province		Place of Intended Landing		Port Alfred Aerodrome (FAPA), Eastern Cape Province		
Place of Occurrence	Displaced threshold of Runway 25 at Port Alfred Aerodrome (FAPA), Eastern Cape Province						
GPS Co-ordinates	Latitude	33° 33' 13.68" S	Longitude	026° 53' 10.40" E	Elevation	296ft	
Aircraft Information							
Registration	ZS-KEC						
Make; Model; S/N	Cessna C210M (Serial Number: 210-62590)						
Damage to Aircraft	Substantial			Total Aircraft Hours	6031.8		
Pilot-in-command							
Licence Type	Private Pilot Licence (PPL)		Gender	Male		Age	56
Licence Valid	Yes	Total Hours	898.6		Total Hours on Type	832.5	
Total Hours 30 Days	8.6		Total Flying on Type Past 90 Days		12.2		
People On-board	1+1	Injuries	0	Fatalities	0	Other (on ground)	0

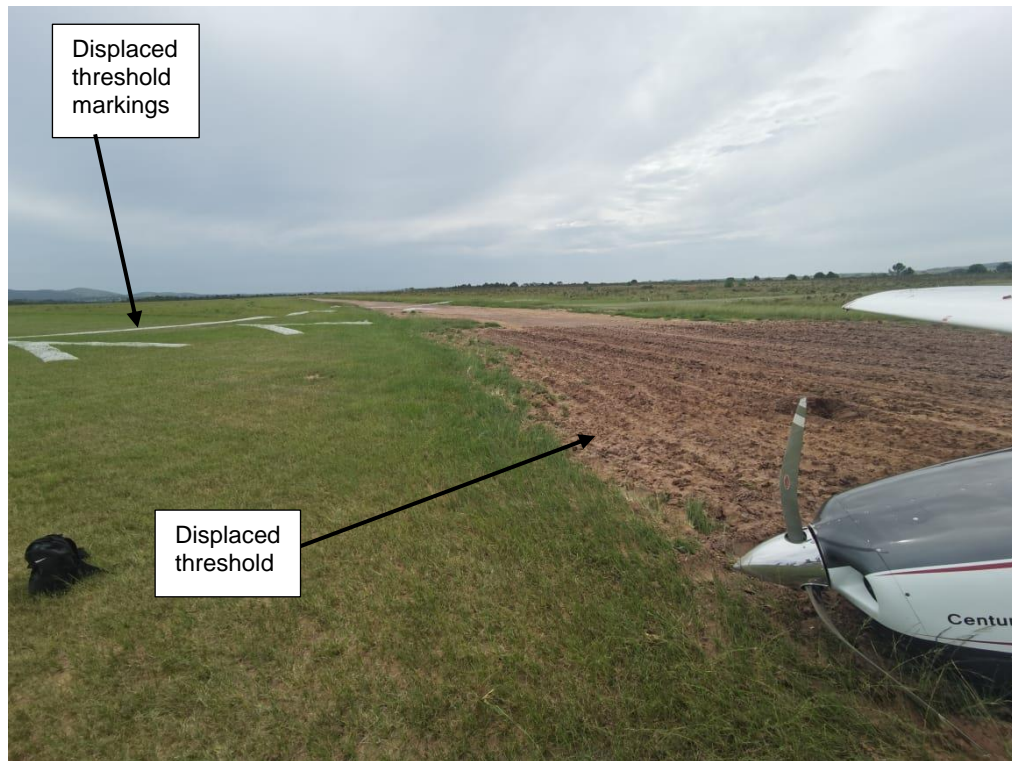
- Runway 25 is 1037.7m X 35m.
- The pilot stated that he was not aware of the NOTAM and that there were no markings on the threshold of Runway 25 to indicate the displaced threshold of approximately 350m (see Figure 1).

Figure 1: Displaced threshold markings on Runway 25. (Source: Pilot)

7. The pilot stated that he was not aware of the NOTAM and there were no markings on the threshold of Runway 25 to indicate the displaced runway threshold of approximately 350m.

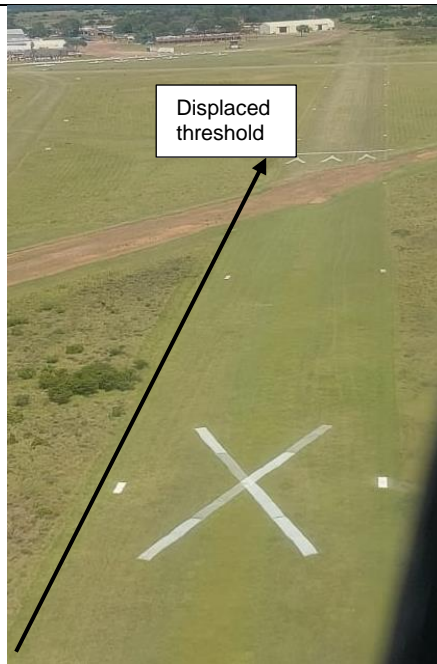
Figure 3: Aerial view of the displaced threshold markings. The arrow shows the length of the displaced threshold. (Source: Airport manager)

8. The investigation found that there were runway markings showing the displaced threshold a few metres from where the aircraft had landed.

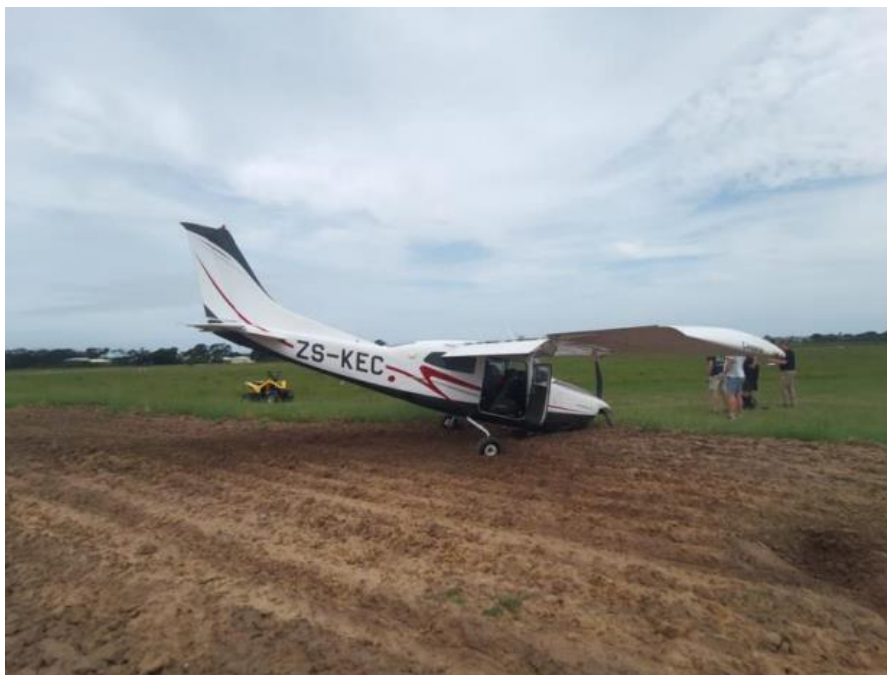
Figure 4: The final position of the aircraft. (Source: Pilot)

6. The pilot was not aware of the NOTAM which stated that the threshold of Runway 25 was displaced. The pilot landed short of the runway threshold, which led to the nose landing gear, engine cowling, propeller blades and right wing tip damage.

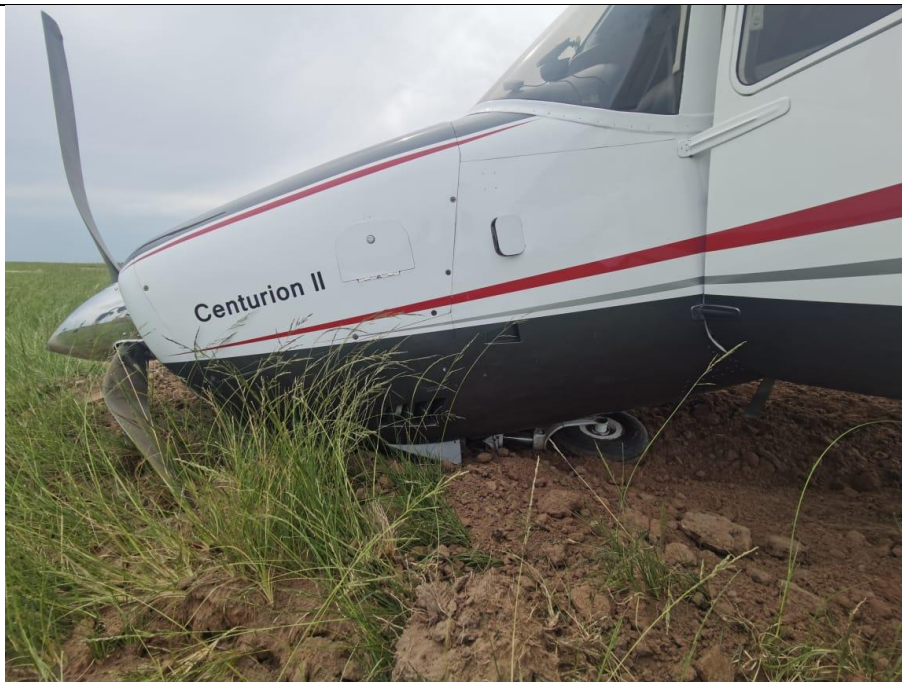
Figure 5: The damaged nose wheel and propeller blades. (Source: Pilot)

Probable Cause
The aircraft landed short of the displaced Runway 25 and, as a result, the nose gear bent backwards and the propeller blades struck the ground.
Contributing Factor(s)
Poor or no flight planning which led to non-adherence to the published NOTAM at the destination aerodrome.
Safety Action(s)
None.
Safety Message
Pilots are advised to always carry out a proper flight planning whilst taking into consideration the conditions at the departure aerodrome, en route facilities/aerodromes, the destination aerodrome and the aerodrome to divert to in case of an emergency.
About this Report
<p><i>The decision to conduct a limited investigation is based on factors including whether the cause is known and the evidence supporting the cause is clear, the level of safety benefit likely to be obtained from an investigation and that will determine the scope of an investigation. For this occurrence, a limited investigation has been conducted, and the Accident and Incident Investigations Division (AIID) has relied on the information submitted by the affected person/s and organisation/s to compile this limited report. The report has been compiled using information supplied in the initial notification, as well as from follow-up desk top enquiries to bring awareness of potential safety issues to the industry in respect of this occurrence, as well as possible safety action/s that the industry might want to consider in preventing a recurrence of a similar occurrence.</i></p> <p><i>All times given in this report are Co-ordinated Universal Time (UTC) and will be denoted by (Z). South African Standard Time is UTC plus 2 hours.</i></p>
