LIMITED OCCURRENCE INVESTIGATION REPORT – FINAL

Reference Number	CA18/2/3/10244						
Classification	Accident	Date	24 December 2022		Time	0830Z	
Type of Operation	Private (Part 91)						
Location							
Place of Departure	Grand Central Aerodrome (FAGC), Gauteng Province		Place of Intended Landing		Zebula Lodge Estate Airstrip, Limpopo Province		
Place of Occurrence	Between the trees next to the threshold of Runway 08 at Zebula Lodge Estate Airstrip, Limpopo province						
GPS Co-ordinates	Latitude	24°45'34.5" S	Longitude	027°58'19.6" E	Elevation	4 213 ft	
Aircraft Information							
Registration	ZS-PYL						
Make; Model; S/N	Reims Cessna; F172M Skyhawk (Serial Number: F172-01039)						
Damage to Aircraft	Substantial			Total Aircraft Hours	14 651.1		
Pilot-in-command							
Licence Type	Private Pilot Licence (PPL)		Gender	Male		Age	22
Licence Valid	Yes	Total Hours	198		Total Hours on Type	33.8	
Total Hours Past 30 Days	21.9		Total Flying Hours on Type Past 90 Days			33.8

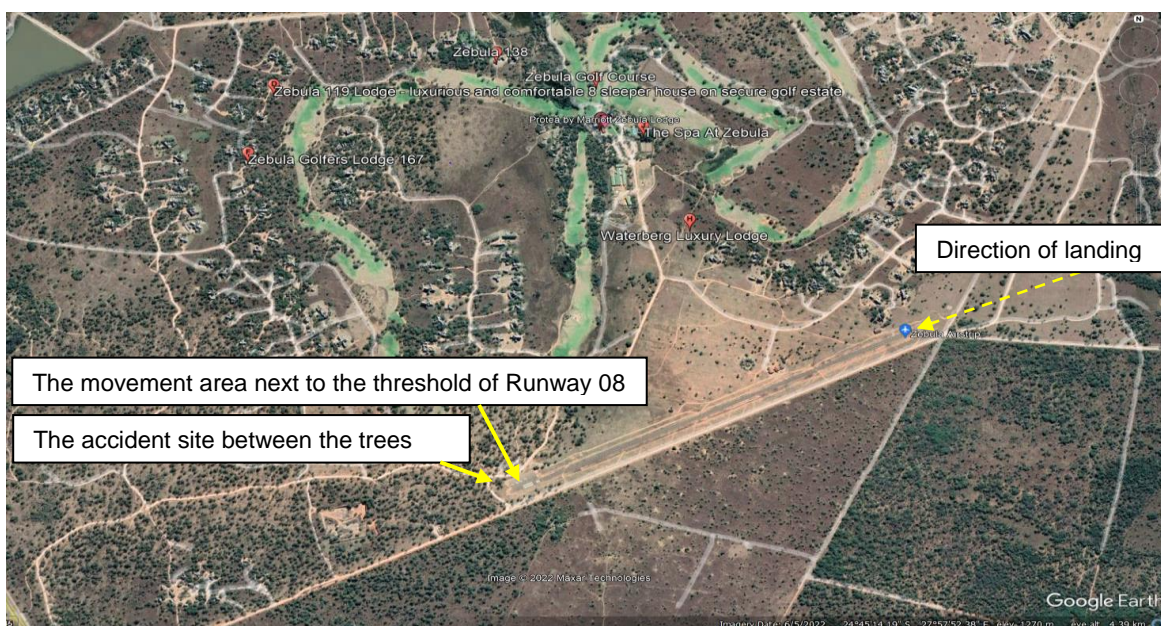
Figure 1: Runway 26 at Zebula Lodge Estate Airstrip and the accident site. (Source: Google Earth)

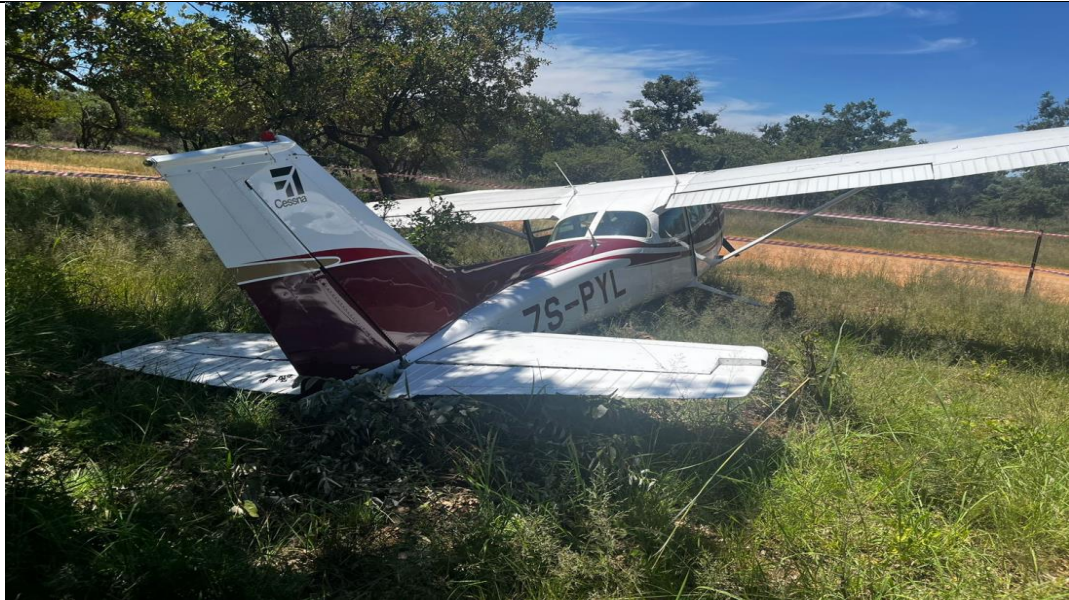
Figure 2: The final position of the ZS-PYL aircraft post-accident. (Source: Pilot)

The pilot seemed to have initiated a go-around with the flaps still extended to 40° which resulted in the massive drag and the subsequent hard landing towards the end of the runway. The aircraft exited the runway and came to a stop between trees.

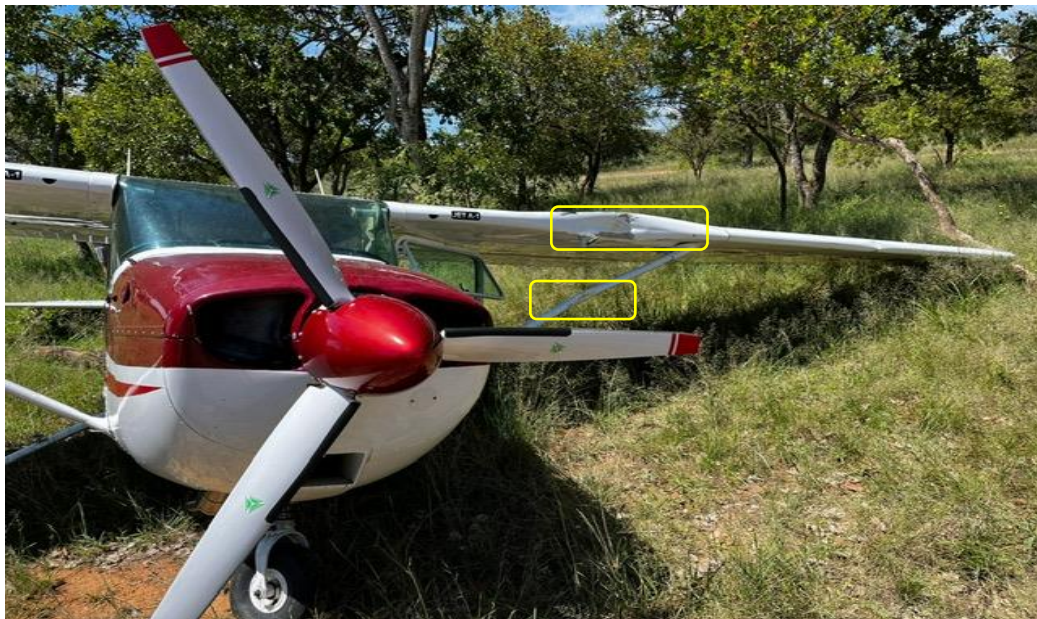
An assessment of the accident site was made based on the eyewitness' version and photographic evidence. The skid mark made by the right main gear wheel tyre was observed on the runway surface/movement which indicated excessive braking until the aircraft came to a stop, approximately 430m from the touchdown point. The aircraft sustained impact damage on the left-wing leading edge inboard area and wing support strut. The left main landing gear strut collapsed during the accident sequence after colliding with a tree stump.

Figure 3: The aircraft at the accident site with sustained damage highlighted in the yellow windows. (Source: Pilot)

The aircraft remained upright, leaning on its left wing and the left horizontal stabiliser. The engine and the cockpit/cabin area were intact. The fuel tank selector handle was found in the OFF position, it rotated smoothly through all the other positions with the detents plainly noted in each position. The left and the right front seats were correctly attached or fitted to the rails on the cockpit floor. The throttle control lever operated normally through its whole range. The engine was visually examined, and no pre-accident abnormalities were noted. The fuel system was checked and no defects were identified. The control columns moved freely when tested and the flight control continuity was confirmed on all flight control surfaces.

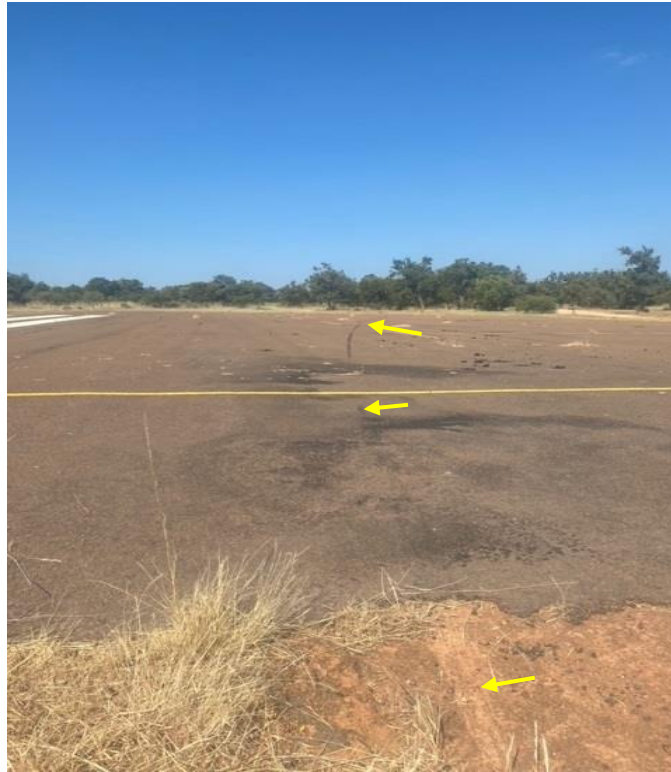
Figure 4: The skid mark made by the right main gear wheel tyre as the aircraft passed the movement before coming to a stop between the trees.

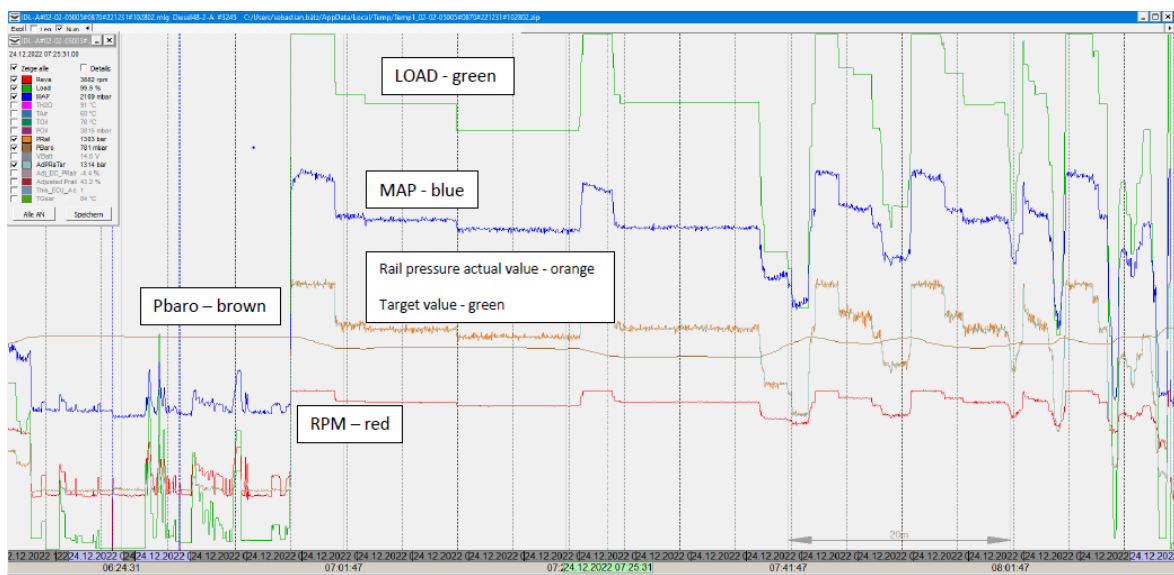
The FADEC computer was removed, and its non-volatile memory was downloaded. The parameters (load setting, the manifold air pressure [MAP], fuel pressure) indicated normal values. Upon reaching Zebula Lodge Estate Airstrip during the final approach for Runway 26, the parameters showed a decrease in engine RPM and the throttle after it (throttle) was opened at 100% as the pilot tried to abort the landing.

The throttle was closed before touchdown. Fuel pressure was recorded at 1 303 bars and the MAP at 2 192 millibars (mbar). The recorded parameters did not show any indication of an impending engine failure or power loss.

Graph 1: The values recorded in the last segment of the flight. (Source: Continental Aerospace)

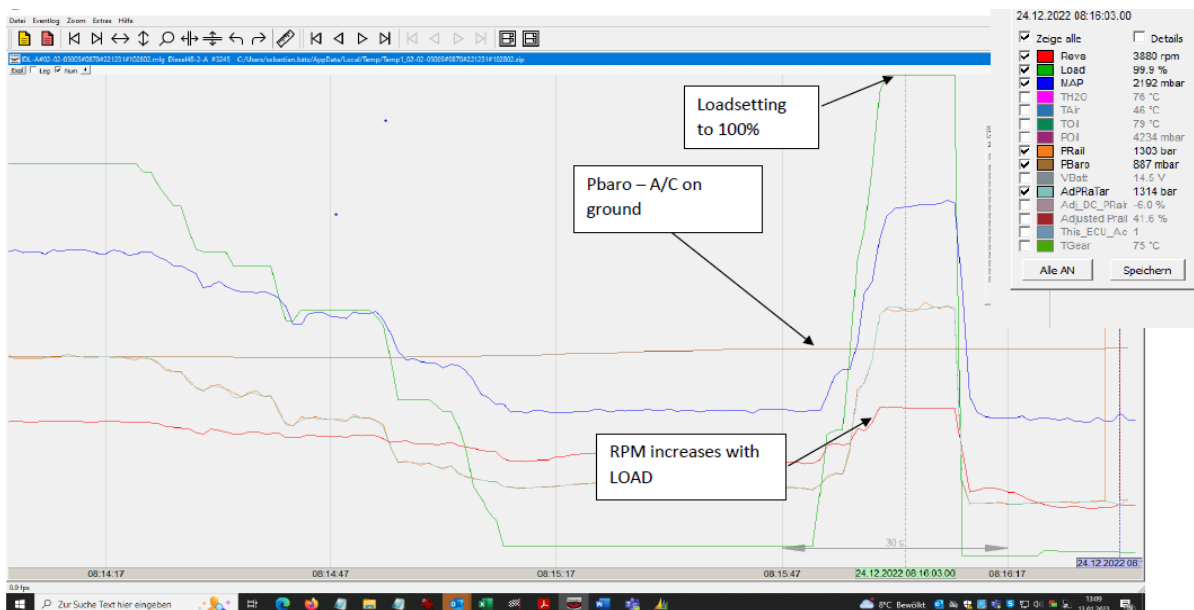
Graph 2: The values recorded in the last segment of the flight. (Source: Continental Aerospace).
