AIRCRAFT ACCIDENT REPORT AND EXECUTIVE SUMMARY

Reference:	CA18/2/3/10246		
Aircraft Registration	ZU-PPA	Date of Accident	2 January 2023		Time of Accident	1615Z	
Type of Aircraft	Sling 4 TSi			Type of Operation	Private (Part 94)		
Pilot-in-command Licence Type	Private Pilot Licence		Age	47	Licence Valid	Yes	
Pilot-in-command Flying Experience	Total Flying Hours		6 881.6		Hours on Type	Unknown	
Last Point of Departure	Tedderfield Aerodrome (FATA), Gauteng Province						
Next Point of Intended Landing	Tedderfield Aerodrome (FATA), Gauteng Province						
Damage to Aircraft	Destroyed						
Location of the accident site with reference to easily defined geographical points (GPS readings if possible)							
Bass Lake near Henley on Klip (GPS position: 26°30'33.66" South 028°03'58.27" East, elevation 4 850 feet)							
Meteorological Information	Surface wind, 030°/1kt; temperature, 23°C; dew point, 11°C; CAVOK						
Number of People On-board	1 + 1	Number of People Injured	0	Number of People Killed	2	Other (On Ground)	0

Reference Number : CA18/2/3/10246
Occurrence Category : Accident (Category 1)
Type of Operation : Private (Part 94)
Name of Operator : Private Flight
Aircraft Registration

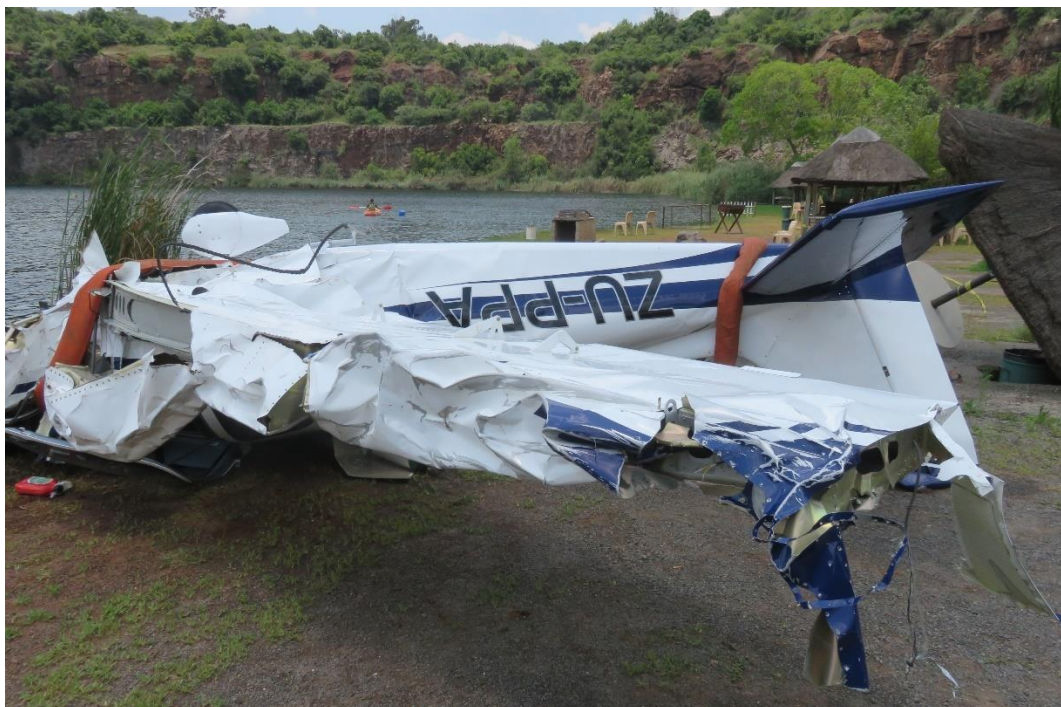
1.3.1 The aircraft was destroyed during impact with the water.

Figure 2: The wreckage after it was recovered from the lake.

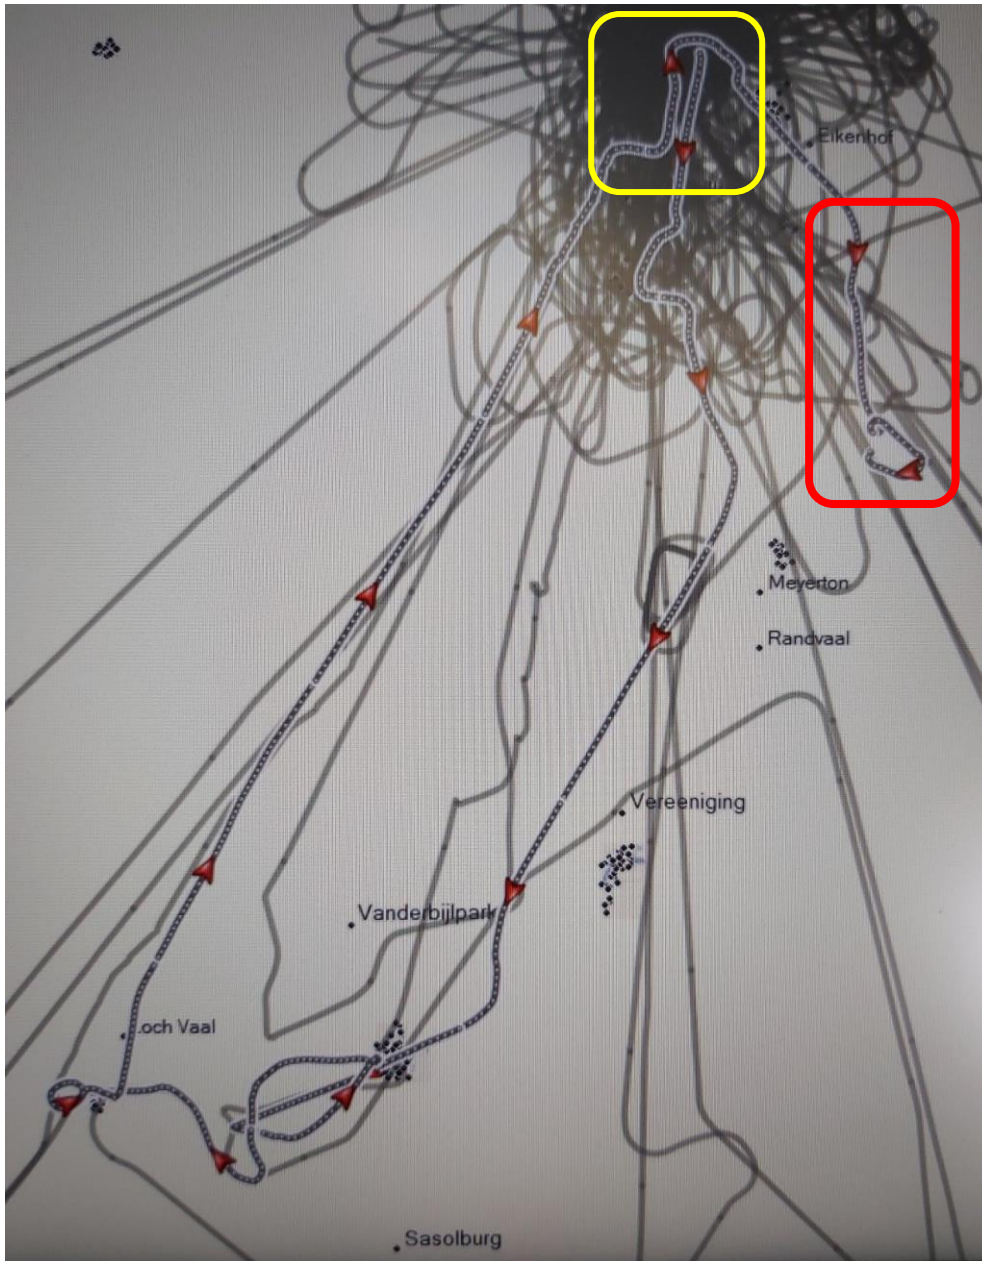
1.11.4 From the flight data, it was possible to trace the track the aircraft flew. After take-off, it headed south and was abeam Riviera on the Vaal Golf Course, thereafter, it proceeded in a west / south-westerly direction along the Vaal River. During this leg, the pilot executed several aerobatic manoeuvres (i.e., Loop, wingover). In the area of Vaal Rus where the river makes a 90° turn to the north, the aircraft made a 180° turn and followed the river until abeam Loch Vaal. From there, the flight continued north-easterly heading back towards FATA (see Figure 6, yellow window). The aircraft was then seen turning right and continued with the flight in a southerly direction. The aircraft followed Klipriver for a short distance and then executed a 180° turn to the right, flying in a northerly direction. Shortly after this turn, the aircraft descended into the Bass Lake quarry where it contacted the water surface twice and, later, crashed into the lake.

Figure 6: The dotted line with the red arrows indicates the flight route.
The last phase of the flight is captured in the red window.

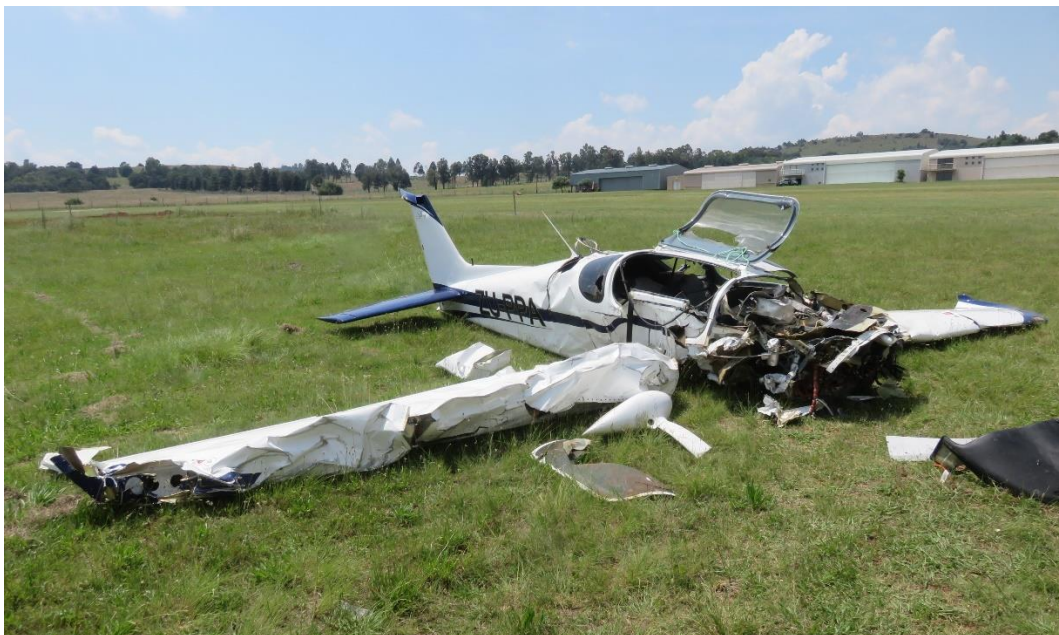
1.12.2 The wreckage was floated with the assistance of several divers and was slowly towed to the shore using a boat after it was lifted out of the lake with a mobile crane. Initial observations of the wreckage indicated severe deformation of the engine and nose section, as well as the right wing. The three propeller blades were severed near the spinner, indicative of an engine that was producing power on impact. The integrity of the aircraft was not compromised, and all the flight controls were accounted for.

Figure 10: The wreckage layout post-recovery with the engine removed.

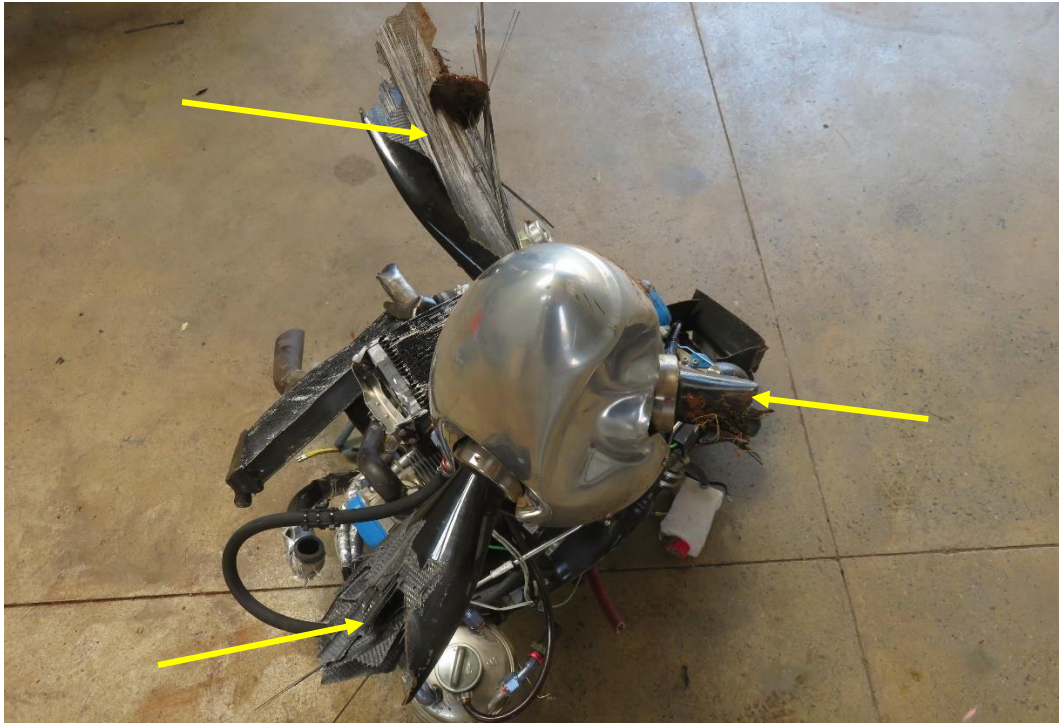
Figure 11: The view of the propeller with all three blades severed near the hub assembly.

The aircraft was maintained in accordance with the required maintenance schedule and no structural failure was observed that could have contributed or have caused the accident. It was evident that the engine was delivering power during the critical phase of the flight as the pilot would not have been able to fly the aircraft out of the predicament he found himself in

after the aircraft's contact with the water surface twice. The deformation visible on the three propeller blades supports this observation.

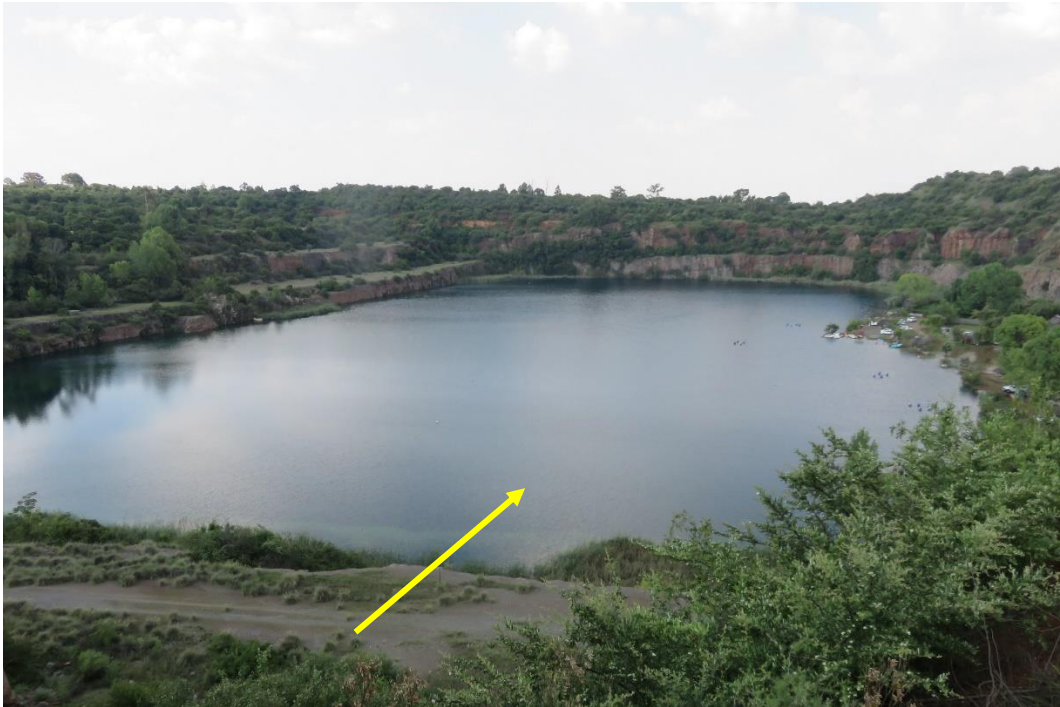
The dimensions of the quarry that is covered by water is approximately 450m long and 250m wide. It is surrounded by high ground which averages 25m (80ft) higher than the water level. On the northern side of the lake, the high ground is (at some places) up to 40m (131ft) above the water level, which was the direction the aircraft was flying when it contacted the water surface. The yellow arrow in Figure 12 indicates the direction the aircraft was flying when it contacted the water surface in the Bass Lake quarry.

Figure 12: A view of the Bass Lake looking north.
