LIMITED OCCURRENCE INVESTIGATION REPORT – FINAL

Reference Number	CA18/2/3/10247						
Classification	Accident	Date	2 January 2023	Time	2030Z		
Type of Operation	Private (Part 91)						
Location							
Place of Departure	Grand Central Airport (FAGC), Gauteng Province		Place of Intended Landing	Grand Central Airport (FAGC), Gauteng Province			
Place of Occurrence	Runway 35 at Grand Central Airport (FAGC)						
GPS Co-ordinates	Latitude	25°59'28.3" S	Longitude	28°08'34.5" E	Elevation	5 325 ft	
Aircraft Information							
Registration	ZS-SMK						
Make; Model; S/N	Cessna 172M Skyhawk (Serial Number: 17263023)						
Damage to Aircraft	Substantial		Total Aircraft Hours	9 810.6			
Pilot-in-command							
Licence Type	Private Pilot Licence (PPL) Aeroplane		Gender	Male	Age	32	
Licence Valid	Yes	Total Hours	190.3	Total Hours on Type	116.2		
Total Hours 30 Days	14.2		Total Flying on Type Past 90 Days	33.9			
People On-board	1 + 1	Injuries	0	Fatalities	0	Other (on ground)	0

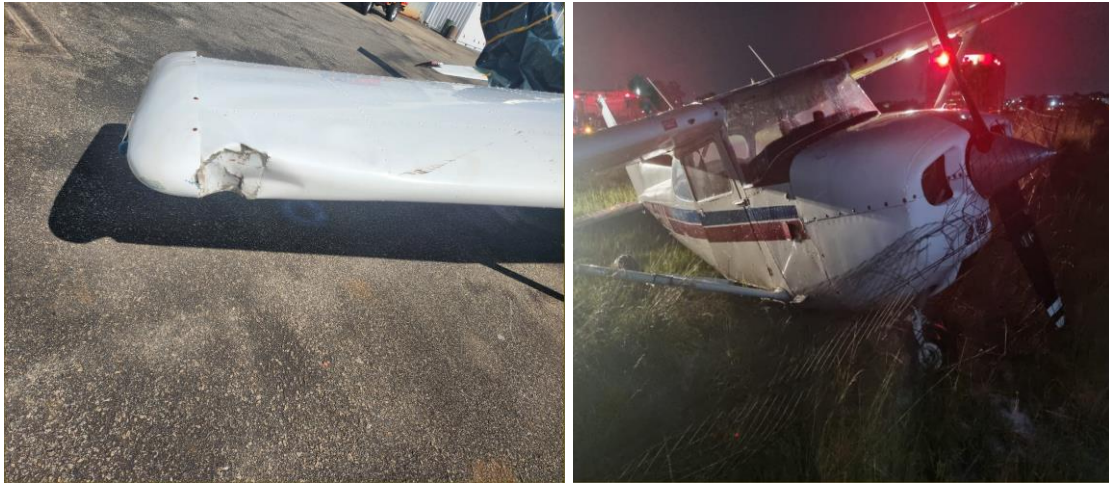
The pilot and the passenger were unharmed; they disembarked the aircraft unassisted. The aircraft sustained damage to the right wing, right landing gear, left and right horizontal stabilisers, spinner, propeller blades and the nose landing gear.

Figures 1 and 2: The damaged right-wing leading edge (right); and the aircraft against the perimeter fence. (Source: FAGC Fire Department)

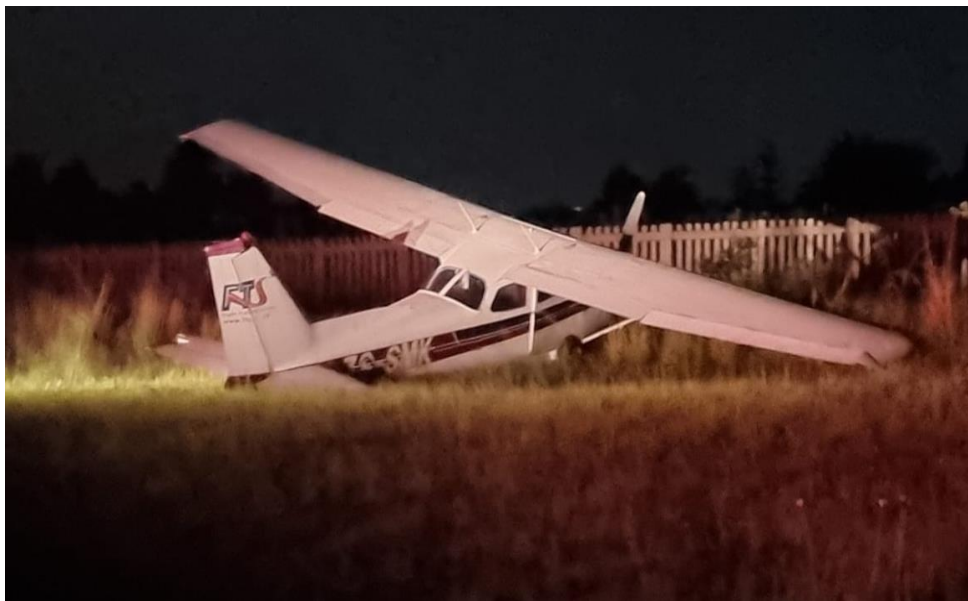
Figure 3: The final position of the aircraft. (Source: FAGC Fire Department)

The aircraft collided with a buck during the landing roll whilst preparing to rotate for a third circuit. As a result, the right-side main landing gear collapsed, and the aircraft veered off to the right-side of the runway before it came to stop against the airport's perimeter fence.

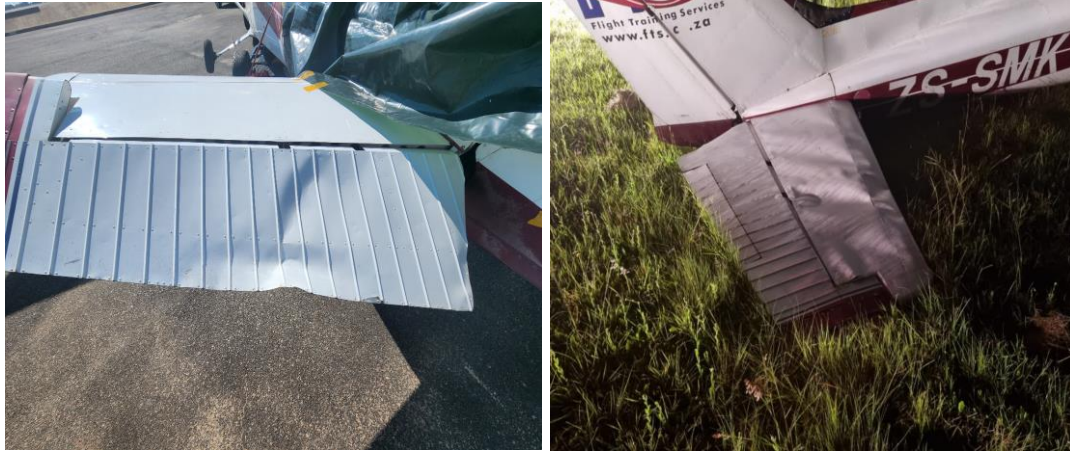
Figures 4 and 5: Damage to the left-side elevator and right-side horizontal stabiliser.
(Source: FAGC Fire Department)
