AIRCRAFT ACCIDENT REPORT AND EXECUTIVE SUMMARY

Reference:		CA18/2/3/10248			
Aircraft Registration	ZS-EAW	Date of Accident	15 January 2023	Time of Accident	0605Z		
Type of Aircraft	Piper PA-30-160 Twin Comanche		Type of Operation	Training (Part 141)			
Pilot-in-command Licence Type	Commercial Pilot Licence (CPL) Aeroplane		Age	28	Licence Valid Yes		
Pilot-in-command Flying Experience	Total Flying Hours	539.4	Hours on Type	55.0			
Last Point of Departure	Grand Central (FAGC) Aerodrome, Gauteng Province						
Next Point of Intended Landing	Grand Central (FAGC) Aerodrome, Gauteng Province						
Damage to Aircraft	Destroyed						
Location of the accident site with reference to easily defined geographical points (GPS readings if possible)							
Crown Mines dump site near National Recreation Centre (NASREC) at Global Positioning System (GPS) co-ordinates determined to be 26°14'05.5" South 027°58'24.0" East, at an elevation of 5600 feet (ft)

Reference Number : CA18/2/3/10248
Occurrence Category : Category 1
Type of Operation : Training (Part 141)
Name of Operator : Flight Training Services (FTS)
Aircraft Registration : ZS-EAW
Aircraft Make and Model : Piper PA-30-160 Twin Comanche
Nati

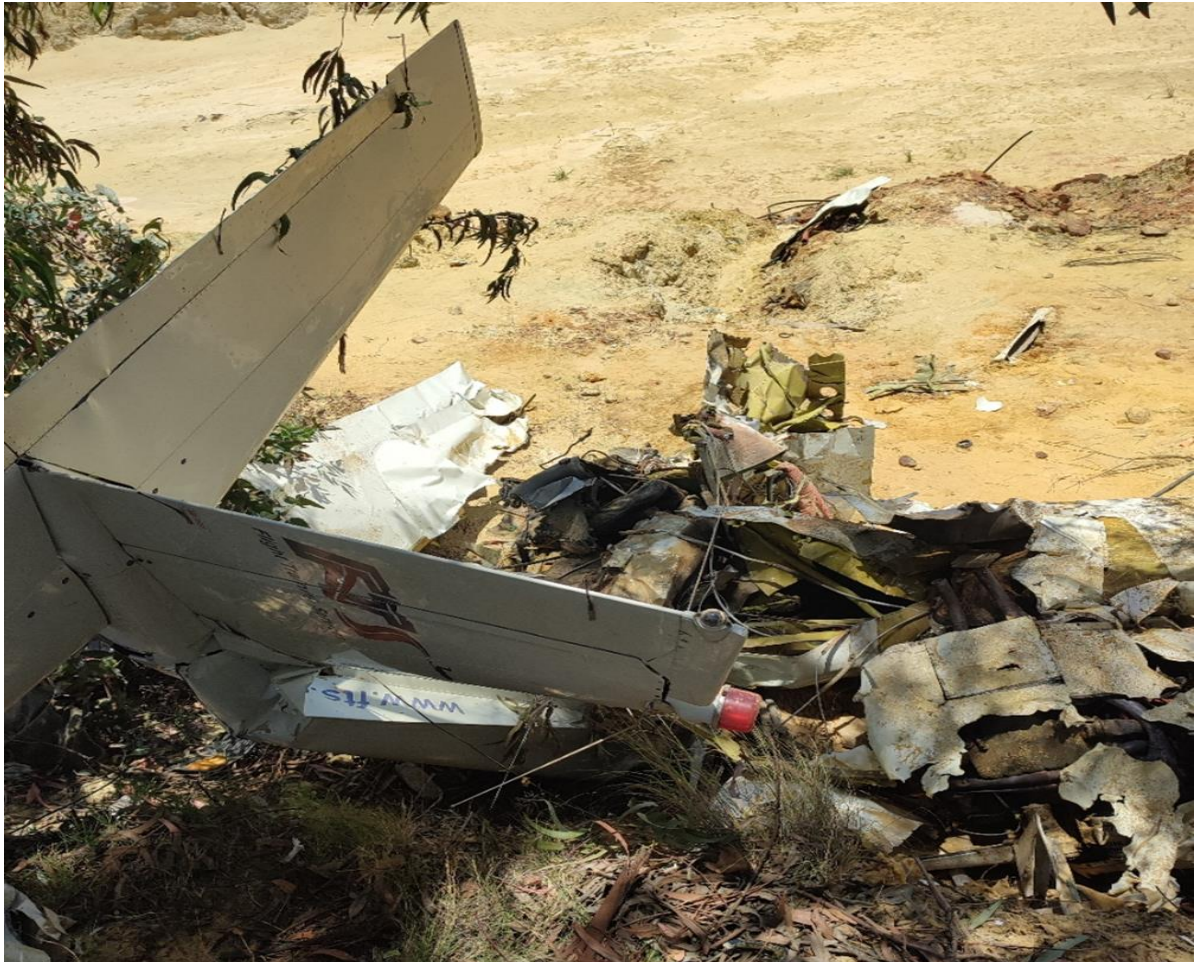
1.3.1. The aircraft was destroyed by impact forces at the base of the mine dump during the accident.

Figure 3: The wreckage at the accident site. (Source: ARFF)

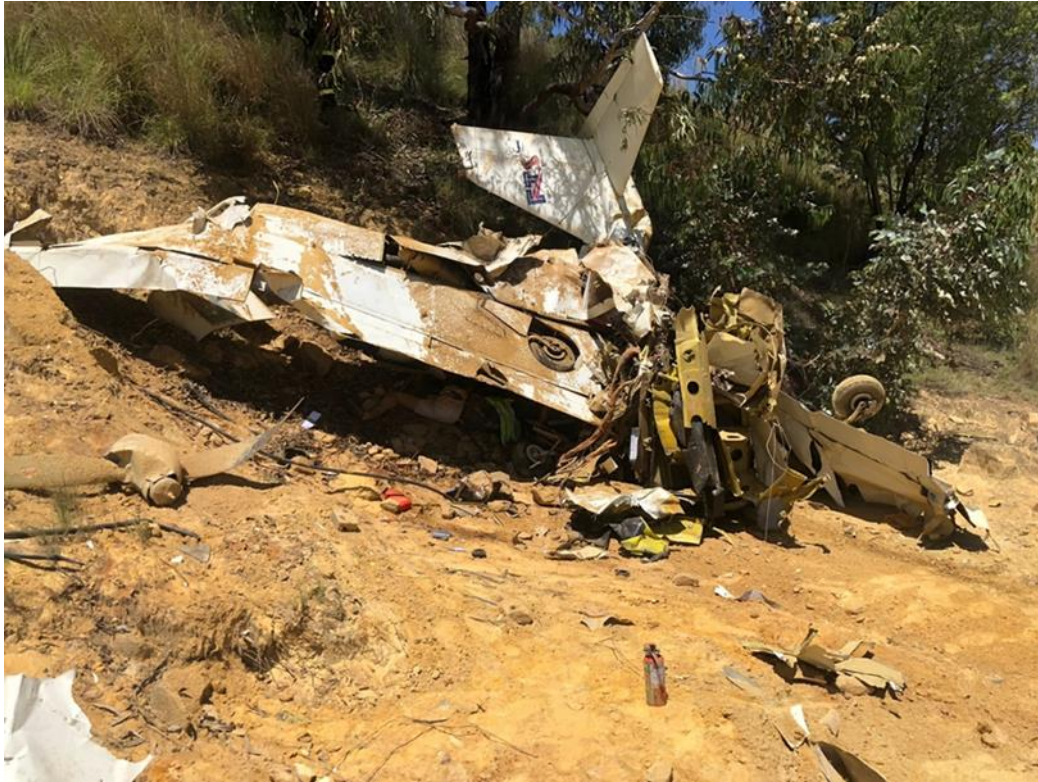
1.12.1. The aircraft struck the ground at a high speed at the mine dump site in Crown Mines, located south-west of Johannesburg central business district (CBD). The aircraft impacted the ground with its left-side and bounced approximately 4 metres, it then hit the ground the second time and bounced again approximately 6 metres. It finally impacted a hillock and flipped over. Fragments of the left engine were found scattered on the hillock. A piece of the left-wing tip was found approximately 4 metres on the left side of the main wreckage.

1.12.2. The pilot's body was found approximately 2 metres from the wreckage, whilst the flight instructor's body was found under the wreckage. The aircraft was crushed from the midsection to the nose section.

1.12.3. The left main gear and the nose gear were found in an extended position, whilst the right main gear was in a retracted position. The landing gears were found selected to the "down" position. The rudder and the right elevator were still intact whilst the left elevator was bent towards the tip. The flight controls (rudder and the elevator) were checked for movement, which was confirmed. Also, the cables were checked for continuity, and they were found to be intact with damage attributed to the accident impact forces.

Figure 4: The wreckage post-accident.

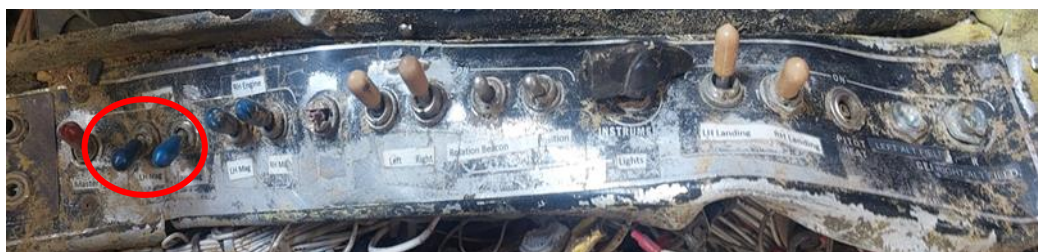
1.12.4 During the on-site inspection of the instrument panels, both the left-side engine magneto switches were in the 'off' position and the instrument indications were damaged by impact forces.

Figure 5: The cockpit instrument with the left-side magneto switch in the 'off' position.

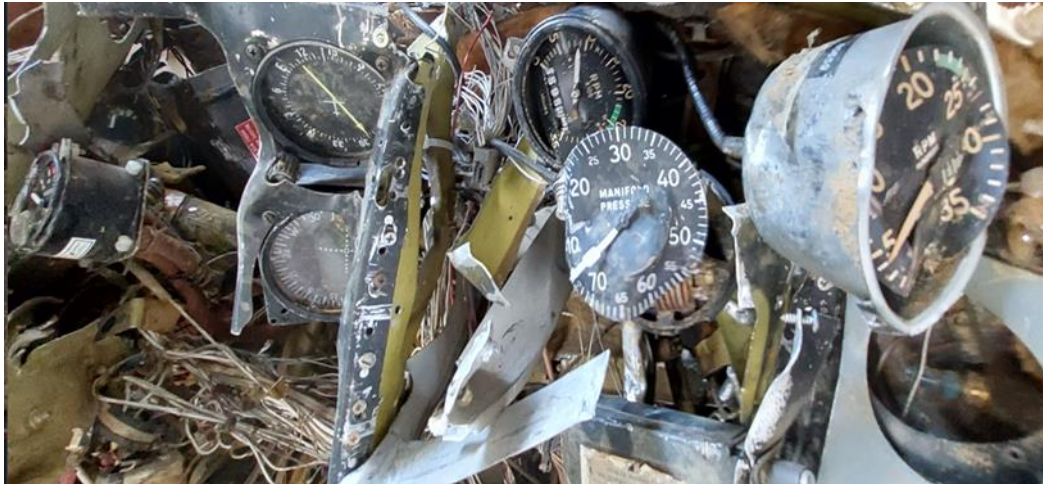
Figure 6: The damaged instruments.

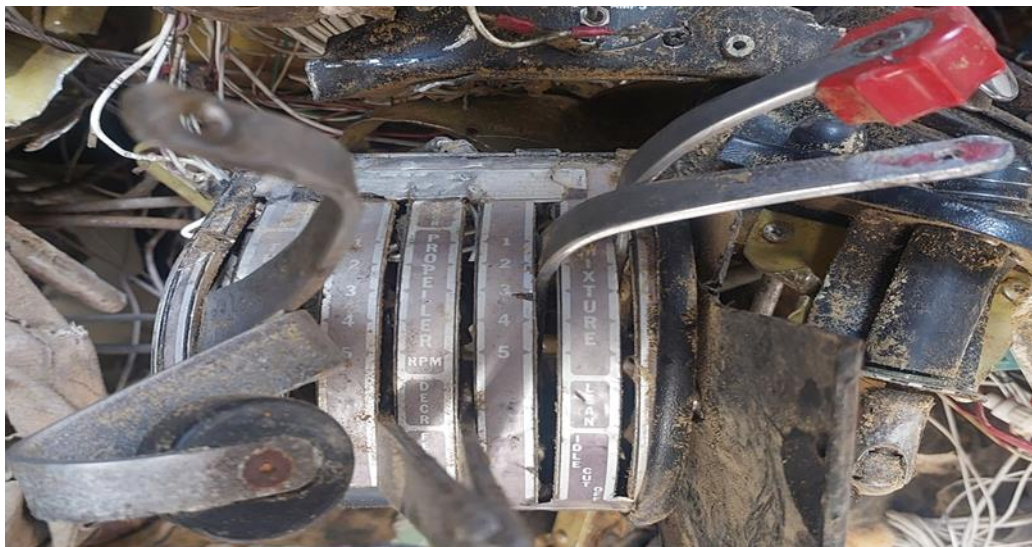
- Left- and right-side engine power levers were towards the “closed” position.
- Left- and right-side propeller levers were feathered.
- Left- and right-side mixture control levers were at full rich.
- Levers were bent and hard to move (forward or backward).

Figure 7: The console showing the position of the power levers.

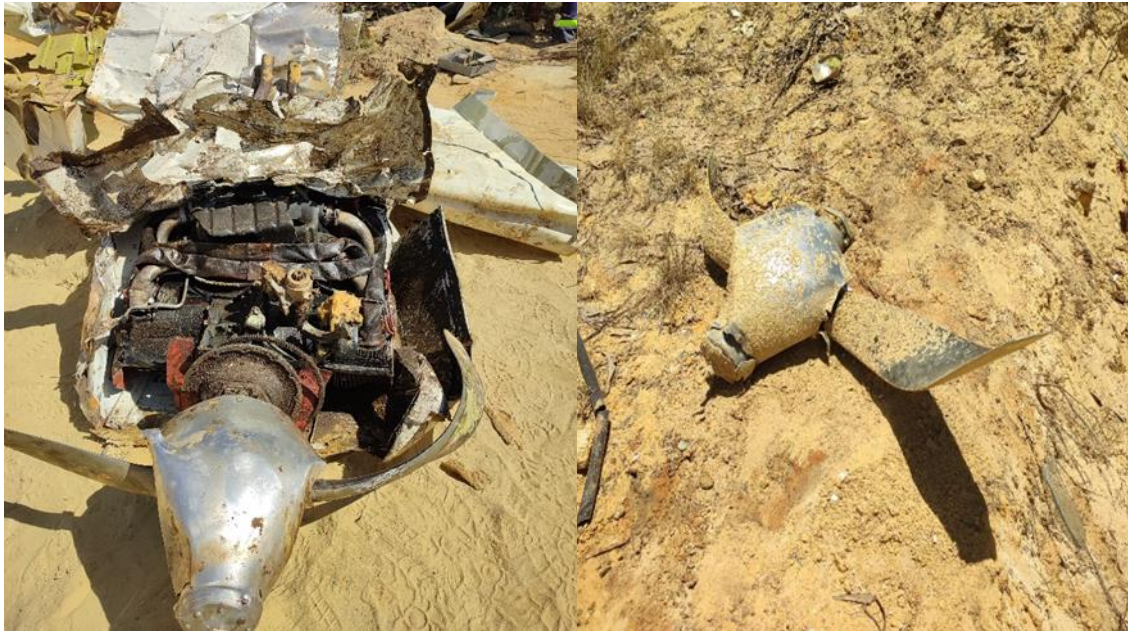
1.12.7 The inspection of the airframe, engine and propeller indicated that there was no pre-impact failure, and all damage was attributed to the impact forces. The propeller damage had minimal rotation force during impact, indicative of no significant engine power. Both engines were subjected to a teardown inspection and no anomalies were noted.

Figure 8: The bent propellers.

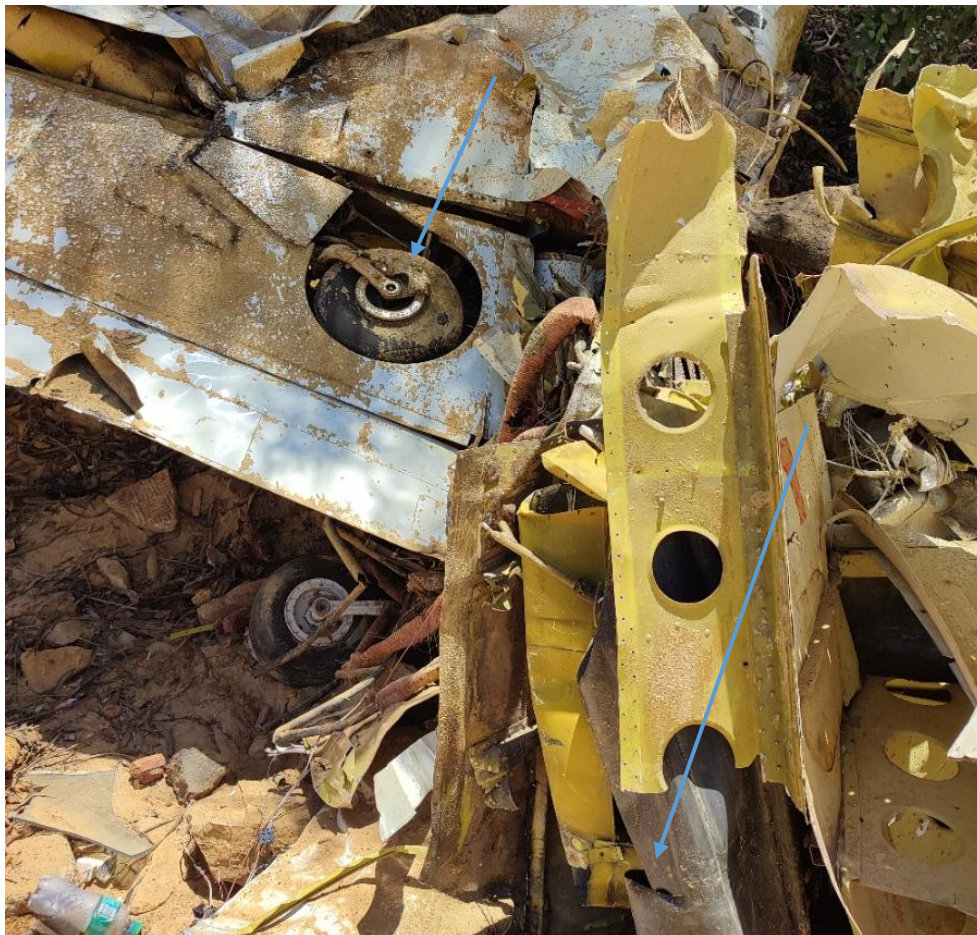
1.12.8 The right tank switch was in the “auxiliary” (Aux) position whilst the left tank switch was in the “off” position. The aircraft’s main fuel bladder tanks had ruptured, and some fuel leaked to the ground. The exact fuel contents leak could not be determined. There was no indication of fuel pooling around the accident site.

Figure 9: The ruptured fuel tank bladder and the right main gear in a retracted position.
