**AIRCRAFT ACCIDENT REPORT AND EXECUTIVE SUMMARY**

| | | | | <b>Reference:</b> | | <b>CA18/2/3/10249</b> | |
| <b>Aircraft Registration</b> | <b>ZS-PNC</b> | <b>Date of Accident</b> | 13 January 2023 | | <b>Time of Accident</b> | 0950Z | |
| <b>Type of Aircraft</b> | Ayres S2R-T34 | | <b>Type of Operation</b> | | Crop-spraying (Part 137) | | |

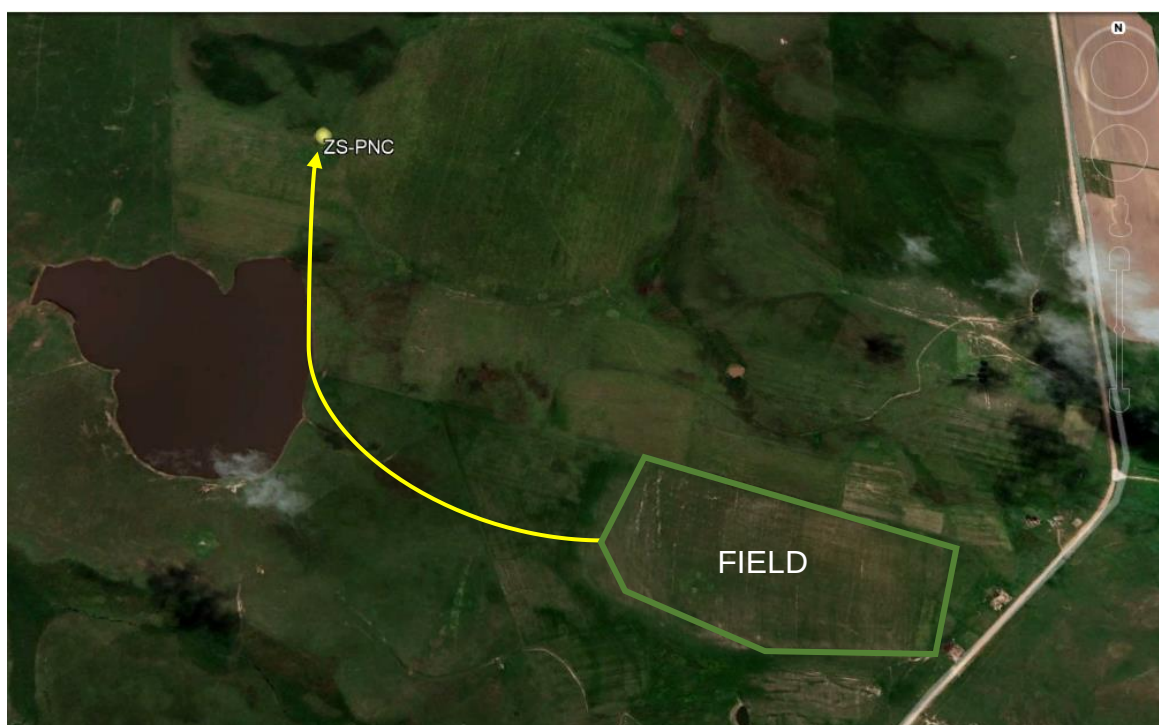
**Figure 2:** The yellow line indicates the flight path of the aircraft when it experienced power loss.  
(Source: Google Earth)

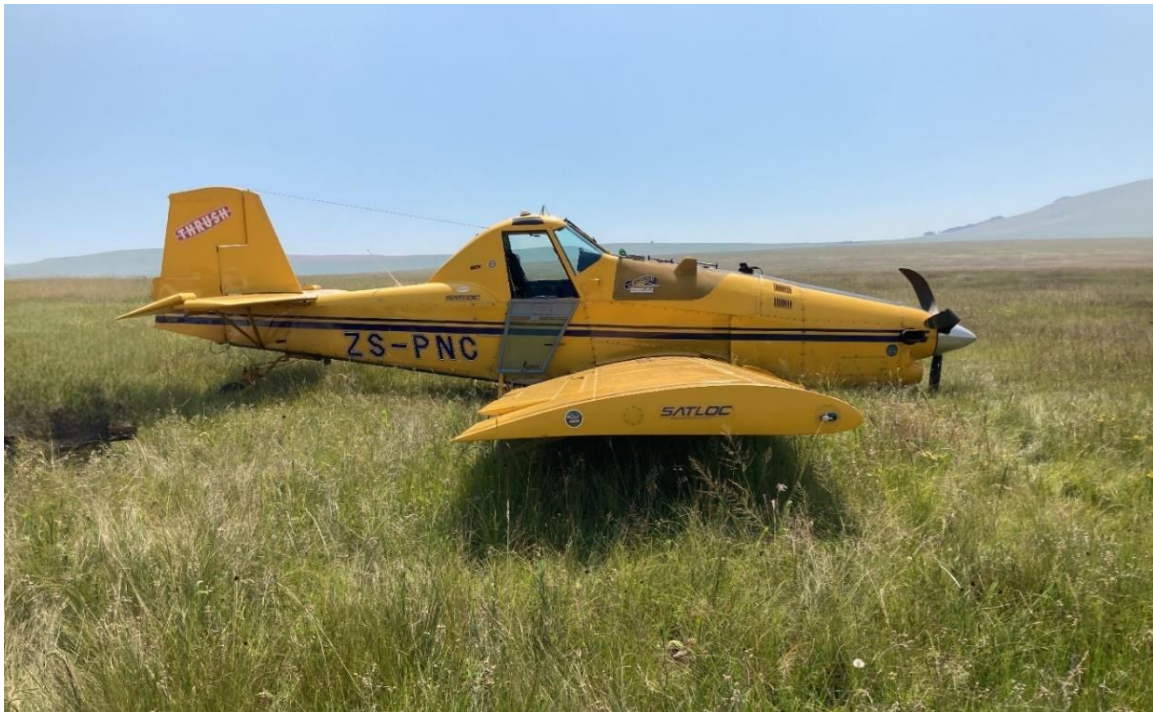
1.3.1. The aircraft sustained substantial damage to the propeller and the main undercarriage.

**Figure 3:** The aircraft post-accident. (Source: Operator)

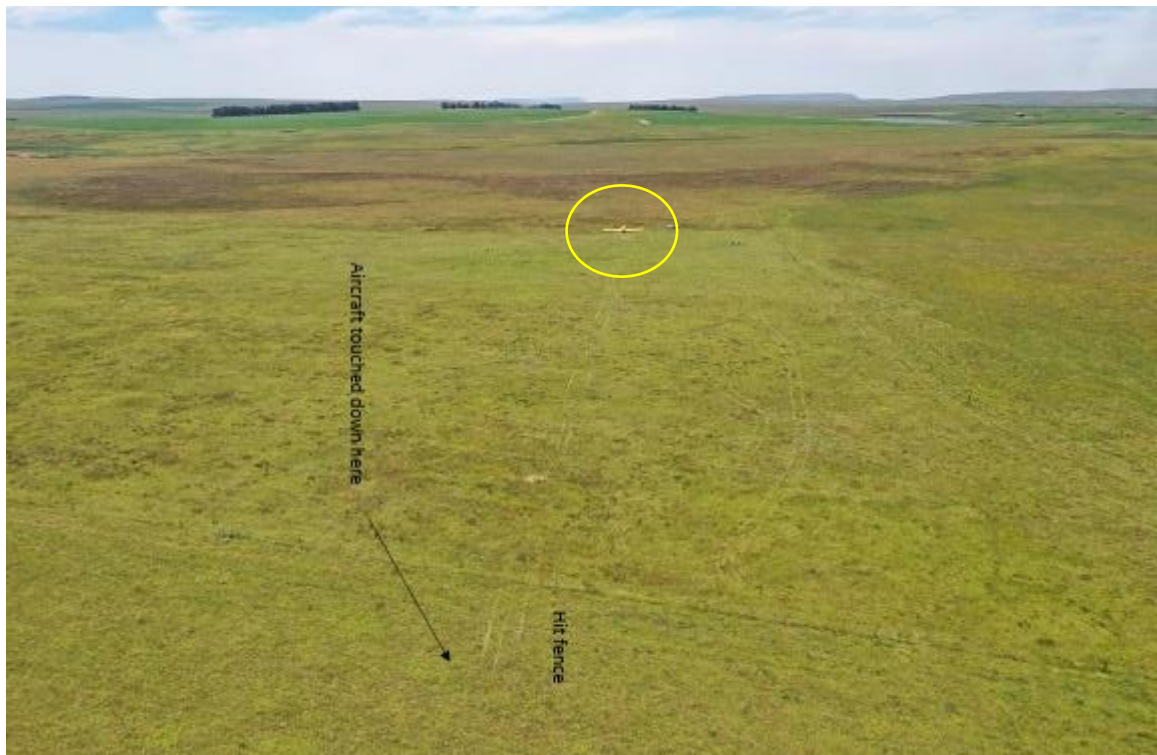
- 1.12.1 The aircraft touched down on uneven terrain and, after a few metres, it impacted a fence and flattened it whilst still rolling. Thereafter, the aircraft impacted a large rock on the ground and bounced back into the air. Upon touch down again, the wheel support struts broke off, which caused the main undercarriage to collapse and the propeller blades to strike the ground.

**Figure 5:** An aerial view showing the aircraft's ground roll after the forced landing. (Source: Operator)

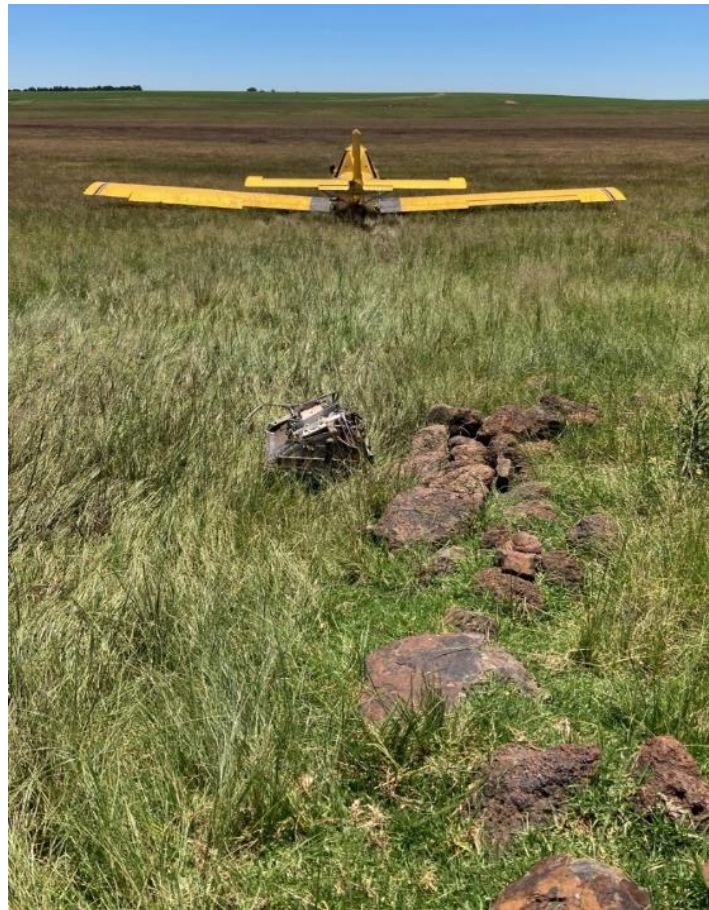
1.12.2 Approximately 300m after the aircraft touched down, the undercarriage impacted a large rock, which resulted in the spray pump and the gate box being severed. The spray pump was found behind the aircraft among rocks that the aircraft initially impacted.

**Figure 6:** Rocky terrain and the spray pump and the gate box. (Source: Operator)

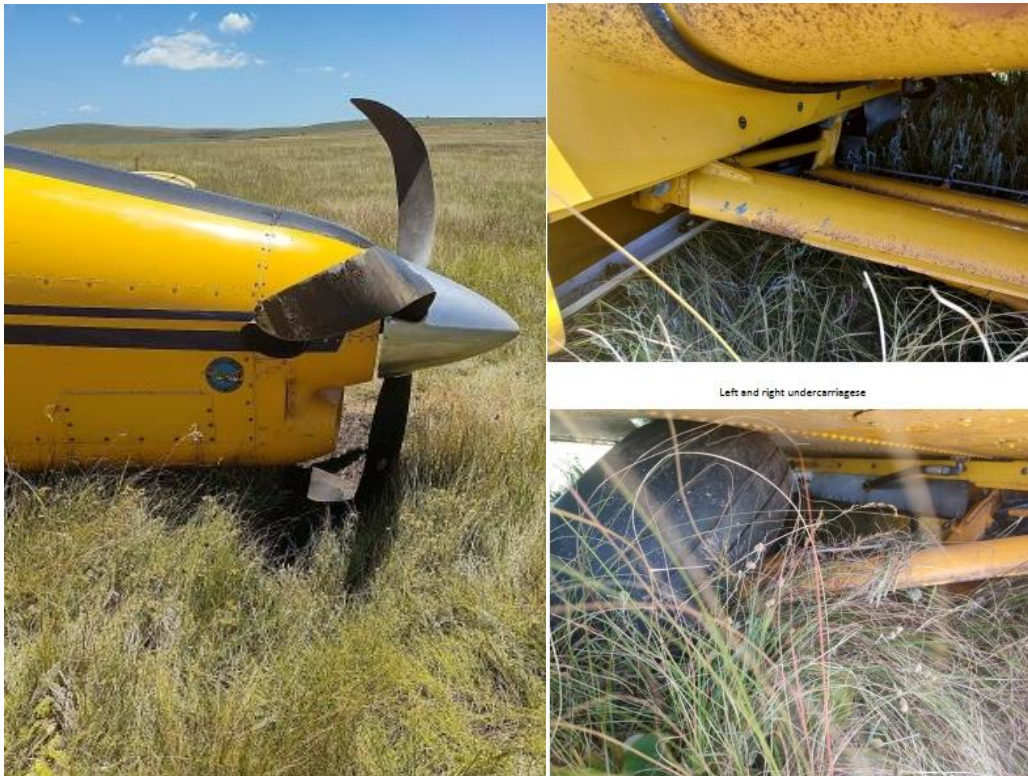
- 1.12.3 All three propeller blades bent backwards, which indicated that there was some power (the aircraft restarted) when the aircraft impacted the ground after it bounced.

**Figure 7:** The damaged propeller (left) and main undercarriage (right). (Source: Operator)

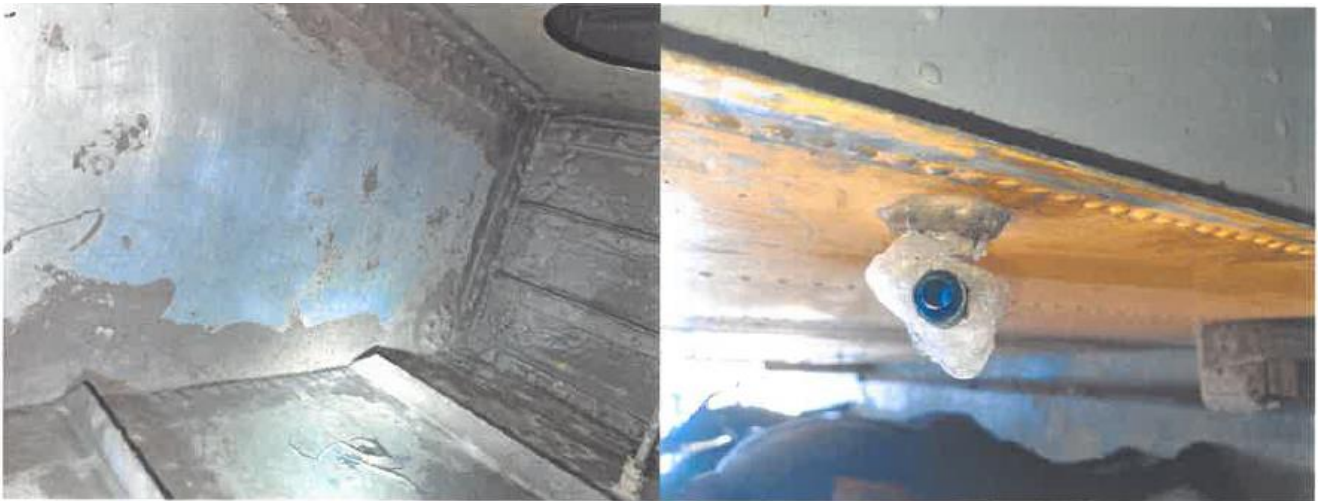
- Both fuel tank inspection covers were removed, and both tanks were dry.
- The rear and front fuel tank outlets for both wings were unobstructed.
- The fuel lines to the header tank were unobstructed.
- Both fuel cap sealing and the O-rings were in good condition.
- Both fuel cap locking mechanisms were functioning correctly.
- Both fuel tank drains were found clear and functioning correctly.
- The header tank drain was removed and there were no contaminants found.
- Both vent lines were physically blown, and no obstructions were found.
- The fuel control unit (FCU) fuel filter bowl was removed, and fuel was found inside. No abnormalities were observed.

**Figure 8:** The right fuel tank and the right fuel tank outlet. (Source: AMO)

The aircraft was recovered to an AMO where both fuel tank covers were removed, and they were found dry. All other fuel-related systems/parts were recovered with no anomalies detected. The FCU fuel filter bowl was removed, and fuel was found inside with no contaminants observed. The FCU was shipped to the manufacturer for further investigation, and there were no indications of any mechanical anomalies that could have caused the engine to lose power during flight.

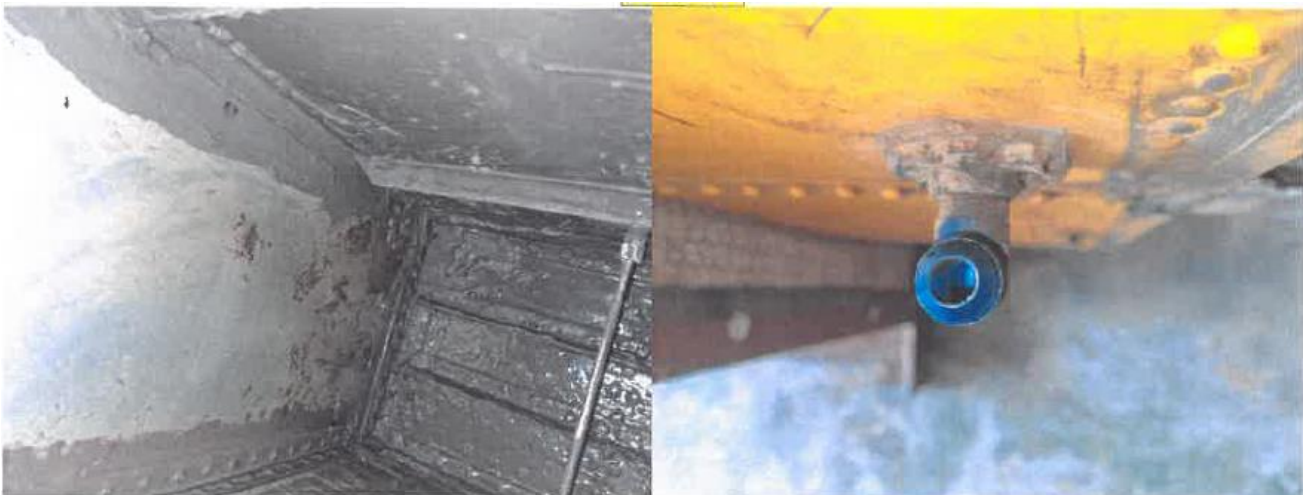
**Figure 9:** The left fuel tank and the left fuel tank outlet. (Source: AMO)

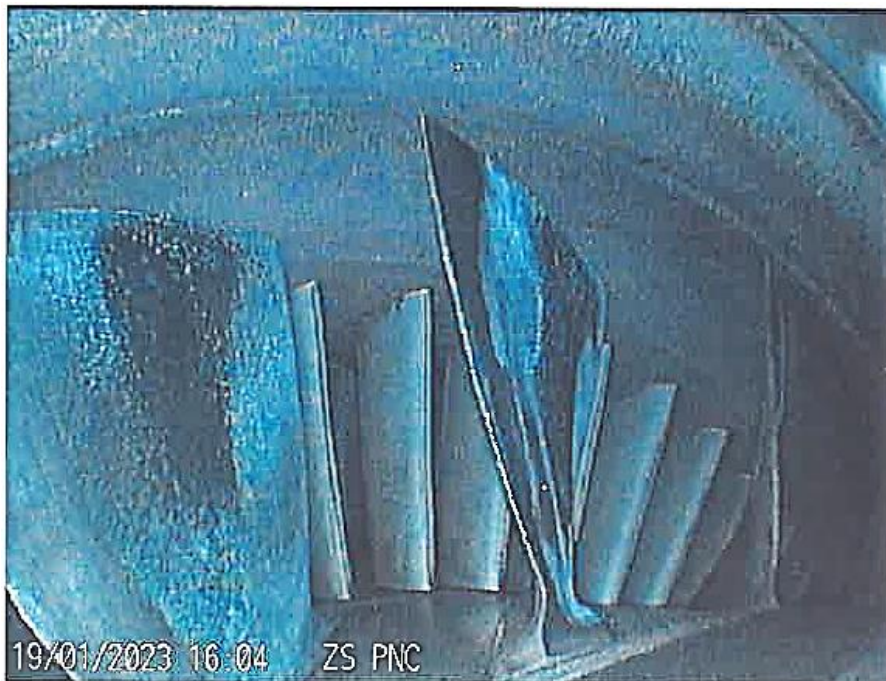
- *First stage inlet blades found in good condition with no FOD (foreign object damage).*
- *First stage stator found in good condition with no FOD.*

**Figure 10:** First stage rotor and the stator inlet blades. (Source: AMO)

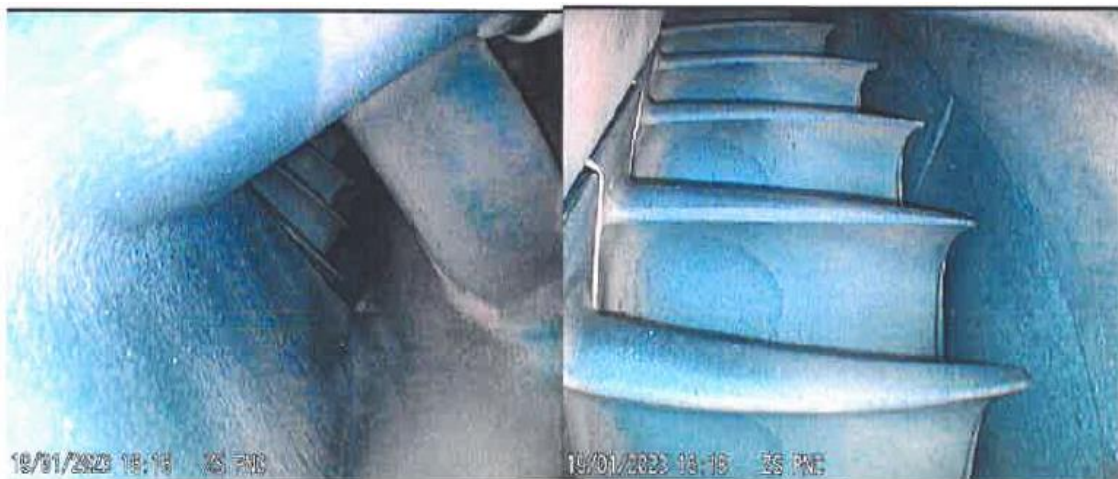
- Compressor turbine (CT) blades and the vane ring were inspected, and no blades were broken nor had FOD. A blue discolouration was observed which is indicative of a high temperature associated with overtemperatures or a hot start.

**Figure 11:** CT blades and the vane ring showing discolouration. (Source: AMO)

During the flight whilst the aircraft was turning right, the engine flamed out, followed by a drop in ITT, torque and RPM which are symptoms of an engine power loss. The cause of engine flameout was attributed to fuel exhaustion, which meant that the aircraft was flown until it ran out of fuel. After realising that the engine had lost power, the pilot levelled the aircraft from a right turn to force land it. On short finals whilst at wings level, the pilot was able to restart the engine by switching on the igniters and engaging the starter. The engine did not spool up timeously at the start due to the pilot omitting to select the propeller control lever to maximum, which caused drag and increased ITT, thus, the discolouration in the PT disc and blades.

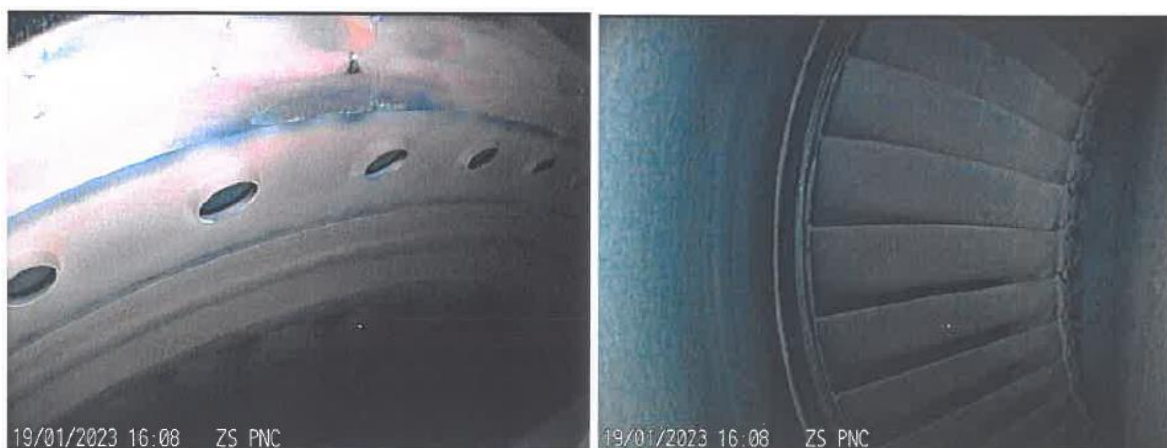
- Power Turbine (PT) blades and PT vane were found in a good condition and had no damage.
- Combustion chamber was found with evidence of heat discolouration on the small exit duct surface.

**Figure 12:** Combustion chamber on the left and PT blades on the right. (Source: AMO)
