LIMITED OCCURRENCE INVESTIGATION REPORT – FINAL

Reference Number	CA18/2/3/10250						
Classification	Accident	Date	16 January 2023	Time	0707Z		
Type of Operation	Training (Part 141)						
Location							
Place of Departure	Wonderboom Aerodrome (FAWB), Gauteng Province		Place of Intended Landing	Wonderboom Aerodrome (FAWB), Gauteng Province			
Place of Occurrence	Runway 06 at Wonderboom Aerodrome (FAWB) in Gauteng Province						
GPS Co-ordinates	Latitude	25°39'13" S	Longitude	028°13'27" E	Elevation	4 095 feet (ft)	
Aircraft Information							
Registration	ZS-SDA						
Make; Model; S/N	Cessna; 172P Skyhawk (Serial Number: 17276251)						
Damage to Aircraft	Substantial		Total Aircraft Hours	14 895.8			
Pilot-in-command							
Licence Type	Student Pilot Licence (SPL)		Gender	Female		Age	19
Licence Valid	Yes	Total Hours	45.9		Total Hours on Type	42.6	
Total Hours 30 Days	0.7		Total Flying on Type Past 90 Days	12.6			
People On-board	1+0	Injuries	0	Fatalities	0	Other (on ground)	0

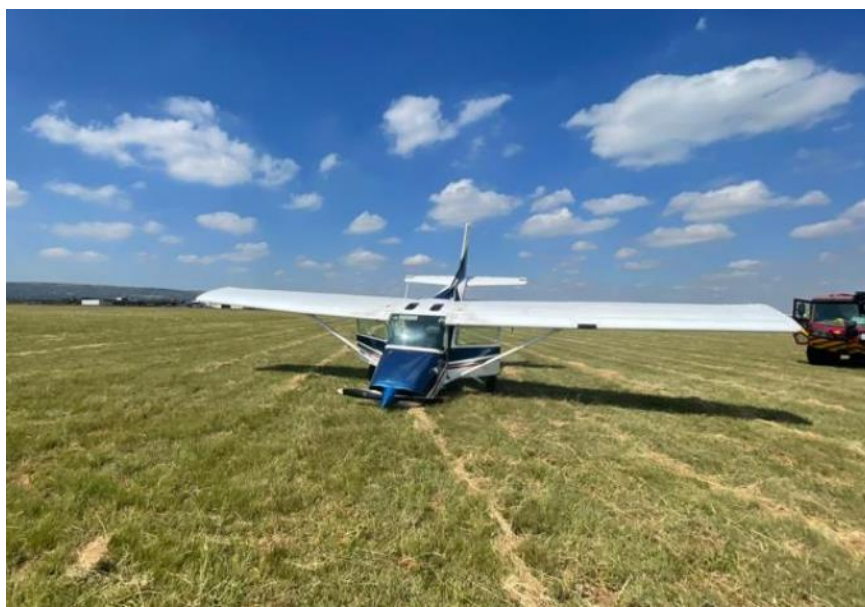
gear strut broke off and the aircraft skidded on its nose section before the aircraft came to a stop. The aircraft was substantially damaged; however, no person was injured.

Figure 1: The aircraft after it came to a stop. (Source: Operator)

Loss of control during take-off resulted in the aircraft's failure to lift-off adequately; this caused the aircraft to settle back onto the runway before it veered off to the left and onto the grass. The cause of the aircraft settling back was due to a lack of compensation for drift which was caused by the crosswind during take-off.

Pilots operating similar aircraft type to the one in this report are urged to adhere to instructions and procedures laid out in the POH for safe operation to prevent damage to aircraft.

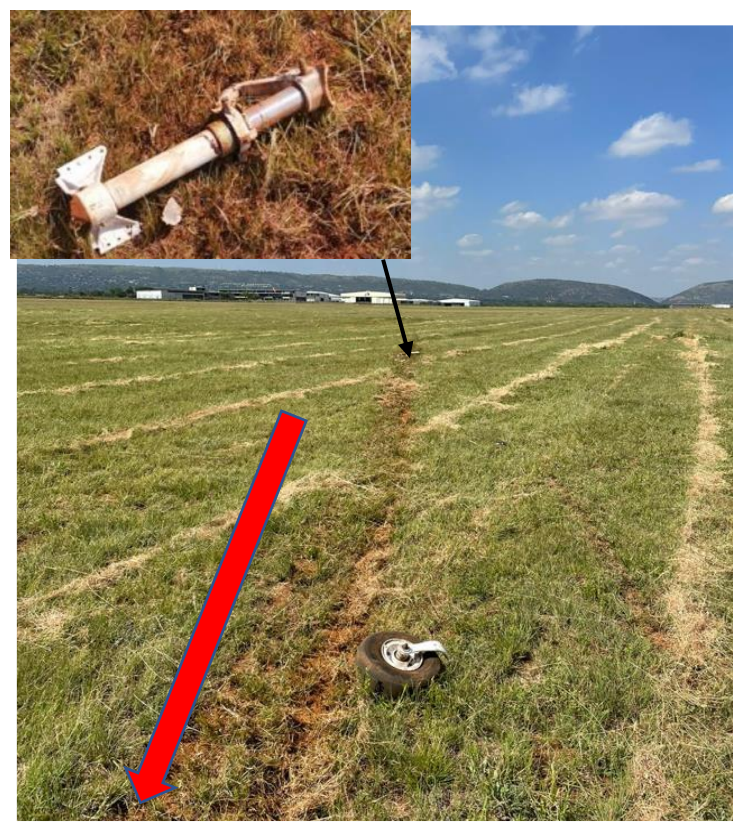
Figure 2: The nose strut and nose wheel after separating from the aircraft. The arrow shows the direction of the aircraft. (Source: Operator)

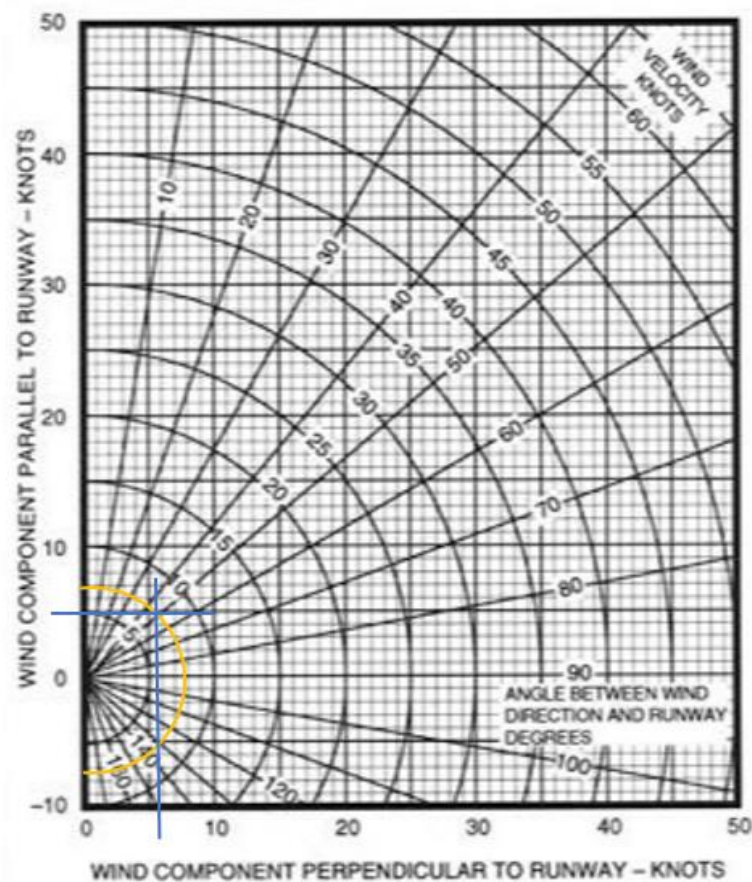
Chart 1: Wind component chart.

According to the SAWS, the reported wind direction on the day of the accident was 110° at 7 kts. The SP stated that the aircraft took off from RWY06 with a 50° angle between wind direction and runway heading. When plotted on the graph (above), the weather conditions showed the headwind component of 5 kts and the crosswind component of 6 kts; therefore, the crosswind encountered at take-off was not considered significant. According to the SAWS weather report, there was no tailwind at the time of the accident as stated by the SP.
