**LIMITED OCCURRENCE INVESTIGATION REPORT – FINAL**

<b>Reference Number</b>	CA18/2/3/10251					
<b>Classification</b>	Accident	<b>Date</b>	13 January 2023	<b>Time</b>	0900Z	
<b>Type of Operation</b>	Private (Part 94)					
<b>Location</b>						
<b>Place of Departure</b>	Rhino Park Airfield, Gauteng Province		<b>Place of Intended Landing</b>	Rhino Park Airfield, Gauteng Province		
<b>Place of Occurrence</b>	Runway 09 at Rhino Park Airfield, Gauteng Province					
<b>GPS Co-ordinates</b>	<b>Latitude</b>	25°49'52.84" S	<b>Longitude</b>	28°32'26.43" E	<b>Elevation</b>	4 776 feet
<b>Aircraft Information</b>						
<b>Registration</b>	ZU-ISK					
<b>Make; Model; S/N</b>	Jabiru; J400 (Serial Number: 0054)					
<b>Damage to Aircraft</b>	Substantial		<b>Total Aircraft Hours</b>	407.4		
<b>Pilot-in-command</b>						
<b>Licence Type</b>	Private Pilot Licence (PPL) Aeroplane		<b>Gender</b>	Male	<b>Age</b>	43
<b>Licence Valid</b>	Yes	<b>Total Hours</b>	80.9	<b>Total Hours on Type</b>	62.6

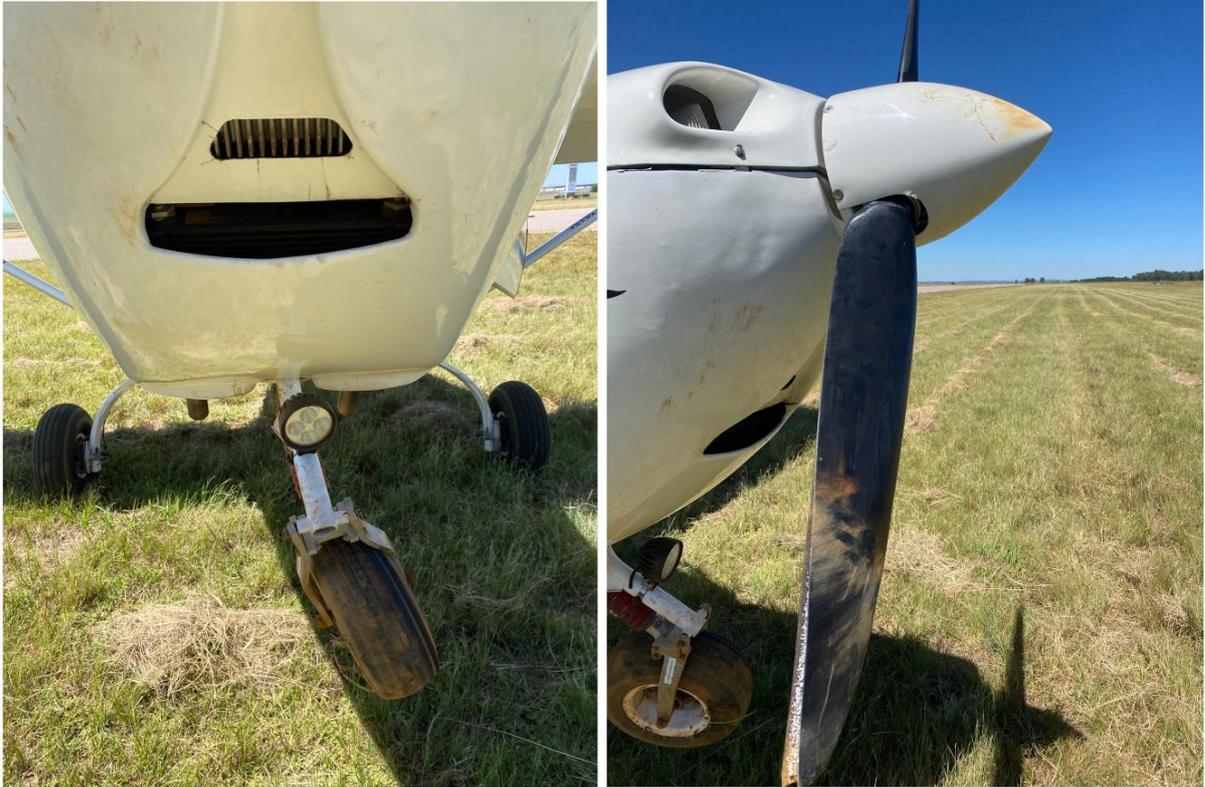
**Figures 1 and 2:** The bent nose landing gear oleo and a split propeller on the trailing edge side. (Source: Operator)

9. The aircraft landed hard on its nose wheel, which caused the oleo to bend to the left.
10. The pilot stated that he was unable to steer the nose wheel, and the aircraft was not responding to the rudder input. Following the accident, the aircraft maintenance organisation (AMO) that recovered the aircraft stated that their investigation of the rudder and steering control system as well as the main wheel brakes revealed no faults on these controls and systems.

The approach speed was high, and the aircraft was unstable and as a result, the landing was hard. This caused the nose gear oleo to bend upon touchdown, and the aircraft veered off to the left of the runway.

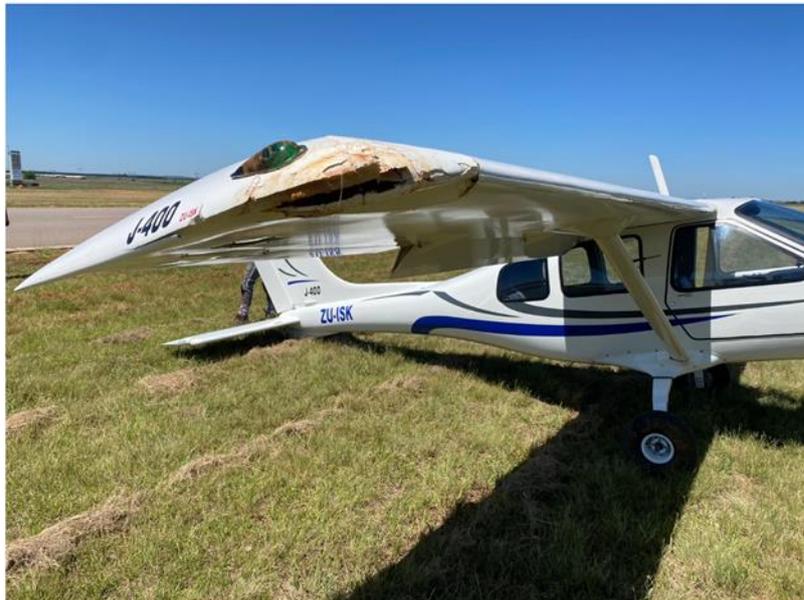
**Figure 3:** Damaged right-wing leading-edge area and fairing. (Source: Operator)
