**LIMITED OCCURRENCE INVESTIGATION REPORT – FINAL**

<b>Reference Number</b>	CA18/2/3/10252					
<b>Classification</b>	Accident	<b>Date</b>	11 January 2023	<b>Time</b>	0545Z	
<b>Type of Operation</b>	Aerial Work Application – Agricultural (Part 137)					
<b>Location</b>						
<b>Place of Departure</b>	Leeukop Aerodrome, Deneysville, Free State Province		<b>Place of Intended Landing</b>	Leeukop Aerodrome, Deneysville, Free State Province		
<b>Place of Occurrence</b>	Maize field on Leeukop Farm, Deneysville, Free State Province					
<b>GPS Co-ordinates</b>	<b>Latitude</b>	26°51'57.10" S	<b>Longitude</b>	028°03'58.51" E	<b>Elevation</b>	4 985 ft
<b>Aircraft Information</b>						
<b>Registration</b>	ZS-THH					
<b>Make; Model; S/N</b>	Air Tractor; AT-402A (Serial Number: 402A-1352)					
<b>Damage to Aircraft</b>	Substantial		<b>Total Airframe Hours</b>	1 917.6		
<b>Pilot-in-command</b>						
<b>Licence Type</b>	Commercial Pilot Licence (CPL)			<b>Gender</b>	Male	<b>Age</b> 44

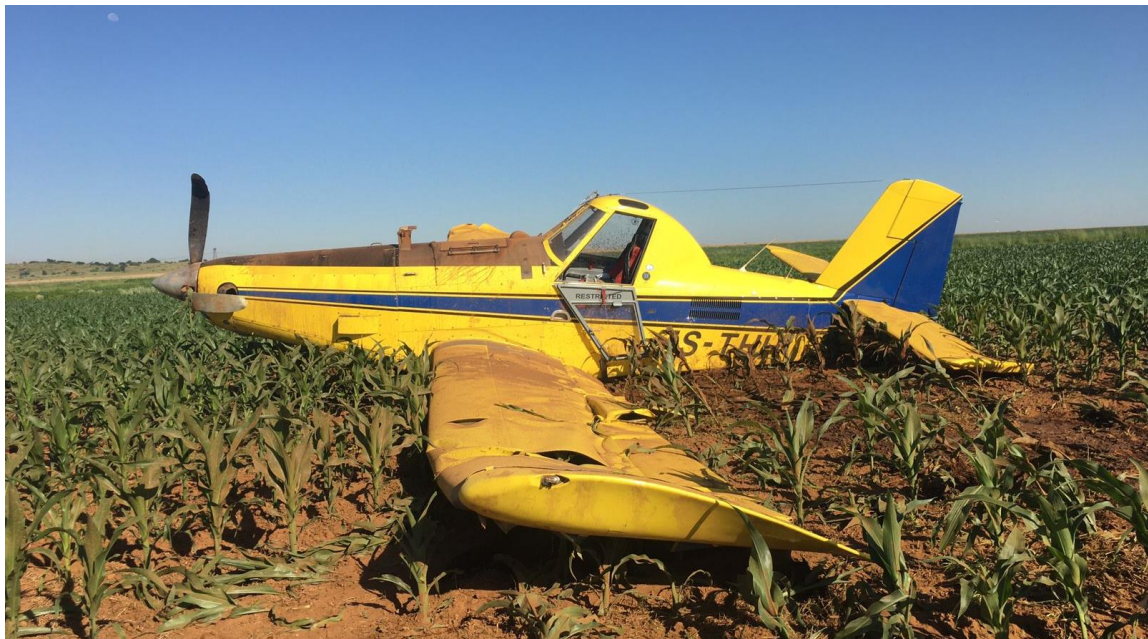
The pilot reported that after commencing with the take-off run and as the tail of the aircraft started to lift off (tail dragger) with the main wheels still on the ground, he felt a strong gust of wind from the right and the tail wheel settled back on the ground. At this stage, “he knew he was in trouble”, and he dumped the hopper load to reduce the take-off weight as this would allow the aircraft to get airborne faster. The farm perimeter fence with a locked double gate is positioned at the end of the runway; the gate is about 1.20m (4 feet) high. The left main gear struck the fence post and the support pole, and the left wing collided with the gate. This caused the aircraft to spin 180° along the vertical axis before it crashed on the maize field adjacent to the fence and came to rest facing the direction of take-off. The pilot indicated that he sustained a few bruises during the impact sequence but was able to disembark from the aircraft unassisted. The aircraft was substantially damaged, including the dispersal system.

**Figure 1:** The aircraft as it came to rest. (Source: Pilot)

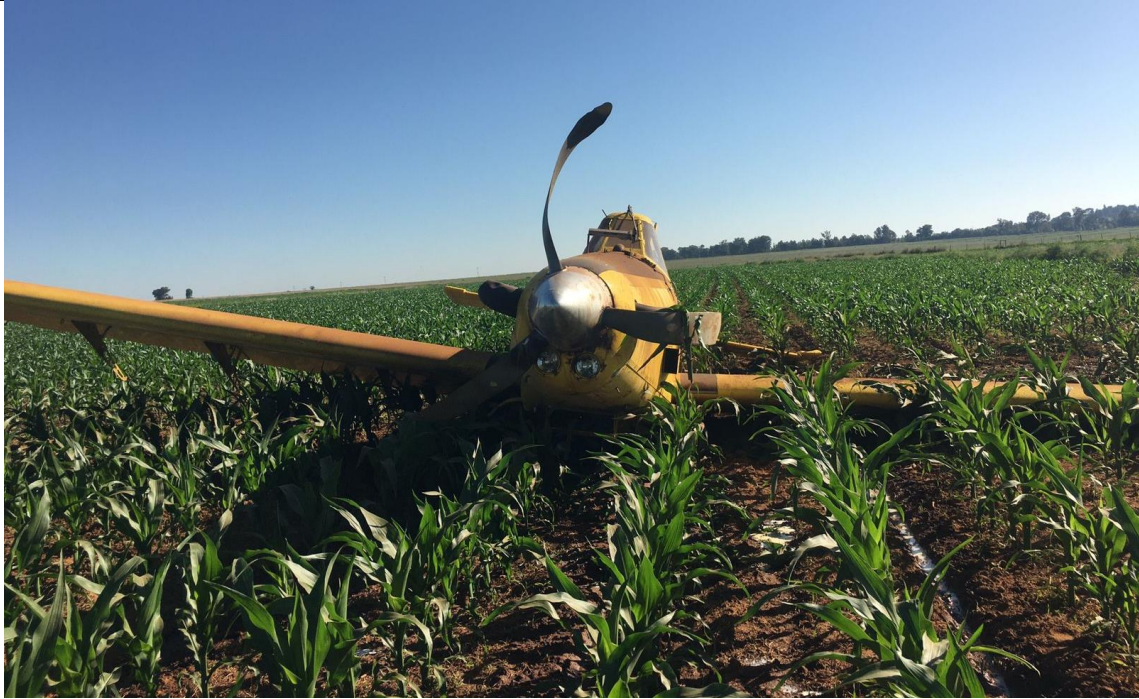
**Figure 2:** The front view of the aircraft on the maize field. (Source: Pilot)

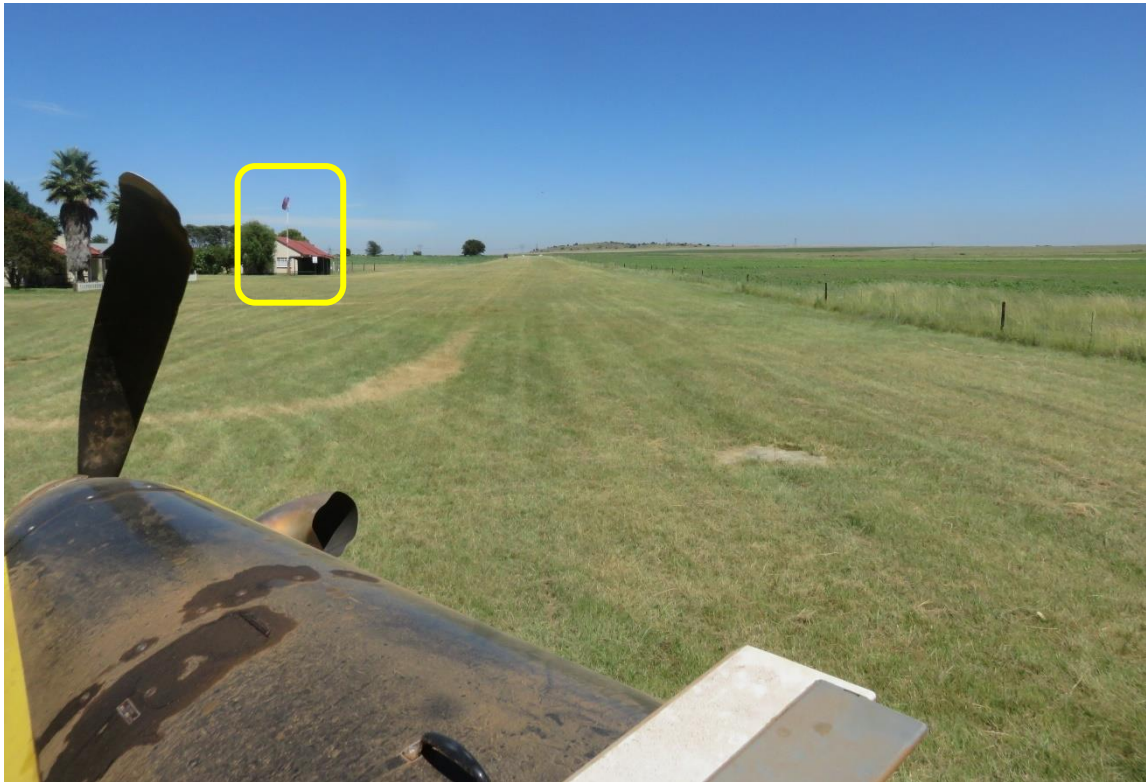
**Figure 3:** A view of the runway with the aircraft at the threshold of Runway 26 after it was recovered from the maize field. The windsock is visible in the yellow window.

4.1 The pilot made use of Leeukop Aerodrome, which is unlicensed. According to the farm owner, the runway was constructed in 1986 and has been in operation since. It is grass-covered and is 980m long and 25m wide. The runway orientation is 08/26. The pilot opted to use runway 26 for take-off. He stated that the runway surface was rough.

The runway is used on a regular basis for skydiving activities. The runway has an uphill slope when taking off from Runway 26. The grass was cut short when the investigator visited the aerodrome.

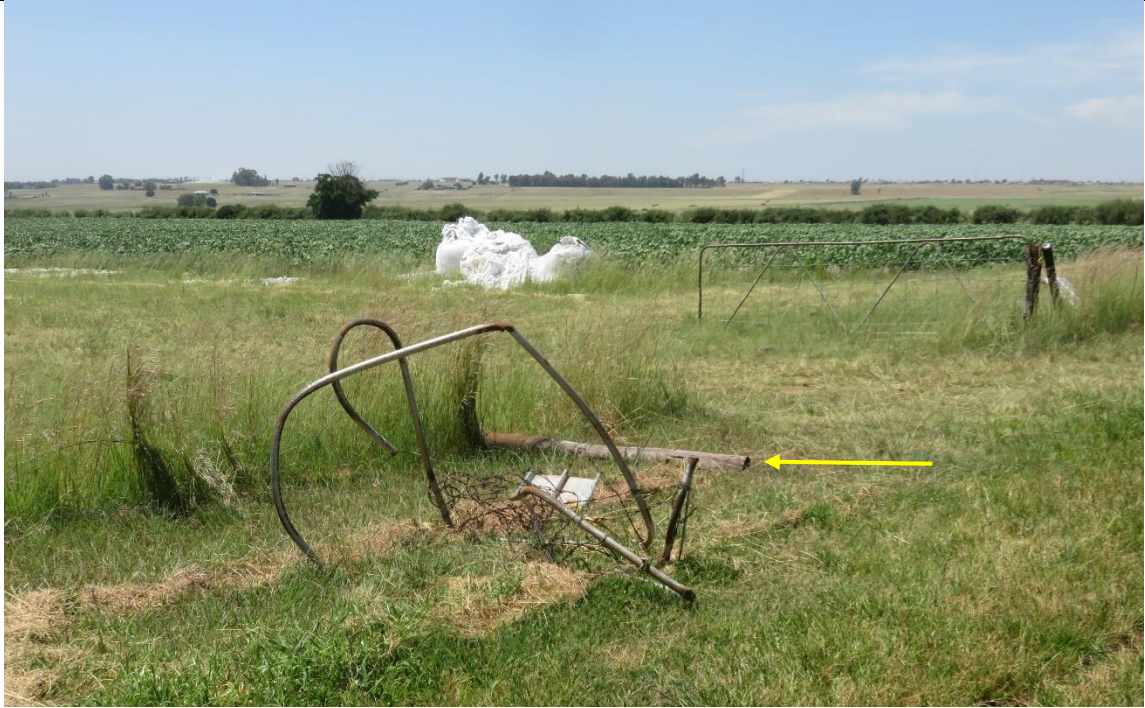
**Figure 4:** The mangled gate and supporting wooden post with which the aircraft collided.

The pilot did not calculate the take-off distance prior to the first load of the day and opted to commence with the take-off with an aircraft that exceeded its MTOW, as a result, the aircraft failed to obtain rotational speed. The aircraft impacted the perimeter fence on rotation, and the pilot lost control of the aircraft and crashed.

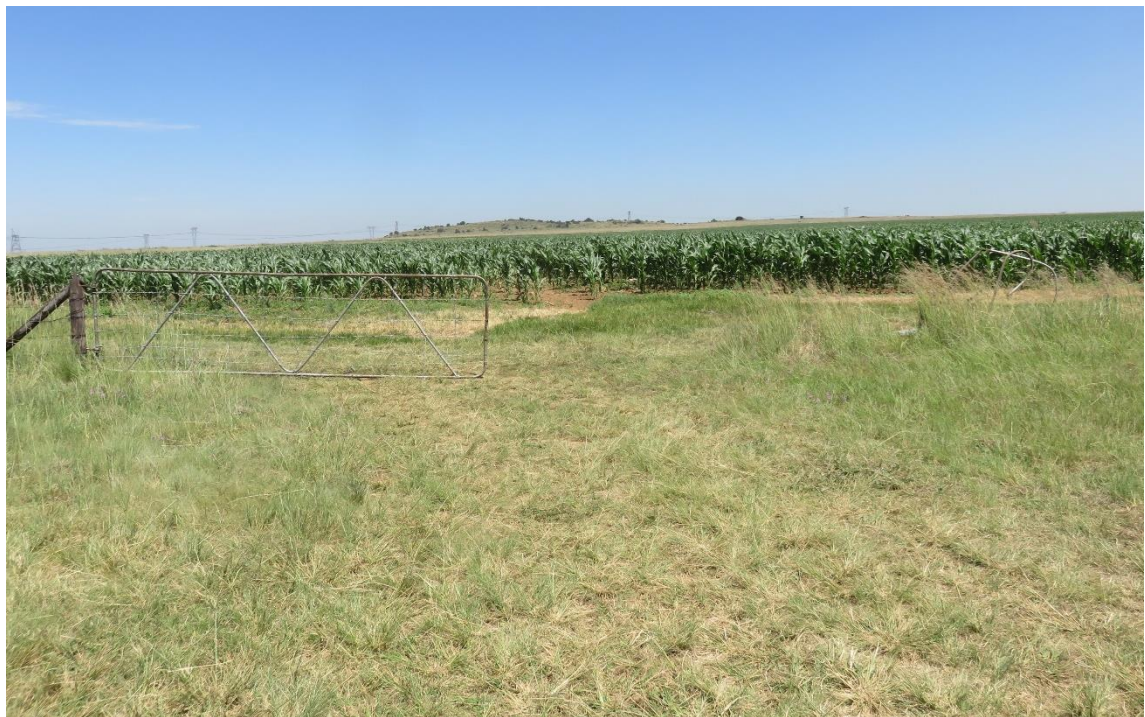
**Figure 5:** The left gate viewed from the direction of take-off whilst still intact.
