LIMITED OCCURRENCE INVESTIGATION REPORT – FINAL

Reference Number	CA18/2/3/10253						
Classification	Accident	Date	23 January 2023		Time	0951Z	
Type of Operation	Training (Part 141)						
Location							
Place of Departure	Cape Town International Airport (FACT), Western Cape Province		Place of Intended Landing	Cape Town International Airport (FACT), Western Cape Province			
Place of Occurrence	Runway 01 at Cape Town International Airport (FACT), Western Cape Province						
GPS Co-ordinates	Latitude	33°58'51.83" S	Longitude	018°36'24.40" E	Elevation	144 feet (ft)	
Aircraft Information							
Registration	ZS-DVY						
Make; Model; S/N	Cessna 172 E (Serial Number: 17251654)						
Damage to Aircraft	Substantial			Total Aircraft Hours	4446.59		
Pilot-in-command							
Licence Type	Student Pilot Licence		Gender	Male		Age	20
Licence Valid	Yes	Total Hours	57.2		Total Hours on Type	57.2	
Total Hours 90 Days	36.2		Total Flying Hours on Type Past 90 Days	36.2

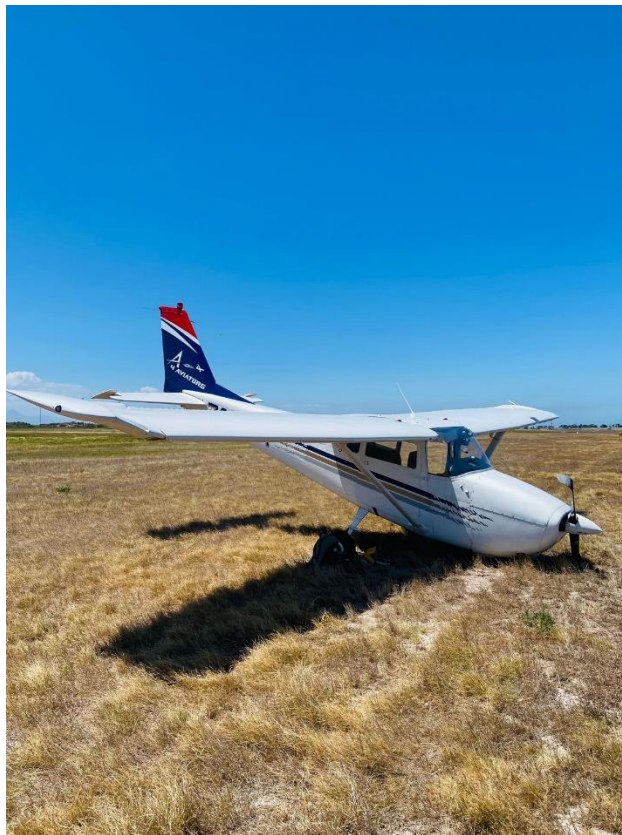
People On-board	1 + 0	Injuries	0	Fatalities	0	Other (on ground)	0
What Happened							
<p>On Monday, 23 January 2023 at 0951Z, a Cessna 172 aircraft with registration ZS-DVY was involved in an accident at Cape Town International Airport (FACT) in the Western Cape province. Visual meteorological conditions (VMC) by day prevailed at the time of the flight. The flight was conducted under the provisions of Part 141 of the Civil Aviation Regulations (CAR) 2011 as amended.</p> <p>The student pilot took off on a training flight from FACT to the general flying area (GFA) with the intention to return to FACT. On his return flight whilst on final approach for a full stop landing, the indicated airspeed on the aircraft was 90-95 knots. <i>The prescribed airspeed in the aircraft Pilot's Operating Handbook (POH) landing procedures is 55-65 knots.</i> The student pilot corrected the airspeed to 56 knots and set the flaps to 30 degrees before the aircraft touched down on Runway 01. After round out (flare), the aircraft ballooned. To correct the anomaly, the student pilot applied back pressure to the control column and added power. However, the right wing dropped and impacted the ground. This caused the pilot to lose control of the aircraft. Subsequently, the nose wheel impacted the ground hard and broke off. The propeller blades struck the runway and the aircraft veered off to the right before it came to a stop on the grass, about 30m from the edge of the runway.</p>

Figure 1: The aircraft as it came to rest. (Source: Operator)

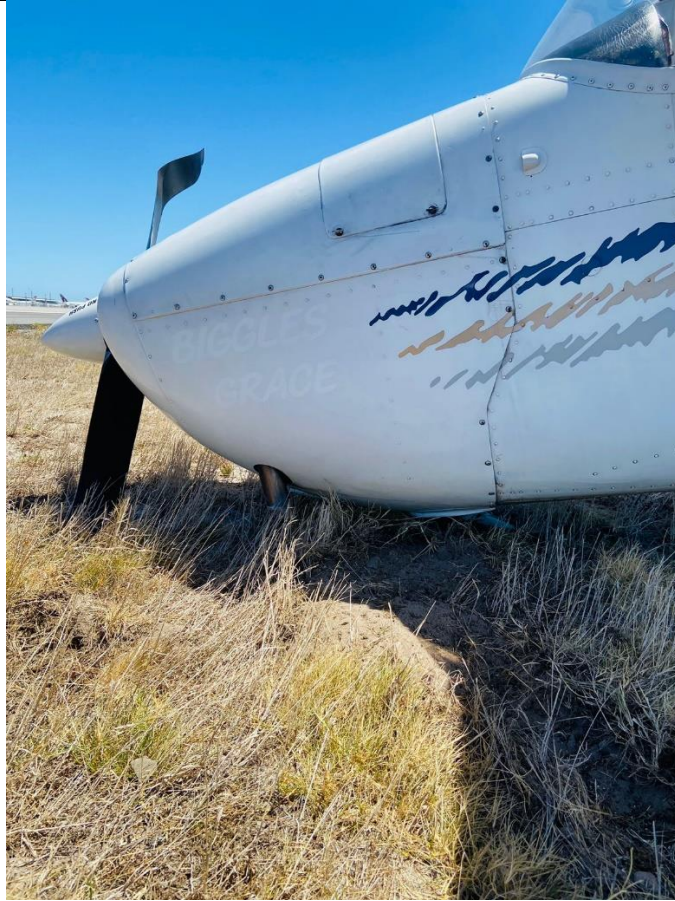
The aircraft sustained damage to the right-wing tip, propeller blades, nose wheel and nose gear strut. The pilot was not injured during the accident sequence.

Figure 2: Close up image of the nose section. (Source: Operator)

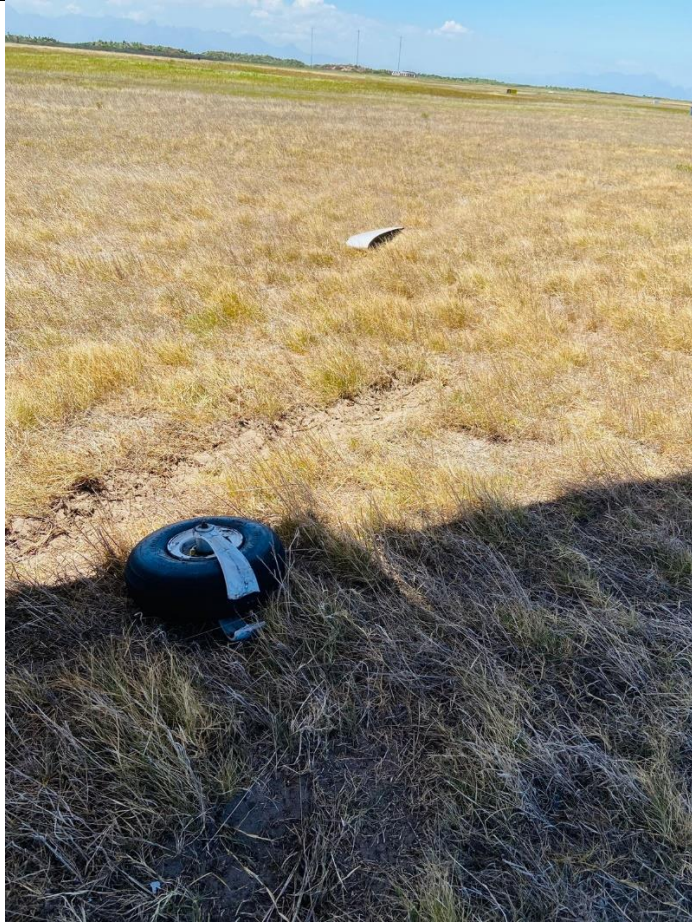
Figure 3: The detached nose wheel. (Source: Operator)

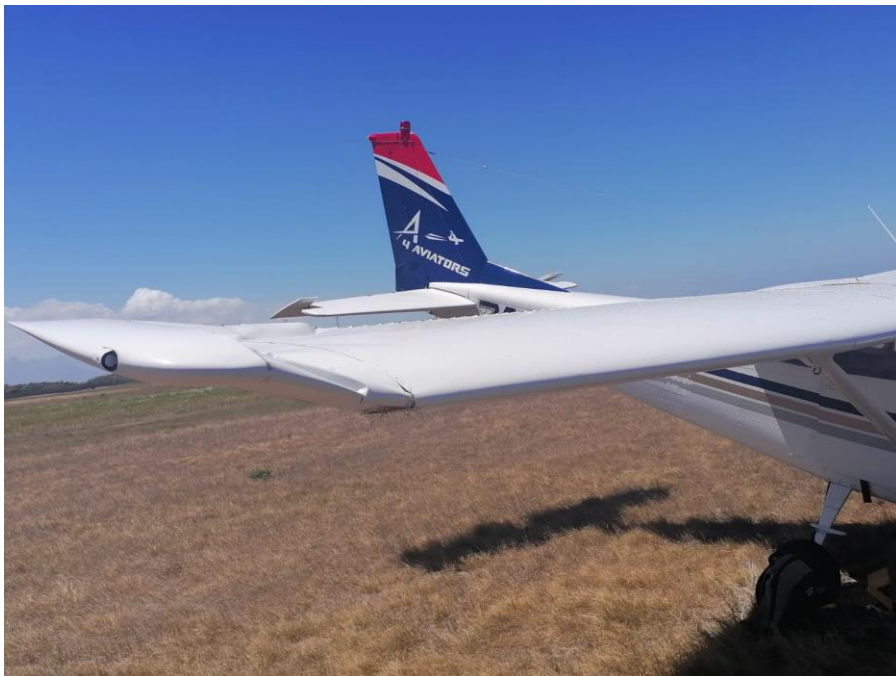
Figure 4: Damage on the right-wing tip. (Source: Operator)
