LIMITED OCCURRENCE INVESTIGATION REPORT – FINAL

Reference Number	CA18/2/3/10254						
Classification	Accident		Date	14 December 2022		Time	0900Z
Type of Operation	Remotely Piloted Aircraft System (RPAS) Training (Part 101)						
Location							
Place of Departure	Houtkop AH near Vereeniging, Gauteng Province		Place of Intended Landing	Houtkop AH near Vereeniging, Gauteng Province			
Place of Occurrence	At Houtkop AH near Vereeniging						
GPS Co-ordinates	Latitude	26° 35' 31.21" S	Longitude	025° 53' 19.59" E	Elevation	5024ft	
Aircraft Information							
Registration	ZT-WGG						
Make; Model; S/N	UAV Drone Solutions; Kestrel (Serial Number: K0015)						
Damage to Aircraft	Substantial		Total Aircraft Hours	472.29			
Pilot-in-command							
Licence Type	Remotely Pilot Licence		Gender	Male		Age	26
Licence Valid	Yes	Total Hours	1.37		Total Hours on Type	1.37	
Total Hours 30 Days	1.37		Total Flying on Type Past 90 Days	1.37			
People On-board	0	Injuries	0	Fatalities	0	Other (on ground)	0

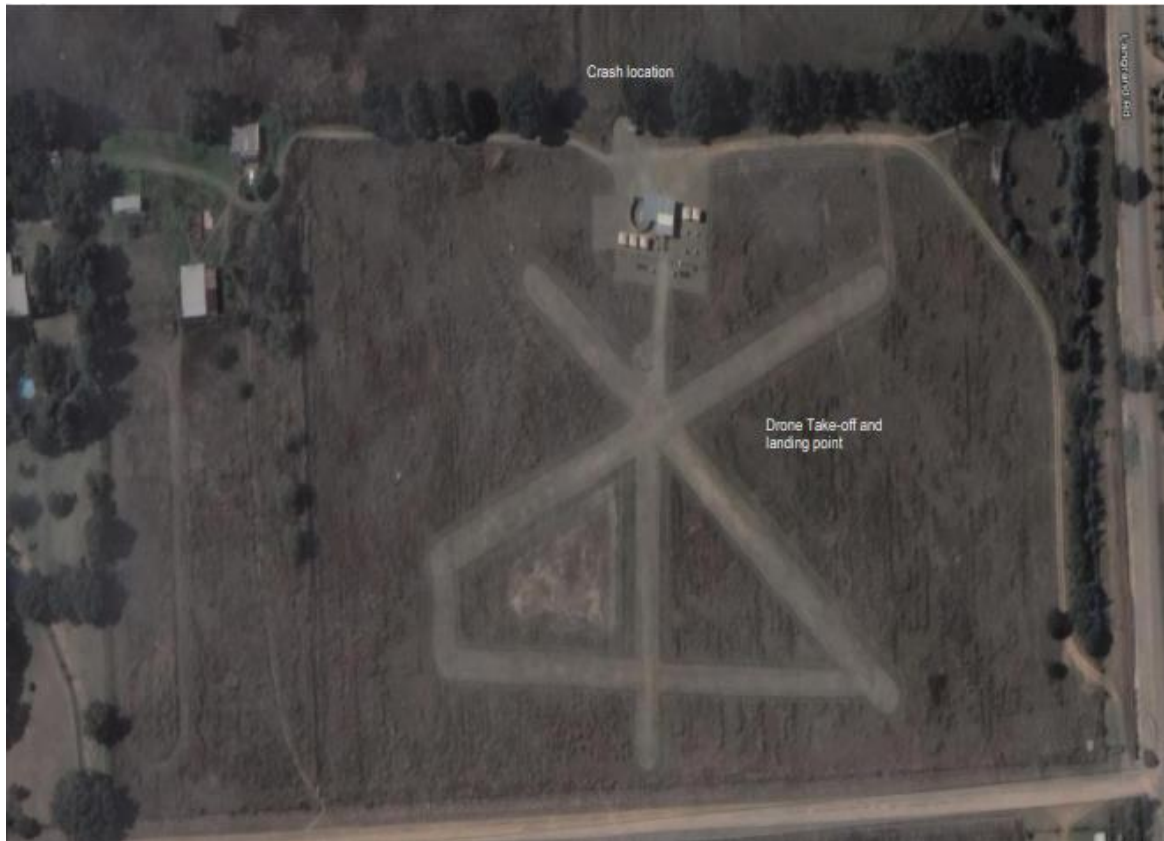
Figure 1: The view of the training field and the accident site.

6. It is evident that the pilot operated the RPA with its nose facing the opposite direction to where it was headed. As such, the pilot's flight inputs were disorientated. The RPAS's heading was facing a different direction to the one he intended, and gave inputs expecting the RPAS to fly towards him, but it went the opposite direction. It is likely that the pilot's inputs caused the RPA to travel facing the opposite direction and, in an attempt to correct the anomaly, the pilot further made inputs which caused the RPA to fly towards the trees where it got caught on one of the branches.

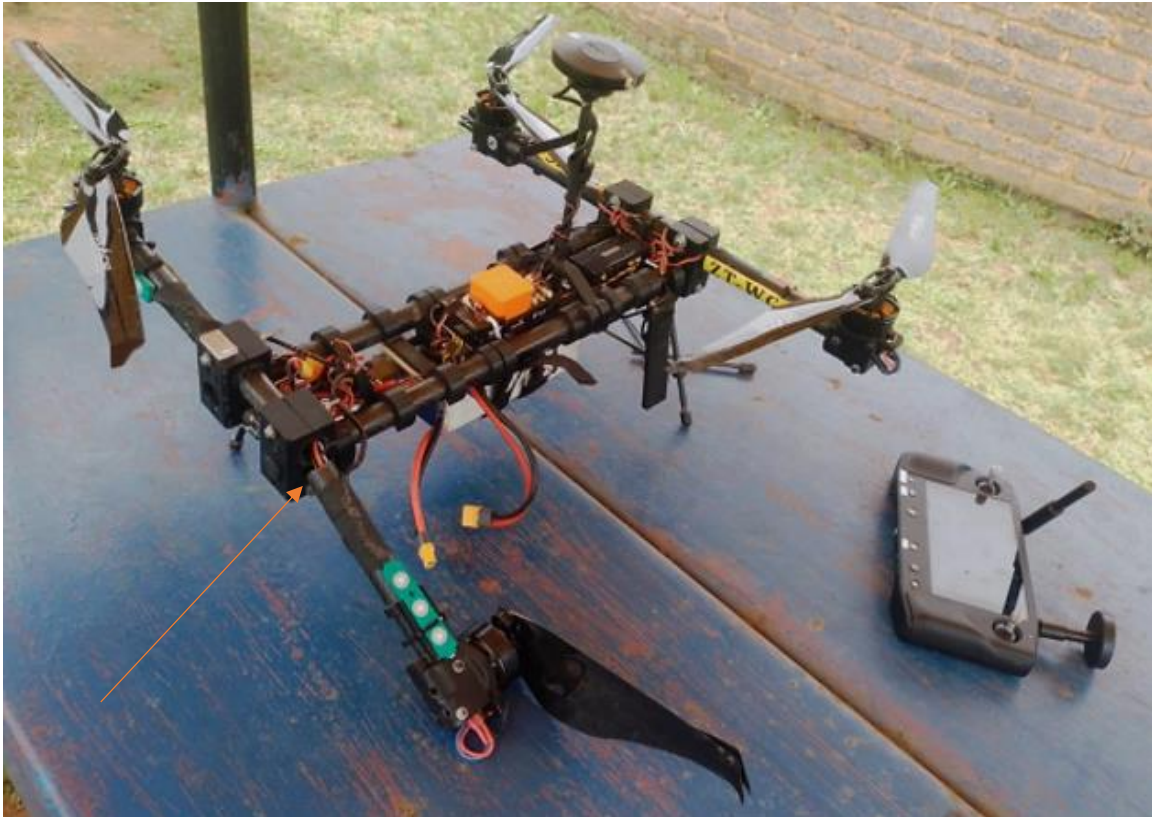
Figure 2: The damage on the right-side rear arm of the RPA.

8. The aircraft accidentally fell to the ground during recovery. It sustained damage to its rear arm and right-side rear landing gear.
