**LIMITED OCCURRENCE INVESTIGATION REPORT – FINAL**

<b>Reference Number</b>	CA18/2/3/10255						
<b>Classification</b>	Accident	<b>Date</b>	22 November 2022	<b>Time</b>	0615Z		
<b>Type of Operation</b>	Remotely Piloted Aircraft Systems - Agriculture (Part 101)						
<b>Location</b>							
<b>Place of Departure</b>	Mansfield Farm, Kokstad, KwaZulu-Natal Province		<b>Place of Intended Landing</b>	Mansfield Farm, Kokstad, KwaZulu-Natal Province			
<b>Place of Occurrence</b>	3.68nm east of Bhongweni, near Kokstad in KwaZulu-Natal Province						
<b>GPS Co-ordinates</b>	Latitude	30°30'29.8" S	Longitude	029°29'13.7" E	Elevation	4176ft	
<b>Aircraft Information</b>							
Registration	ZT-XHF						
Make; Model; S/N	DJI Phantom; 4 RTK (Serial number: 0V2SJ5CRA40257)						
Damage to Aircraft	Substantial		Total Aircraft Hours	77.16			
<b>Pilot-in-command</b>							
Licence Type	Remote Pilot Licence (RPL)		Gender	Male	Age	27	
Licence Valid	Yes	Total Hours	307.56	Total Hours on Type	48.18

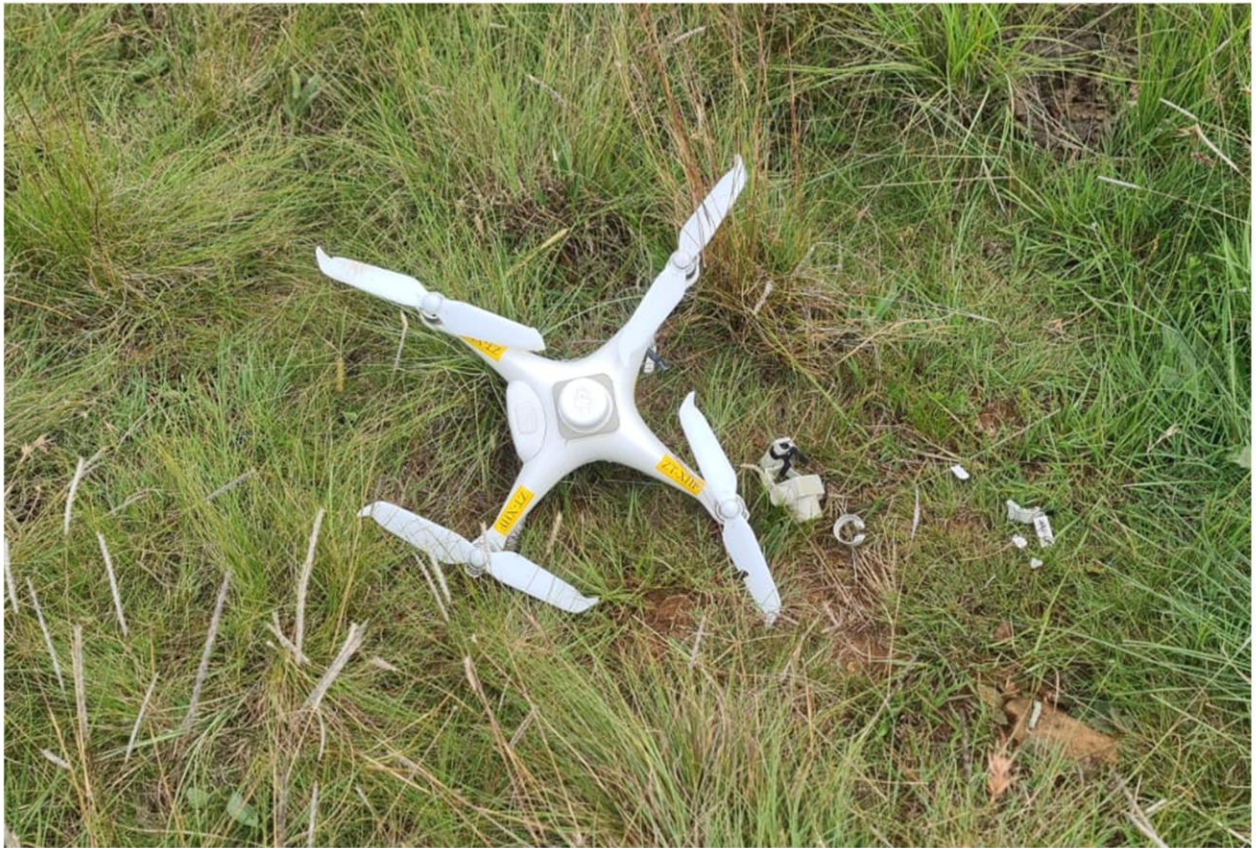
**Figure 1:** ZT-XHF at the accident site. (Source Operator)

Post-accident inspection revealed that the front right motor had stopped operating, and there was a build-up of black residue around four of the battery connector pins. Further inspection revealed black residue on the battery connectors and cable connectors to the battery. The cause of the black residue was attributed to an electric short circuit between the battery connectors and the cable connectors to the battery.

<p>4. Weather conditions as per the pilot questionnaire were as follows: surface wind, light and variable; clouds, none; temperature, 19°C; dew point, 06°C; visibility, greater than 10km.</p> <p>5. The operator was issued an RPAS Operating Certificate (ROC) with an endorsement of Part 101 by the Regulator (SACAA) on 29 April 2022.</p> <p>6. The RPA's front right motor ceased to operate due to an electrical short circuit which was caused by the RPA cable connection to the battery.</p> <p>7. It is likely that the RPA cable connectors were not properly secured to the battery, which resulted in the electric short.</p>
<p><b>Probable Cause</b></p> <p>One of the RPA's front motors ceased to operate due to an electric short which caused the RPA to lose control and spiral down until it crashed on the ground.</p>
<p><b>Contributing Factors</b></p> <p>Improper connection of the cables to the battery connectors.</p>

<p><b>Safety Action</b></p> <p>None.</p>
<p><b>Safety Message</b></p> <p>RPA pilots should ensure proper connection of batteries during the pre-flight inspection to avoid damage to RPA and/or property.</p>
<p><b>About this Report</b></p> <p><i>The decision to conduct a limited investigation is based on factors including whether the cause is known and the evidence supporting the cause is clear, the level of safety benefit likely to be obtained from an investigation and that will determine the scope of an investigation. For this occurrence, a limited investigation has been conducted, and the Accident and Incident Investigations Division (AIID) has relied on the information submitted by the affected person/s and organisation/s to compile this limited report. The report has been compiled using information supplied in the initial notification, as well as from follow-up desk top enquiries to bring awareness of potential safety issues to the industry in respect of this occurrence, as well as possible safety action/s that the industry might want to consider in preventing a recurrence of a similar occurrence.</i></p> <p><i>All times given in this report are Co-ordinated Universal Time (UTC) and will be denoted by (Z). South African Standard Time is UTC plus 2 hours.</i></p>
