LIMITED OCCURRENCE INVESTIGATION REPORT – FINAL

Reference Number	CA18/2/3/10256						
Classification	Accident	Date	28 January 2023		Time	1150Z	
Type of Operation	Private (Part 91)						
Location							
Place of Departure	Private Farm in Malelane, Mpumalanga Province		Place of Intended Landing	Wonderboom Aerodrome (FAWB), Gauteng Province			
Place of Occurrence	Wonderboom Aerodrome (FAWB) on Runway 29						
GPS Co-ordinates	Latitude	25°39'13.58" S	Longitude	028°13'42" E	Elevation	5 473 ft	
Aircraft Information							
Registration	ZS-LAP						
Make; Model; S/N	Cessna 210 (Serial Number: 210-64078)						
Damage to Aircraft	Substantial			Total Aircraft Hours	8339.2		
Pilot-in-command							
Licence Type	Private Pilot Licence (PPL)		Gender	Male		Age	61
Licence Valid	Yes	Total Hours	246.63		Total Hours on Type	9.1	
Total Hours Past 30 Days	9.1		Total Flying Hours on Type Past 90 Days	9.1			
People On-board	1 + 0	Injuries	0	Fatalities	0	Other (on ground)	0
What Happened

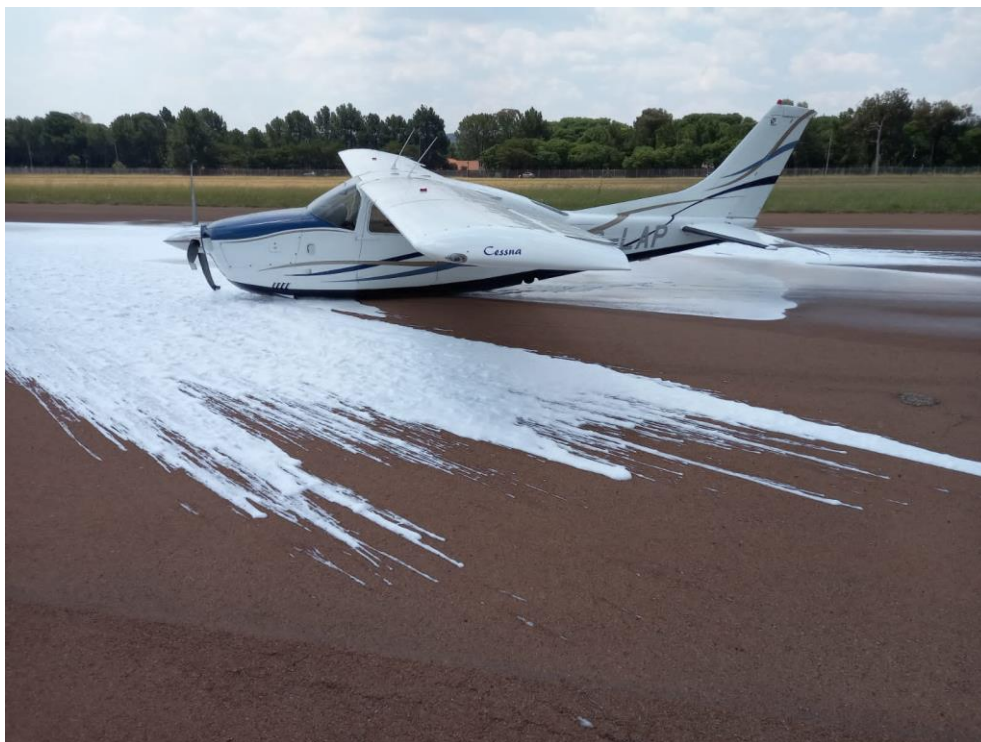
Figure 2: The chemical foam sprayed on the aircraft and the runway to prevent a possibility of fire eruption. (Source: Pilot)

Probable Cause
The pilot forgot to lower the landing gears, therefore, the aircraft landed on its belly.
Contributing Factor
None.
Safety Action(s)
None.
Safety Message and/or Safety Recommendation/s
None.
About this Report
<p><i>The decision to conduct a limited investigation is based on factors including whether the cause is known and the evidence supporting the cause is clear, the level of safety benefit likely to be obtained from an investigation and that will determine the scope of an investigation. For this occurrence, a limited investigation has been conducted, and the Accident and Incident Investigations Division (AIID) has relied on the information submitted by the affected person/s and organisation/s to compile this limited report. The report has been compiled using information supplied in the initial notification, as well as from follow-up desk top enquiries to bring awareness of potential safety issues to the industry in respect of this occurrence, as well as possible safety action/s that the industry might want to consider in preventing a recurrence of a similar occurrence.</i></p> <p><i>All times given in this report are Co-ordinated Universal Time (UTC) and will be denoted by (Z). South African Standard Time is UTC plus 2 hours.</i></p>
