LIMITED OCCURRENCE INVESTIGATION REPORT – FINAL

Reference Number	CA18/2/3/10257						
Classification	Accident	Date	27 January 2023		Time	0542Z	
Type of Operation	Training (Part 141)						
Location							
Place of Departure	Wonderboom Aerodrome (FAWB), Gauteng Province		Place of Intended Landing		Wonderboom Aerodrome (FAWB), Gauteng Province		
Place of Occurrence	Taxiway Delta at FAWB, Gauteng Province						
GPS Co-ordinates	Latitude	25°39' 19.11" S	Longitude	028°13' 16.81" E	Elevation	4 095 ft	
Aircraft Information							
Registration	ZS-SNS						
Make; Model; S/N	Cessna 172M Skyhawk (Serial Number: 172-61620)						
Damage to Aircraft	Substantial			Total Aircraft Hours	1 819.6		
Pilot-in-command							
Licence Type	Student Pilot Licence (SPL)		Gender	Female		Age	24
Licence Valid	Yes	Total Hours	35		Total Hours on Type	17	
Total Hours Past 30 Days	17		Total Flying Hours on Type Past 90 Days			17	
People On-board	1 + 0	Injuries	0	Fatalities	0	Other (on ground)	0

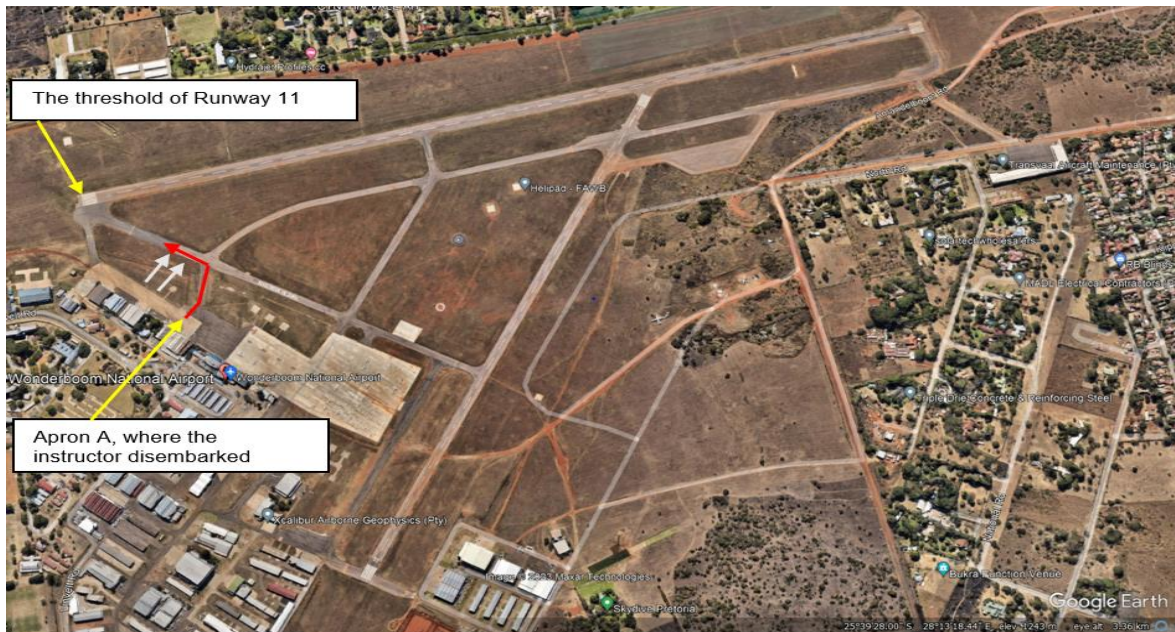
Figure 1: FAWB layout. The two white arrows indicate the position of the two stationary aircraft the ZS-SNS collided with on taxiway Delta to Runway 11. (Source: Google Earth).

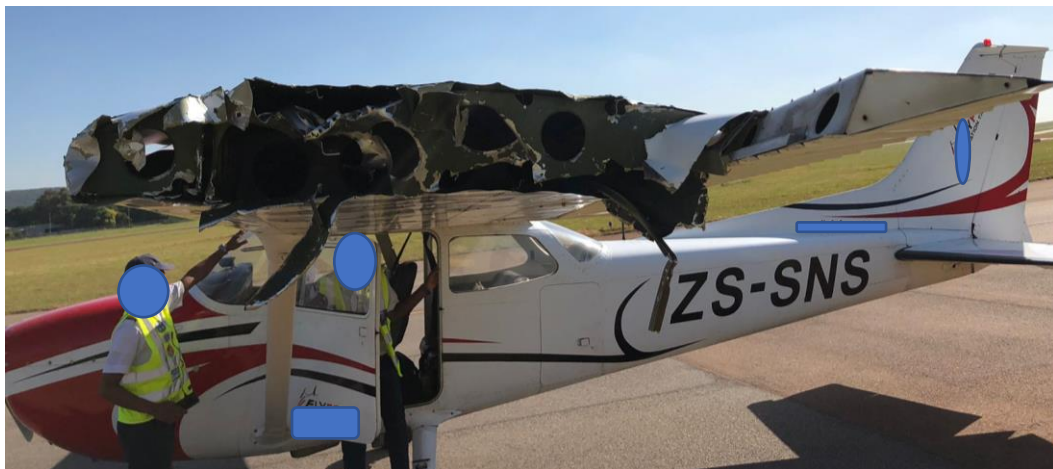
Figure 2: The ZS-SNS aircraft after the accident. (Source: ARFF)

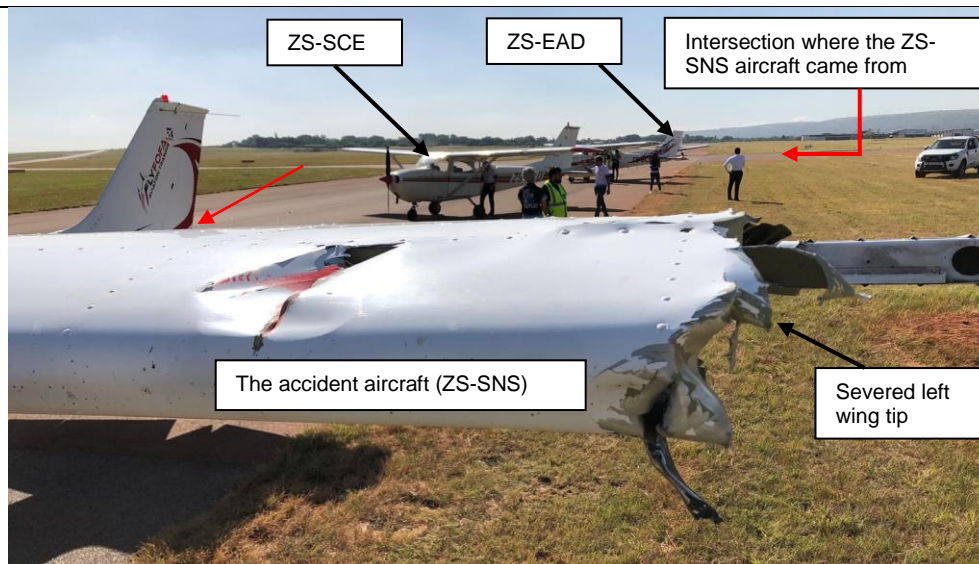
Figure 3: The accident aircraft (forefront) and the two stationary aircraft that had lined-up on taxiway Delta. (Source: ARFF)

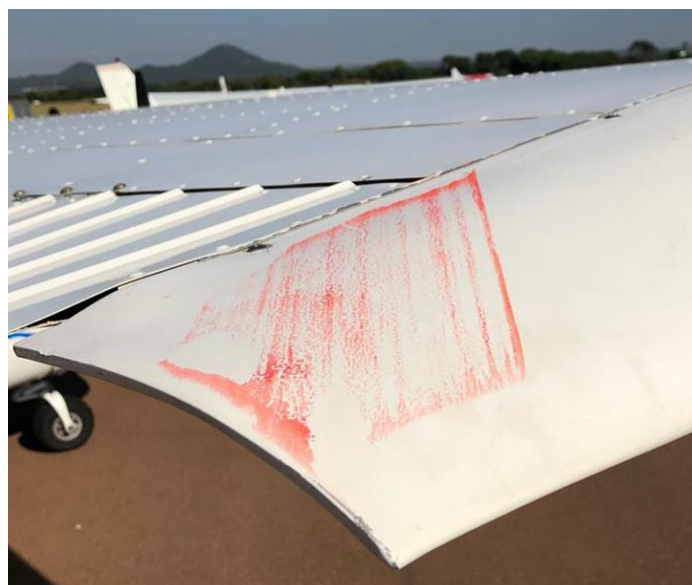
Figure 4: Paint scraping on the ZS-EAD right wing tip fairing.

The investigation concluded that the student pilot seemed to have made a premature left turn when entering the taxiway Delta and had misjudged the distance between her aircraft's (ZS-SNS) left wing tip and that of the ZS-EAD right wing tip fairing and collided with the left-wing tip; the aircraft further struck the ZS-SCE wing tip.

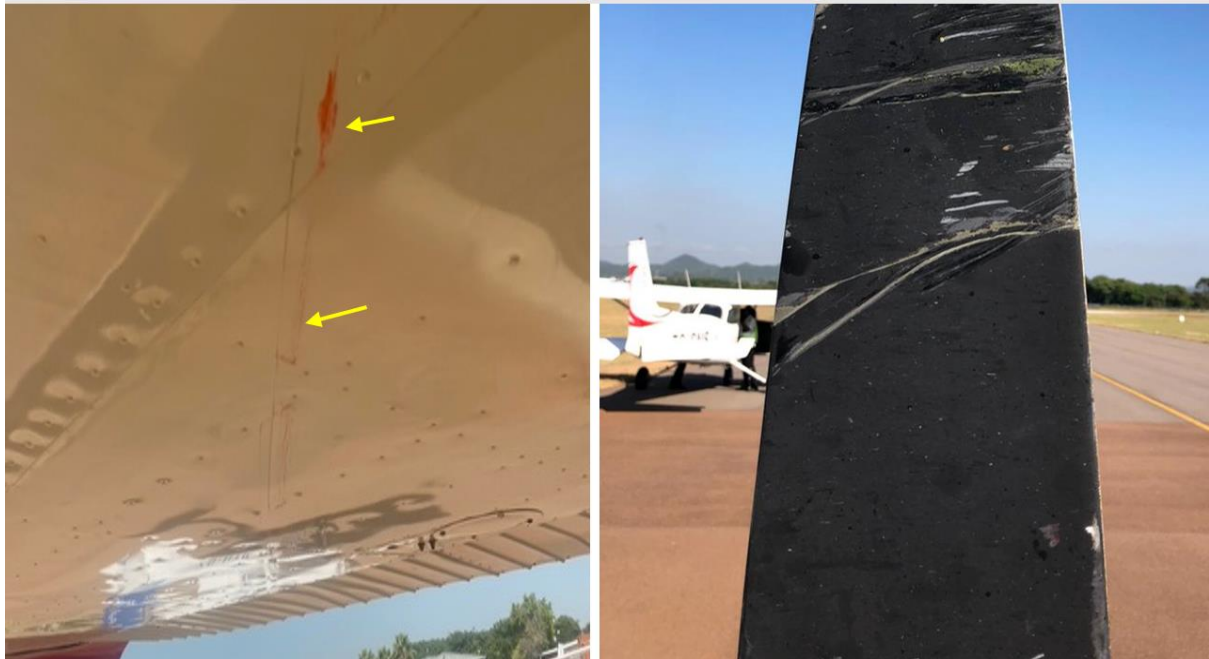
Figures 5 and 6: Scrape marks on the ZS-SCE aircraft right wing lower skin surface area and fairing (left picture). Witness marks on the blade as it cut through the ZS-SNS left wing tip (right picture).

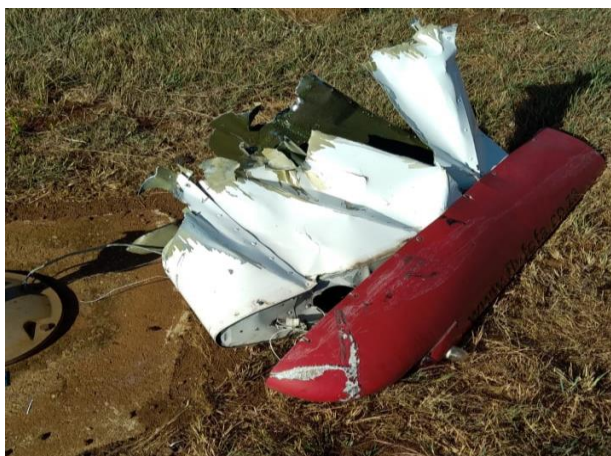
The accident aircraft (ZS-SNS) was visually examined at FAWB to assess the damage sustained during the accident sequence. The left-wing tip was severed by the rotating propeller of the ZS-SCE aircraft. The left-wing bladder fuel tank remained intact with no evidence of spillage observed on the tarmac taxiway Delta. Examination of the aircraft steering control indicated nothing abnormal. There was no evidence of hydraulic fluid leakage on the nose gear strut oleo and main landing gear wheels brake linings, fittings and callipers. The main wheels brakes were tested after the accident and were found to operate normally.

Figure 7: The severed wing tip of the ZS-SNS aircraft. (Source: ARFF)
