**AIRCRAFT ACCIDENT REPORT AND EXECUTIVE SUMMARY**

<b>Reference:</b>		CA18/2/3/10258	
<b>Aircraft Registration</b>	ZS-IBX	<b>Date of Accident</b>	30 January 2023		<b>Time of Accident</b>	1313Z	
<b>Type of Aircraft</b>	Beechcraft E33 Bonanza			<b>Type of Operation</b>	Private (Part 91)		
<b>Pilot-in-command Licence Type</b>	Private Pilot Licence (PPL)		<b>Age</b>	43	<b>Licence Valid</b>	Yes	
<b>Pilot-in-command Flying Experience</b>	<b>Total Flying Hours</b>		92.6		<b>Hours on Type</b>	30.1	
<b>Last Point of Departure</b>	Private Farm in Steelpoort, Mpumalanga Province						
<b>Next Point of Intended Landing</b>	Nelspruit Aerodrome (FANS), Mpumalanga Province						
<b>Damage to Aircraft</b>	Destroyed						
<b>Location of the accident site with reference to easily defined geographical points (GPS readings if possible)</b>							
Portion 2 Hermannsburg 450 JJ (GPS position: 25°29'55.5" South 030°52'42.5" East), at an elevation of 3510 feet (ft)

**Reference Number** : CA18/2/3/10258  
**Occurrence Category** : Accident (Category 1)  
**Type of Operation** : Private (Part 91)  
**Name of Operator** : Mashishing Building Material (PTY) LTD  
**Aircraft Registration** : ZS-IBX  
**Aircr

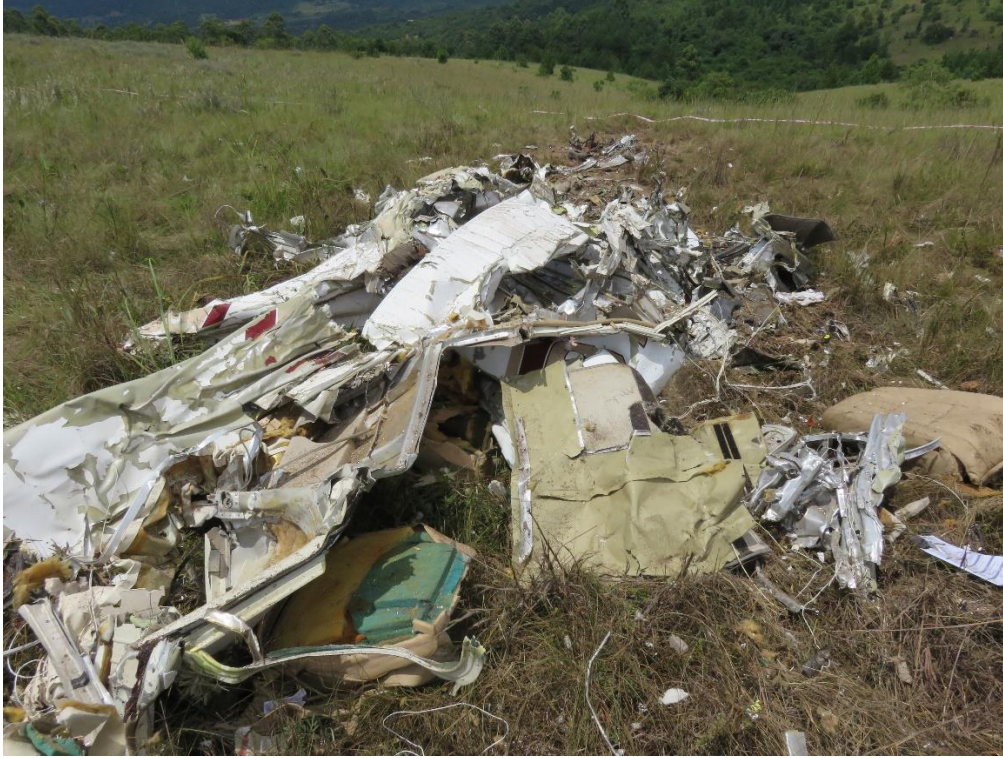
1.3.1. The aircraft was destroyed.

**Figure 3:** The wreckage post-accident.

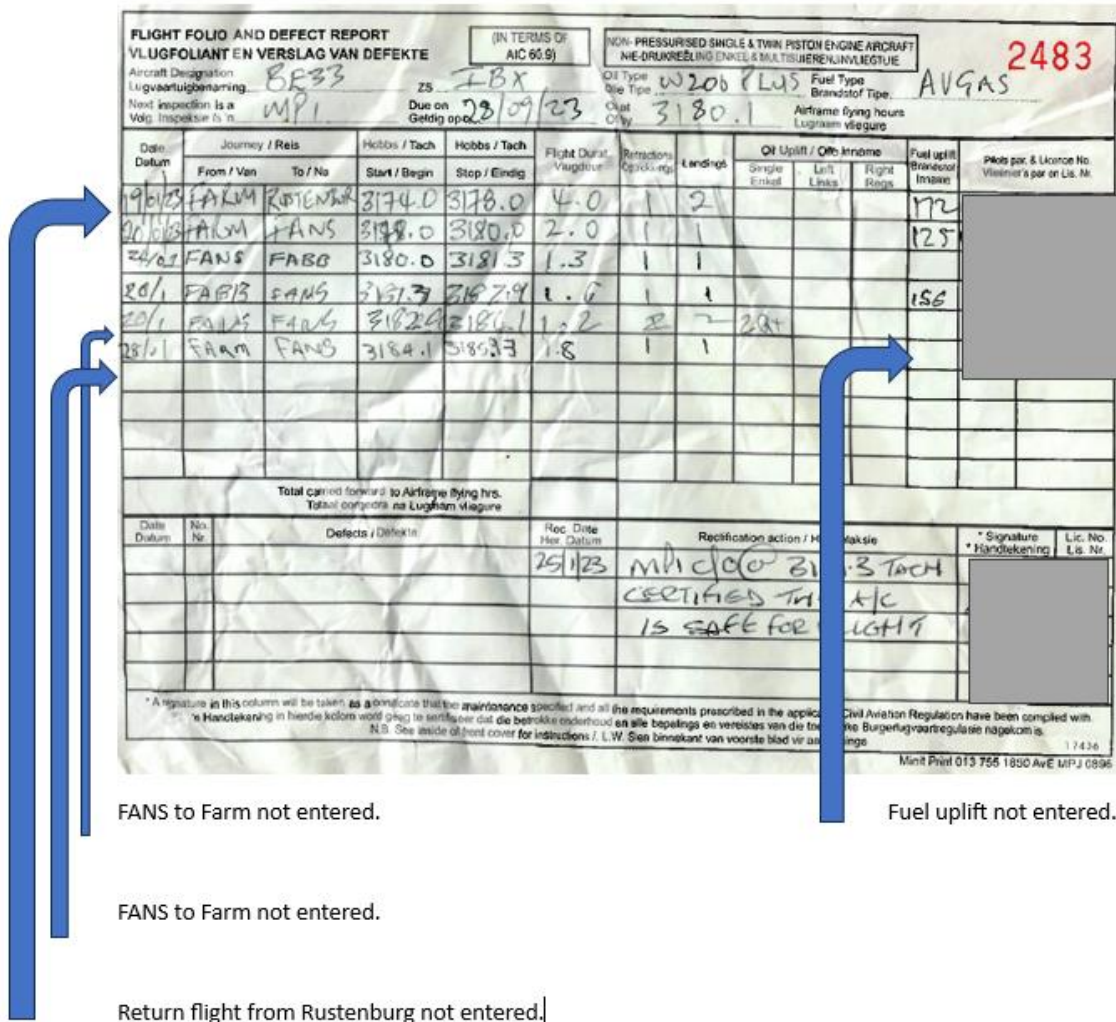
Figure 4: The flight folio with arrows indicating areas where information was not entered.

1.6.4 There were inconsistencies with the recordings in the flight folio. The flight from FANS to the farm was not entered, of which the date of departure (for the first trip) could not be determined. The fuel uplift was not entered. The flight from FANS to the farm on 28 January 2023 was also not recorded; it was confirmed that the pilot departed on 28 January 2023 after refuelling the aircraft.

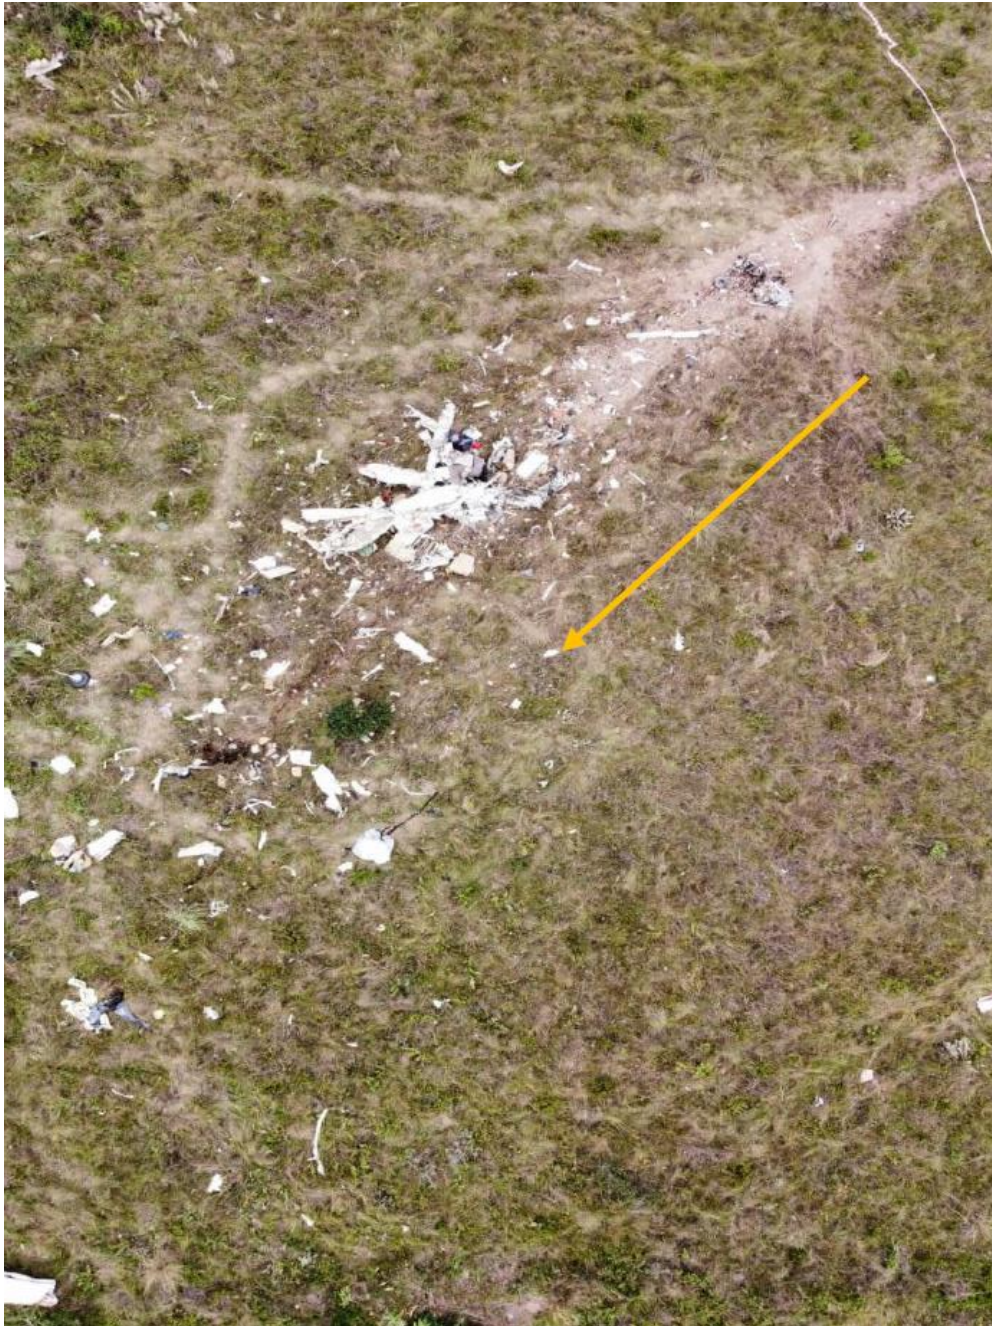
1.12.2 The engine separated from the fuselage and continued to roll in the direction at which the aircraft had impacted the ground. The wings and the horizontal stabiliser separated from the fuselage; they were damaged by impact forces. Other small parts of the aircraft separated

**Figure 7:** The arrow shows the direction of impact.

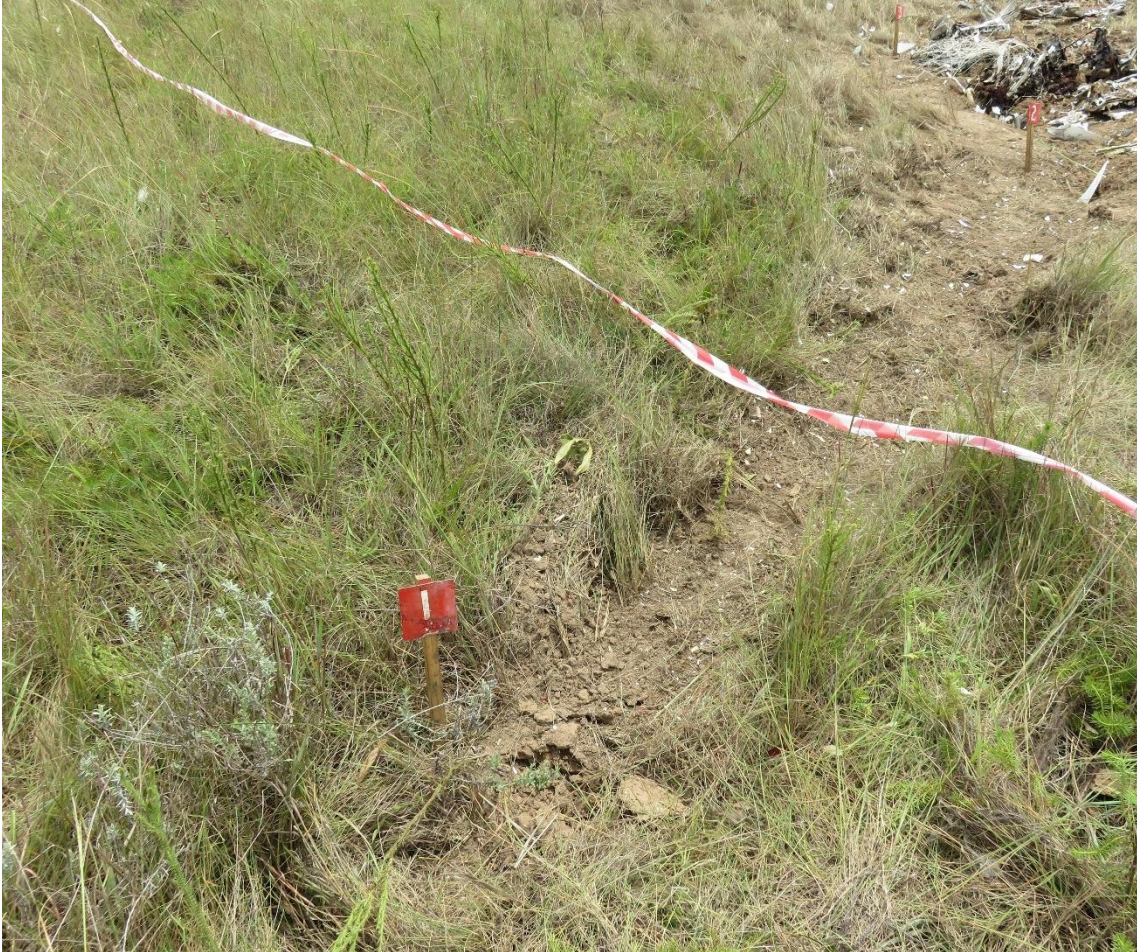
**Figure 8:** Peg number 1 shows the first point of impact.

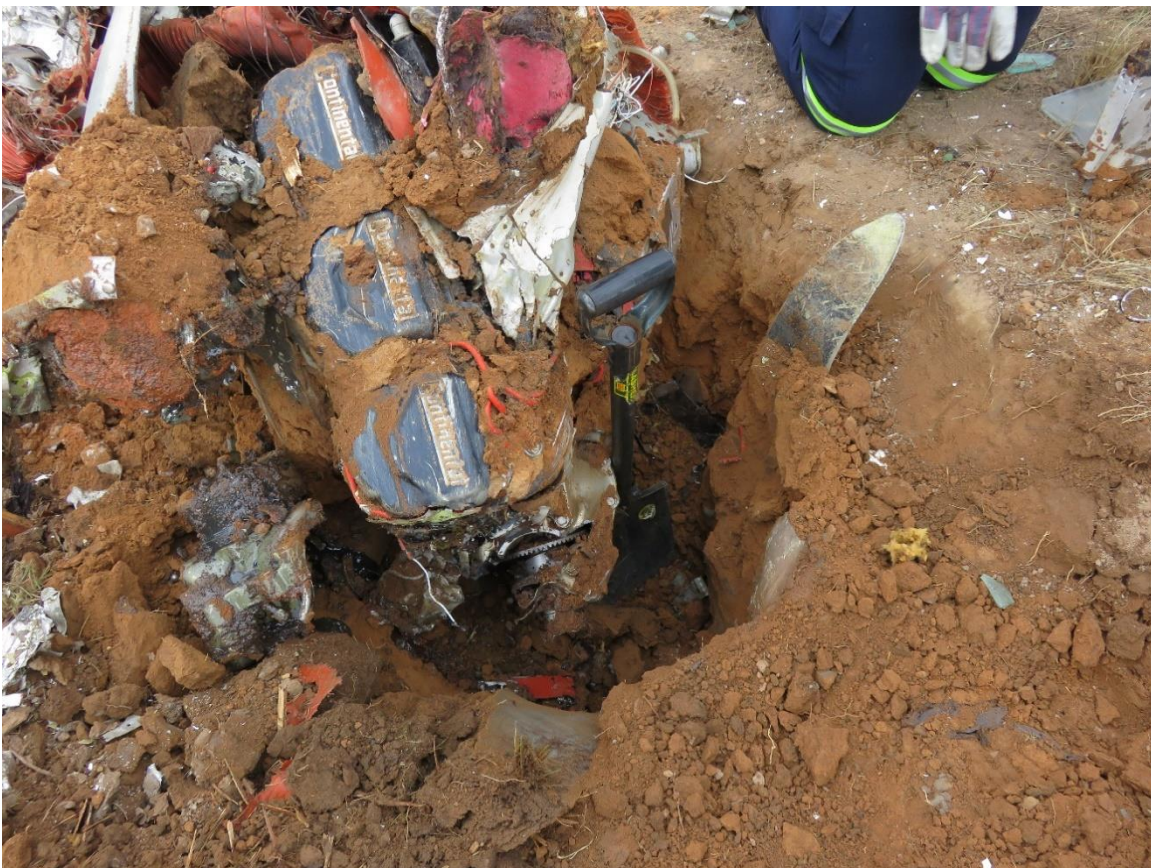
**Figure 9:** The engine after it was pulled out of the ground.

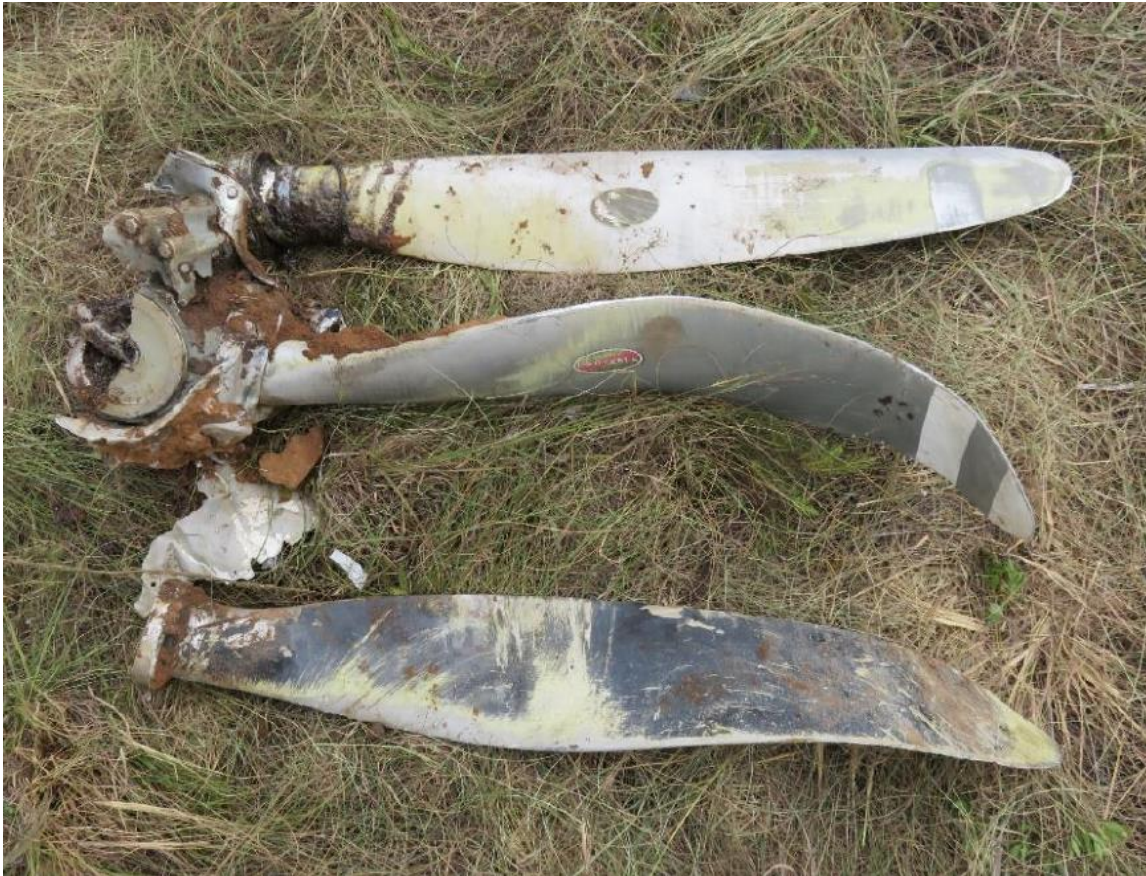
and scattered in different directions. The propellers that dug into the ground did not show any signs that the engine was under power. There were no rotational scars on the blades.

**Figure 10:** Damage to the propellor blades.

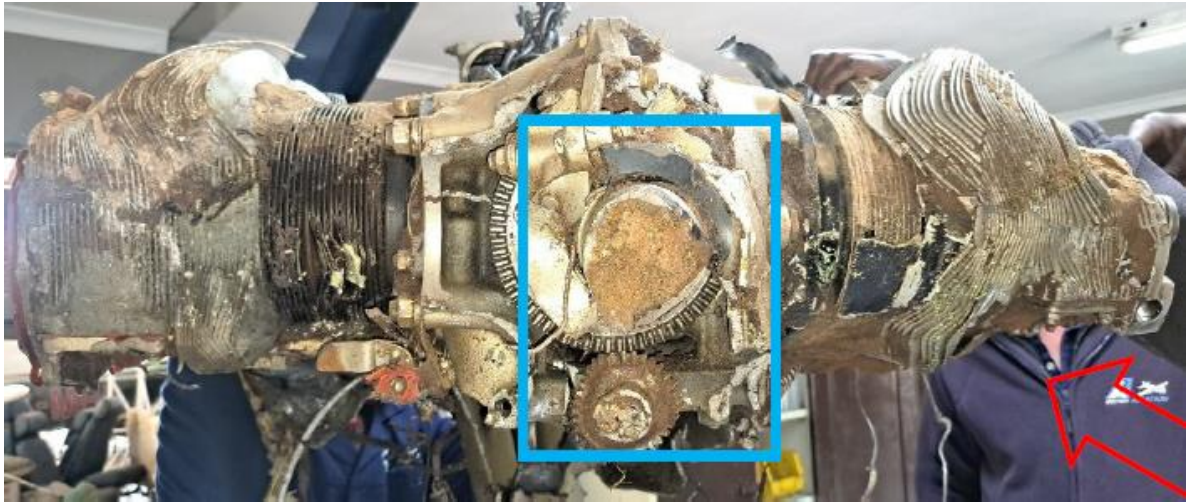
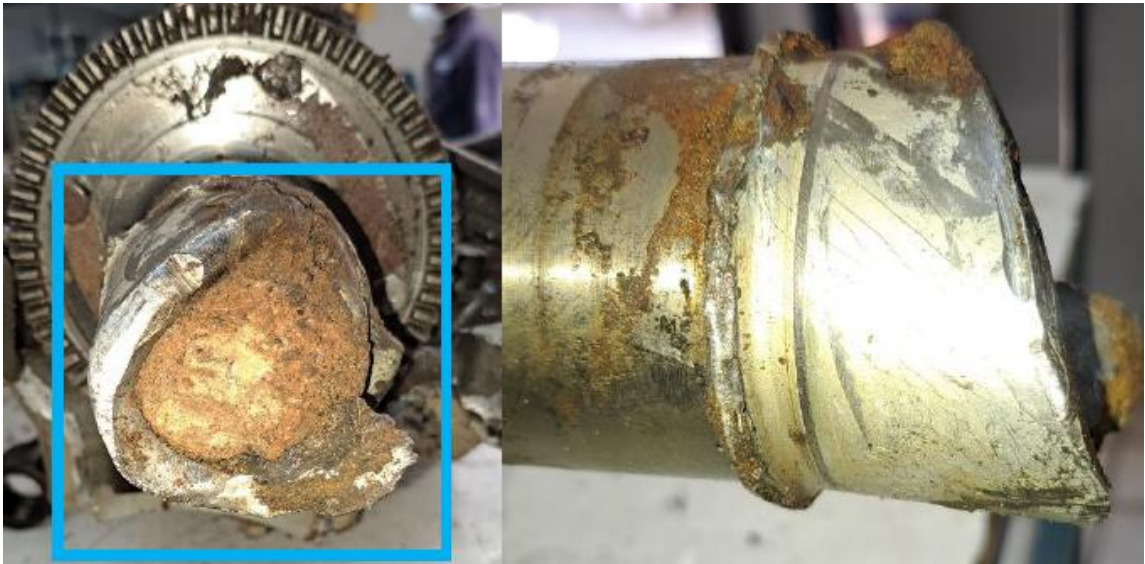
A1

*The crankshaft driveshaft failed under a torsion load Figure 11 and Figure 12. supporting a hypothesis of an operational engine on impact.*

**Figure 12:** Enlarged view of the crankshaft driveshaft that failed under a torsion load depicted by the blue square. (Source: Impact Analysis Report: Engine & Propeller Assy., Beechcraft E33 Aircraft No ZS-IBX)

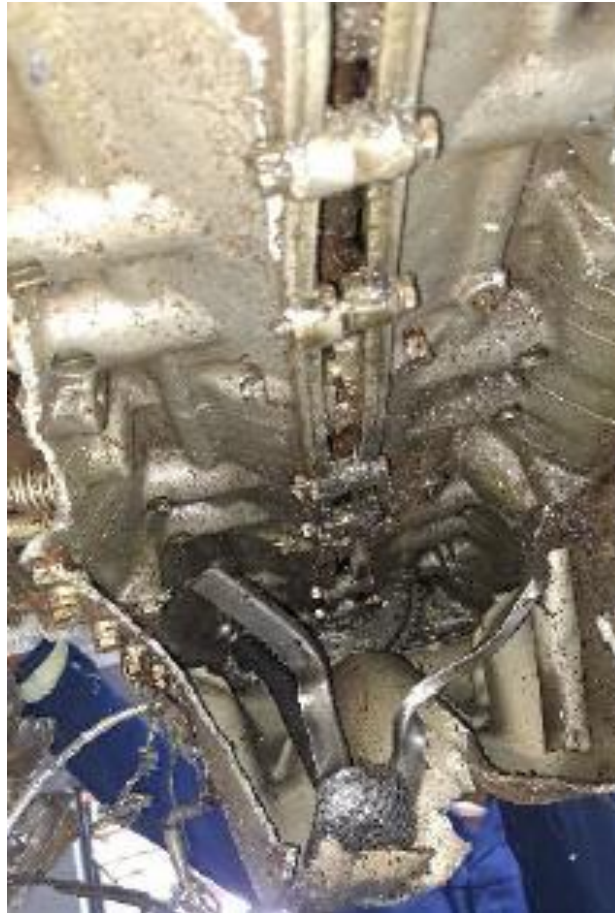
*The engine crankcase revealed several fractures while the oil sump section has been partially severed by the impact Figure 13. No clear pre-existing fractures were noted.*

**Figure 13:** Crankcase showing several fractures and the oil sump section partially severed by the impact. (Source: Impact Analysis Report: Engine & Propeller Assy., Beechcraft E33 Aircraft No ZS-IBX)

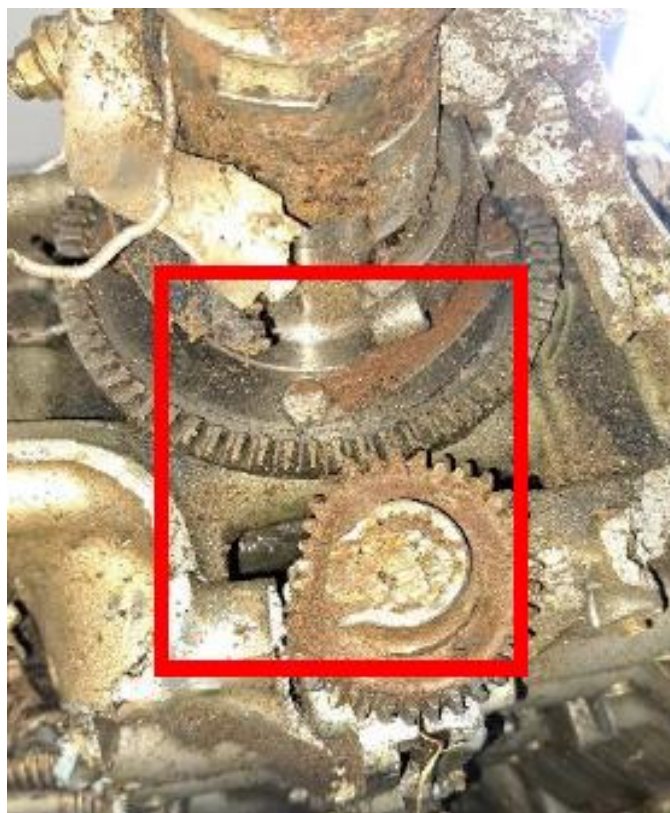
*Damages to the governor drive bevel gear and pinion suggest exposure to a severe impact load for a short time.*

**Figure 14:** Damage to the governor drive bevel gear and pinion depicted by red square. (Source: Impact Analysis Report: Engine & Propeller Assy., Beechcraft E33 Aircraft No ZS-IBX)

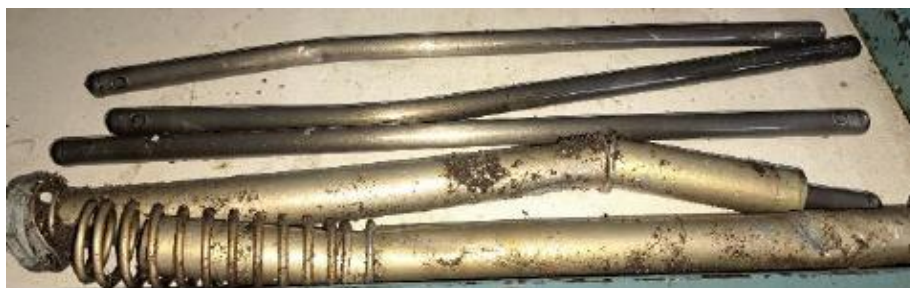
*The pushrod housing- and stems revealed impact damages but no other clear discrepancies*  
*Figure 15.*

**Figure 15:** Pushrod housing and stems. (Source: Impact analysis report: engine & propeller assy., Beechcraft e33 aircraft No ZS-IBX)

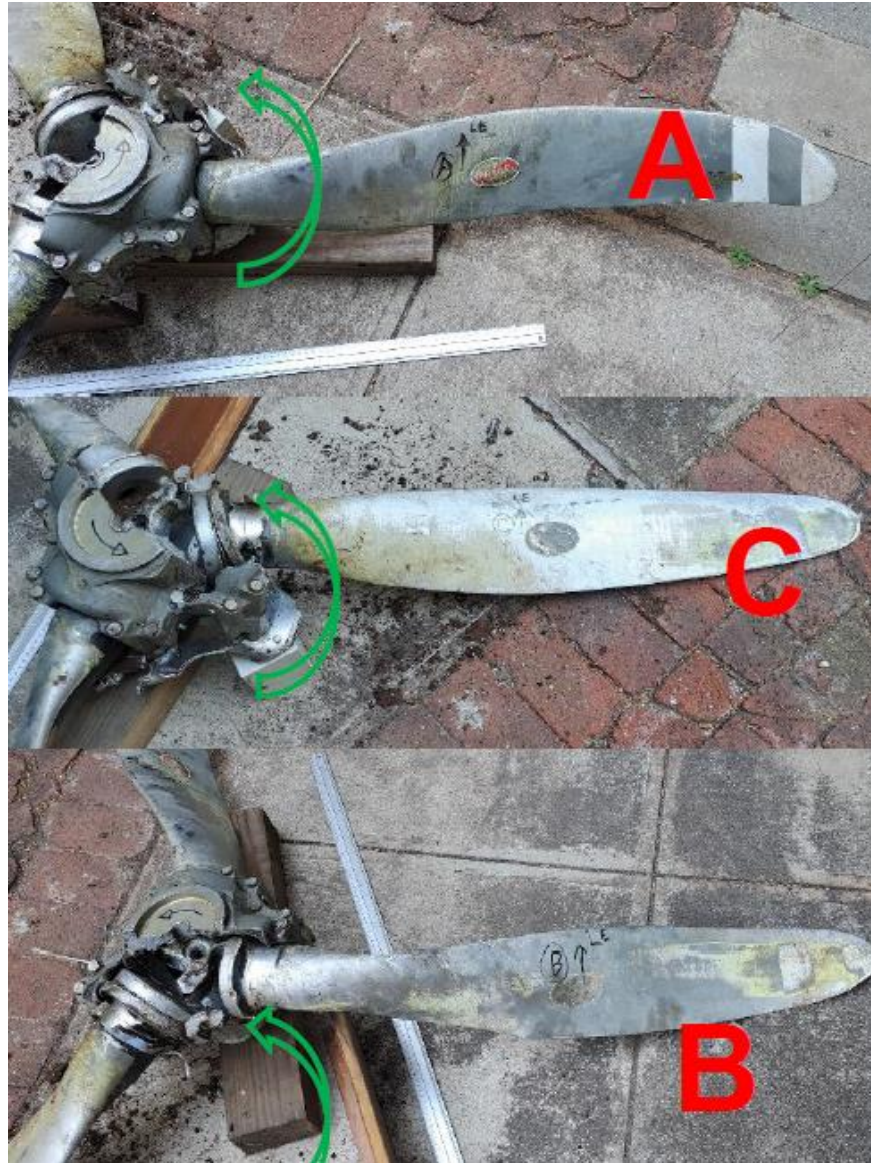
*The visual inspection revealed a fractured hub assembly with 2 forged aluminium blades separated on impact. The damages at the blade butt/propeller hub interfaces suggest rotation under power at the moment of impact.*

*Considering the variation in damages between the 3 blades and the extent thereof, it can be presumed that **blade C** most probable impacted first in the sequence. Therefore, the internal hub impact marks related to **blade C** were used as reference.*

*The degree of damages suggest that the propeller assembly was rotating at the time of impact. However, considering the short impact time, it proved to be impossible to determine from the damages alone if the propeller assembly was indeed under power from the engine at the moment of impact.*

*Based on the relative internal hub impact locations it could be derived that at the moment of impact **blade C** pitch was closer to 'fine' than 'course'. This must be assessed in correlation with the perceived impact ground speed, angle of impact, aircraft attitude and vertical speed impact parameters. Under normal operating conditions, fine pitch will correspond with oil pressure within the constant speed unit (CSU) provided by an operating engine.*

**Figure 16:** Forged aluminium blades. (Source: Impact Analysis Report: Engine & Propeller Assy., Beechcraft E33 Aircraft No ZS-IBX)

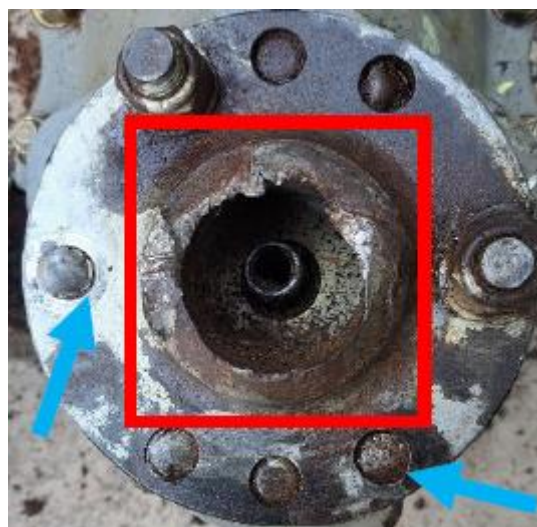
*The fracture at the propeller driveshaft Figure 17 corresponds with that of the engine inspection results Figure 12. The fracture geometries of the driveshaft and the attachment bolts depicted by blue arrows in Figure 17 support the notion towards operation under engine power at the moment of impact.*

**Figure 17:** Propeller driveshaft. (Source: Impact Analysis Report: Engine & Propeller Assy., Beechcraft E33 Aircraft No ZS-IBX)
