**LIMITED OCCURRENCE INVESTIGATION REPORT – FINAL**

<b>Reference Number</b>	CA18/2/3/10260						
<b>Classification</b>	Accident	<b>Date</b>	13 January 2023	<b>Time</b>	2020Z		
<b>Type of Operation</b>	Training (Part 141)						
<b>Location</b>							
<b>Place of Departure</b>	Grand Central Airport (FAGC), Gauteng Province		<b>Place of Intended Landing</b>	Grand Central Airport (FAGC), Gauteng Province			
<b>Place of Occurrence</b>	Runway 35 at FAGC in Gauteng Province						
<b>GPS Co-ordinates</b>	Latitude	25°59'1.68"S	Longitude	28° 8'19.20"E	Elevation	5148.8 ft	
<b>Aircraft Information</b>							
Registration	ZS-TIU						
Make; Model; S/N	Cessna Aircraft Corporation; C172 (Serial Number: 172-81117)						
Damage to Aircraft	Substantial		Total Aircraft Hours	5416.4			
<b>Pilot-in-command</b>							
Licence Type	Private Pilot Licence (PPL)		Gender	Female		Age	24
Licence Valid	Yes	Total Hours	158.7	Total Hours on Type	9.5		
Total Hours Past 30 Days	7.7		Total Hours on Type Past 90 Days	9.5

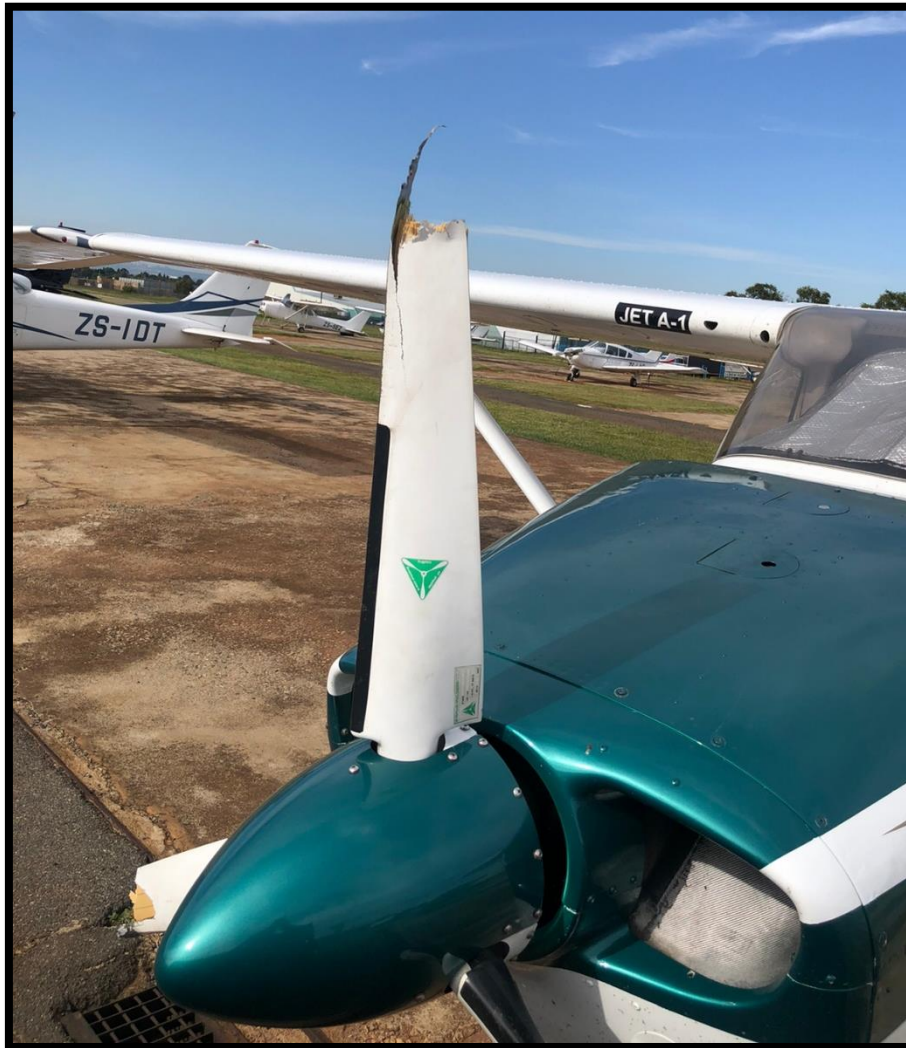
by clicking three times on press-to-talk (PTT) button but that did not work. After flying over the runway orientation numbers imprinted on the edge of the runway at 65 knots, the pilot cut off the power to initiate flaring, but the aircraft floated and finally bounced hard on the runway and ballooned. The pilot then added power to correct the landing, but the aircraft bounced a few more times before she was able to correct the anomaly and bring the aircraft to a stop. The aircraft sustained substantial damage to the propellers, firewall and airframe; the pilot was not injured during the accident sequence.

**Figure 1:** The damaged propeller blades. (Source: Operator)

It is likely that the pilot did not execute the landing technique properly, which resulted in the aircraft floating instead of touching down after flaring.

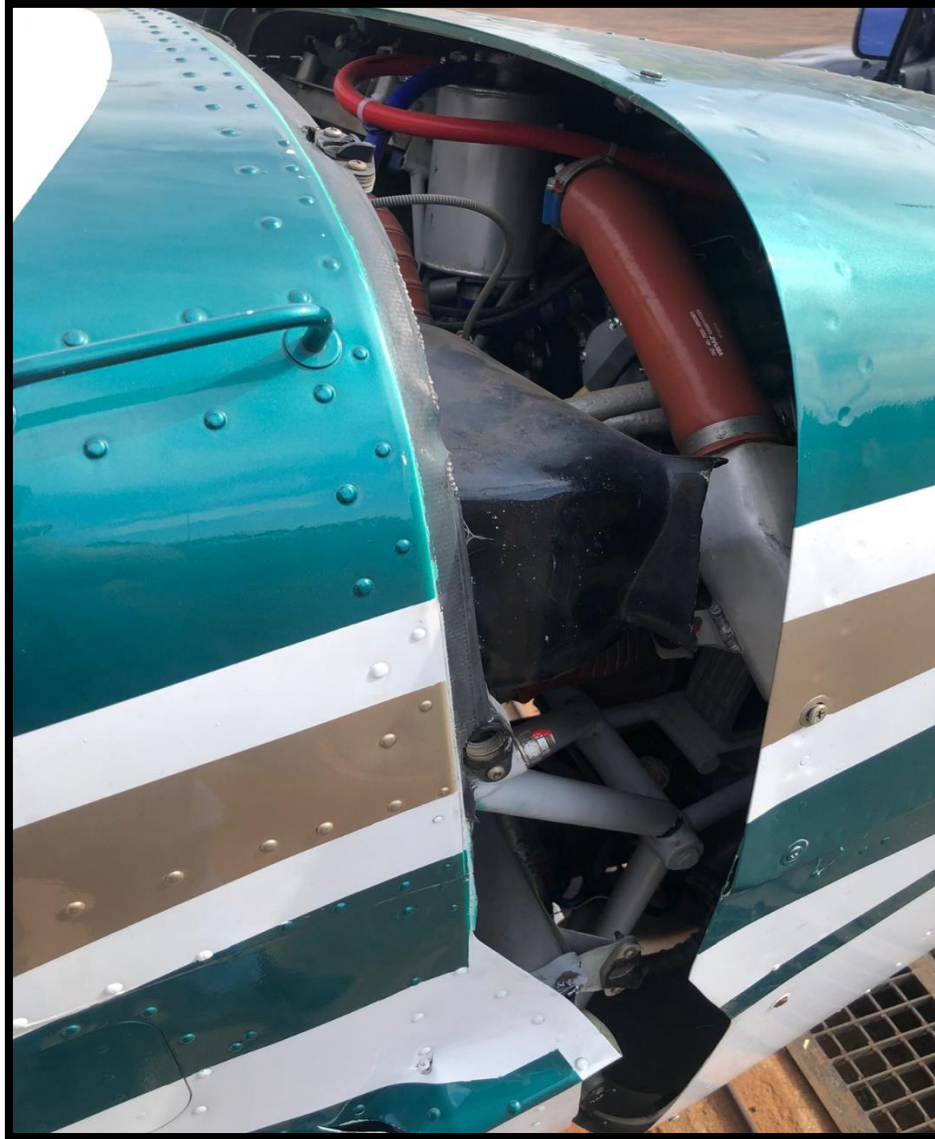
**Figure 2:** The firewall and airframe damage. (Source: Operator)

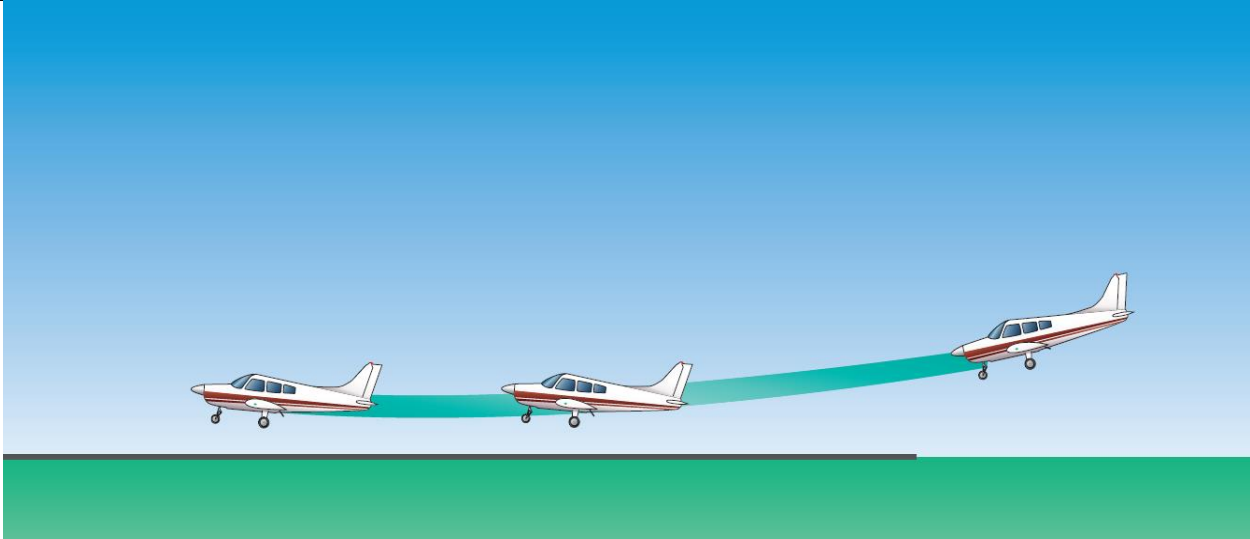
*If the airspeed on final approach is excessive, it will usually result in the airplane floating. [Figure 5] Before touchdown can be made, the airplane may be well past the desired landing point and the available runway may be insufficient. When diving an airplane on final approach to land at the proper point, there will be an appreciable increase in airspeed. The proper touchdown attitude cannot be established without producing an excessive angle of attack and lift. This will cause the airplane to gain altitude or balloon. Any time the airplane floats, judgment of speed, height, and rate of sink must be especially acute. The pilot must smoothly and gradually adjust the pitch attitude as the airplane decelerates to touchdown speed and starts to settle, so the proper landing attitude is attained at the moment of touchdown. The slightest error in judgment and timing will result in either ballooning or bouncing. The recovery from floating will depend on the amount of floating and the effect of any crosswind, as well as the amount of runway remaining. Since prolonged floating utilizes considerable runway length, it should be avoided especially on short runways or in strong crosswinds. If a landing cannot be made on the first third of the runway, or the airplane drifts sideways, the pilot should EXECUTE A GO-AROUND.*

**Figure 5:** Floating during round out. (Source: FAA-H-8083-3A)
