**LIMITED OCCURRENCE INVESTIGATION REPORT – FINAL**

<b>Reference Number</b>	CA18/2/3/10261					
<b>Classification</b>	Accident	<b>Date</b>	12 January 2023	<b>Time</b>	1820Z	
<b>Type of Operation</b>	Aerial Surveillance (Part 101)					
<b>Location</b>						
Place of Departure	AMSA Mine, Orkney, North West Province		Place of Intended Landing	AMSA Mine, Orkney, North West Province		
Place of Occurrence	At Orkney Mine approximately 500 metres from launch position					
GPS Co-ordinates	Latitude	26° 35' 31.21" S	Longitude	025° 53' 19.59" E	Elevation	5024ft
<b>Aircraft Information</b>						
Registration	ZT-XOB					
Make; Model; S/N	ARACE; Sirin (Serial Number: SIR0022)					
Damage to Aircraft	Destroyed		Total Aircraft Hours	591.23		
<b>Pilot-in-command</b>						
Licence Type	Remote Pilot Licence		Gender	Male	Age	34
Licence Valid	Yes	Total Hours	693.24	Total Hours on Type	693.24	
Total Hours 30 Days	16.04		Total Flying on Type Past 90 Days	159.03		
<b>People Controlling</b>	1	<b>Injuries</b>	0	<b>Fatalities</b>	0	<b>Other (on ground)</b> 0

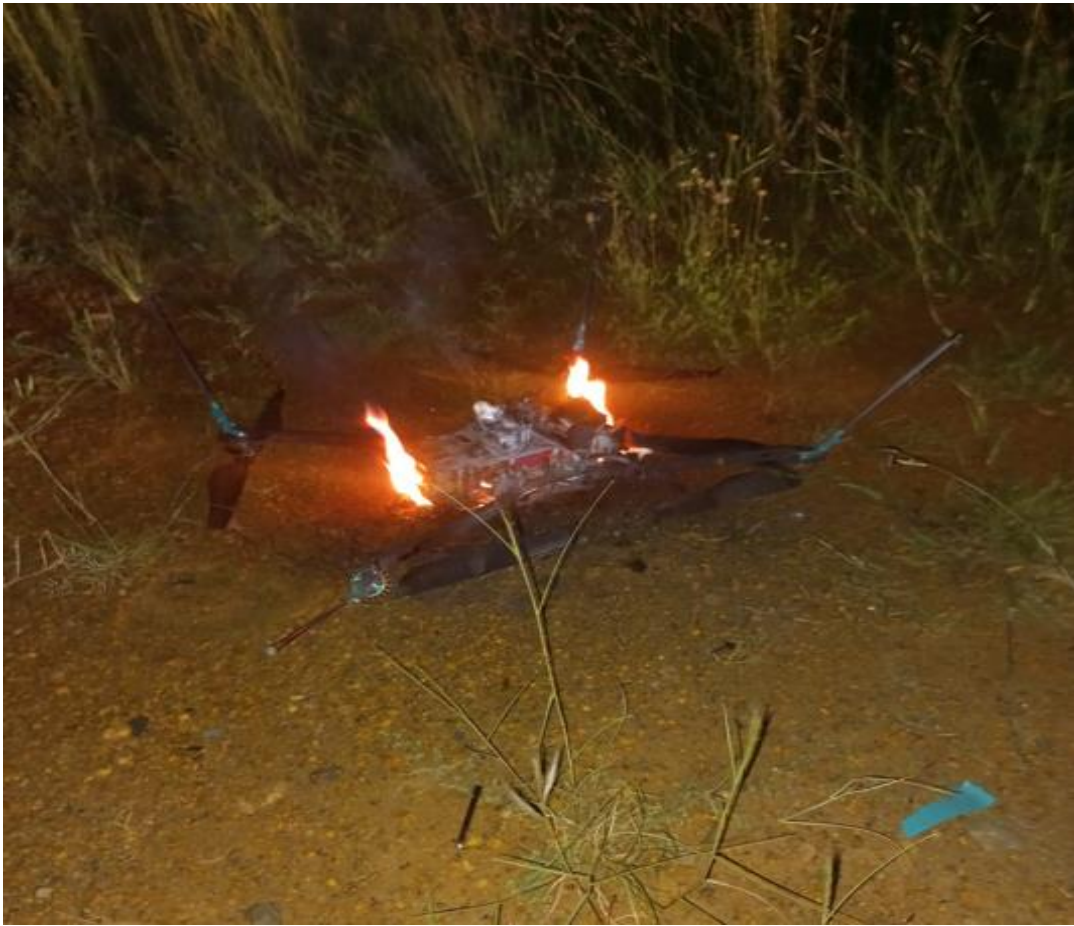
**Figure 1:** The aircraft at the accident site. (Source: Operator)

According to the operator, the RPA was completely burnt, limiting the investigation of components. At the time of the accident flight, the meteorological information indicated strong wind conditions of approximately 26 knots (kts) which likely played a role in this accident.

7. The control signal disconnection was due to the battery depleting too fast as there were strong wind conditions at the time. The wind was blowing against the direction of the flight path of the RPA during the RTL command. The RPA crashed to the ground and the battery casing was torn. Damage was caused to the cells soldering. As a result, the batteries (cells) overheated, and this led to the fire erupting and destroying the critical components.

The RPA crashed following a control signal disconnection due to low battery. The battery depleted fast after the RTL function was activated as there were strong wind conditions at the time of the flight.

<b>Safety Action(s)</b>
None.
<b>Safety Message and/or Safety Recommendation/s</b>
Pilots are encouraged to heed weather conditions and to discontinue operation if the weather does not permit.
<b>About this Report</b>
<p><i>The decision to conduct a limited investigation is based on factors including whether the cause is known and the evidence supporting the cause is clear, the level of safety benefit likely to be obtained from an investigation and that will determine the scope of an investigation. For this occurrence, a limited investigation has been conducted, and the Accident and Incident Investigations Division (AIID) has relied on the information submitted by the affected person/s and organisation/s to compile this limited report. The report has been compiled using information supplied in the initial notification, as well as from follow-up desk top enquiries to bring awareness of potential safety issues to the industry in respect of this occurrence, as well as possible safety action/s that the industry might want to consider in preventing a recurrence of a similar occurrence.</i></p> <p><i>All times given in this report are Co-ordinated Universal Time (UTC) and will be denoted by (Z). South African Standard Time is UTC plus 2 hours.</i></p>

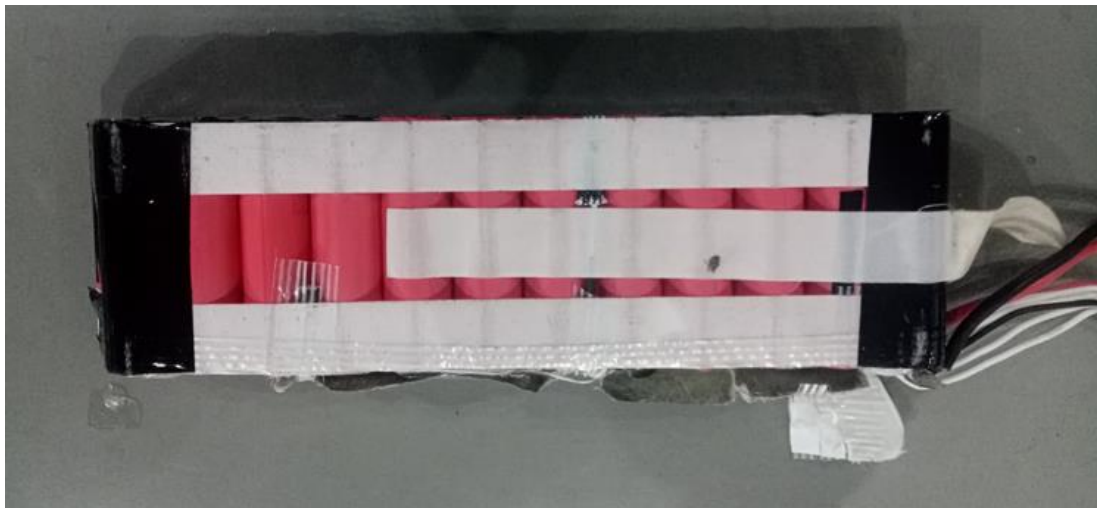
**Figure 2:** The RPA battery pack. (Source: Operator)

Upon impact with the ground, the RPA caught fire which originated from the battery. It is likely that the battery pack casing was torn during impact with the ground, and the soldering between the cells came apart/loosened. As a result, the cells came into contact with each other, overheated and subsequently caught alight.
