LIMITED OCCURRENCE INVESTIGATION REPORT – FINAL

Reference Number	CA18/2/3/10262						
Classification	Accident		Date	1 January 2023		Time	1935Z
Type of Operation	Remotely Piloted Aircraft System – Surveillance (Part 101)						
Location							
Place of Departure	Sibanye Platinum Hex River Helipad, Rustenburg, North West Province			Place of Intended Landing	Sibanye Platinum Hex River Helipad, Rustenburg, North West Province		
Place of Occurrence	Approximately 1.5 kilometres west of Sibanye Platinum Hex River Helipad, Rustenburg, North West Province						
GPS Co-ordinates	Latitude	25° 39'34.48" S	Longitude	27° 15' 49.67" E	Elevation	3 694 ft	
Aircraft Information							
Registration	ZT-XNL						
Make; Model; S/N	ARACE, Sirin Multirotor UAV (Serial Number: SIR0015)						
Damage to Aircraft	Substantial			Total Aircraft Hours	815.75 hours		
Pilot-in-command							
Licence Type	Remote Pilot Licence (RPL)		Gender	Male		Age	26
Licence Valid	Yes	Total Hours	436.52		Total Hours on Type	436.52

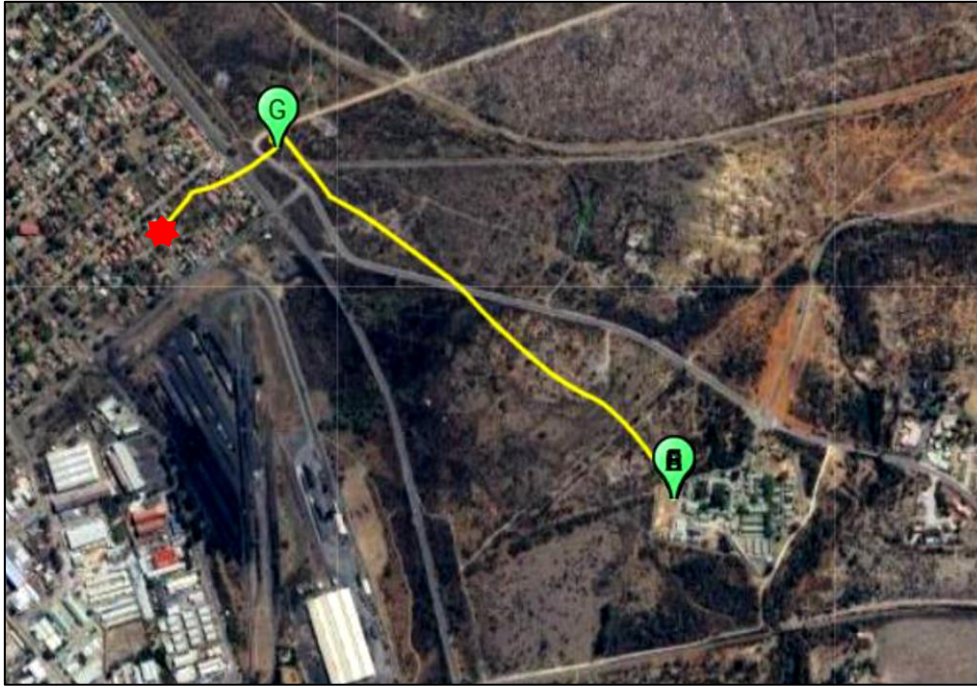
Figure 1: Yellow line shows the flight path of ZT-XNL. G is the way point (intended surveillance area). The end of the yellow line, indicated by the red star, is where the RPA was located. (Source: Operator)

- *The RPA was climbing gently as per the pilot-in-command (PIC) Accident Report (AR). We then see the RPA moving forward, as the PIC switches flight modes, after the RPA reaches the way point it loses signal.*
- *The RPA reached a height of 400 ft before continuing with the mission. It was noted that at the end of the log that it just stops with no warning from the RPA.*
- *It was noted that the RPA just loses total power as both the Volts and Amps start dropping after the RPA reached a height of 400 ft.*

At 19:35:57 the RPA lost all power and crashed shortly after.

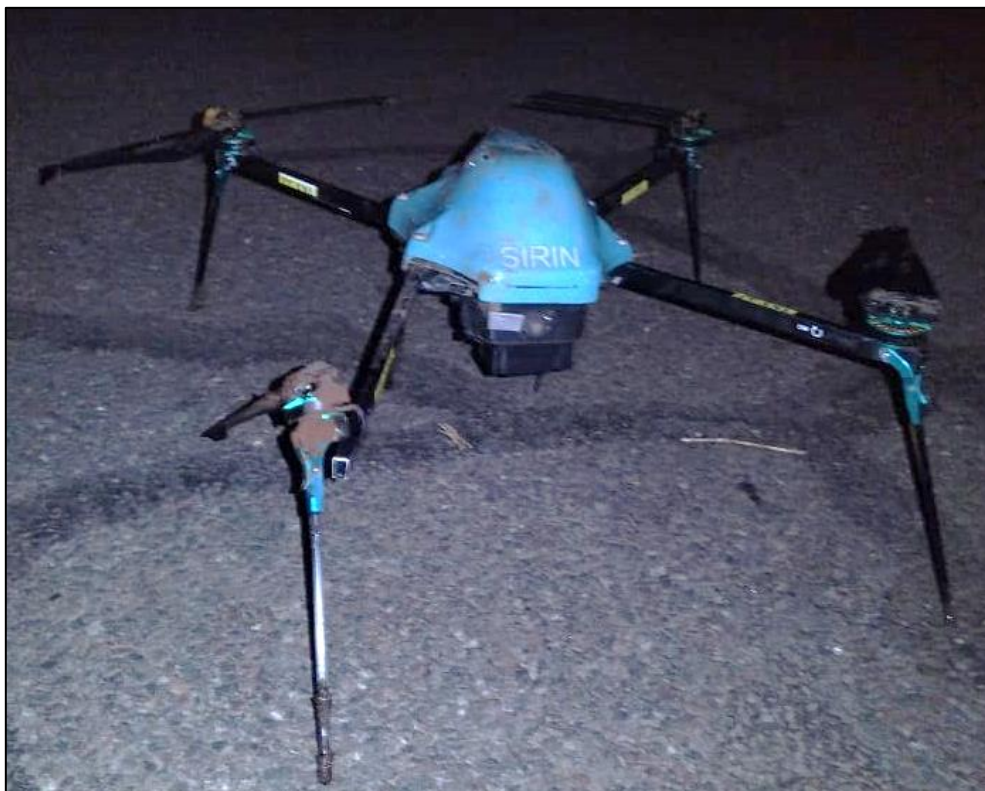
Total Hours 30 Days	± 81.00		Total Flying on Type Past 90 Days			242.52	
People Controlling	1	Injuries	0	Fatalities	0	Other (on ground)	0
What Happened							
<p>On Sunday evening, 1 January 2023, an Arace Sirin Multirotor remotely piloted aircraft (RPA) with registration ZT-XNL was launched for aerial surveillance from Sibanye Platinum Hex River Helipad in Rustenburg, North West province, with the intention to return to the same helipad. Visual meteorological conditions (VMC) by night prevailed at the time of the flight which was conducted under beyond visual line of sight (BVLOS) rules and under the provisions of Part 101 of the Civil Aviation Regulations (CAR) 2011 as amended.</p> <p>The pilot stated that the pre-flight checks were conducted on the RPA with no anomalies detected. The battery voltage indicated 100 percent (%) prior to RPA launch. The pilot launched the RPA which steadily climbed to 400 feet (ft) and proceeded to the initial way point as planned. After reaching the intended position to start aerial surveillance, the RPA lost signal, disconnected from the controller unit, and failed to return to launch position.</p> <p>The pilot used the RPA's recorded flight information on Google Earth search engine to locate the RPA. He later retrieved the RPA approximately 1.5 kilometres (km) west of the launch site. It had sustained damage to the propeller blades, camera and the fuselage. There were no reported injuries on the ground.</p>

Figure 2: The ZT-XNL RPA after recovery. (Source: Operator)

It is possible that the accident was due to the UBEC failing during flight. Based on the logs that the RPA motors just stopped turning during flight.

UBEC failure during flight caused the RPA to suddenly lose rotary power after reaching 400ft above ground level (AGL) and subsequently crashed in a residential area.

Following the accident, the operator determined that they would source reliable battery power regulators to prevent a recurrence of a similar failure during operations.
