LIMITED OCCURRENCE INVESTIGATION REPORT – FINAL

Reference Number	CA18/2/3/10263						
Classification	Accident	Date	20 December 2022		Time	2137Z	
Type of Operation	Aerial Surveillance (Part 101)						
Location							
Place of Departure	Exxaro Leeuwpan Coal Mine, Mpumalanga Province		Place of Intended Landing	Exxaro Leeuwpan Coal Mine, Mpumalanga Province			
Place of Occurrence	Exxaro Leeuwpan Coal Mine						
GPS Co-ordinates	Latitude	26° 10' 43" S	Longitude	28° 44' 59" E	Elevation	5112 ft	
Aircraft Information							
Registration	ZT-YIX						
Make; Model; S/N	DJI Mavic Enterprise (Serial Number: MAV134)						
Damage to Aircraft	Unknown		Total Aircraft Hours	21.21			
Pilot-in-command							
Licence Type	Remote Pilot Licence (RPL)		Gender	Male		Age	27
Licence Valid	Yes	Total Hours	51.21		Total Hours on Type	51.21	
Total Hours Past 90 Days	51.21		Total Flying Past 90 Days on Type	51.21			
People Controlling	1	Injuries	0	Fatalities	0	Other (on ground)	0
What Happened

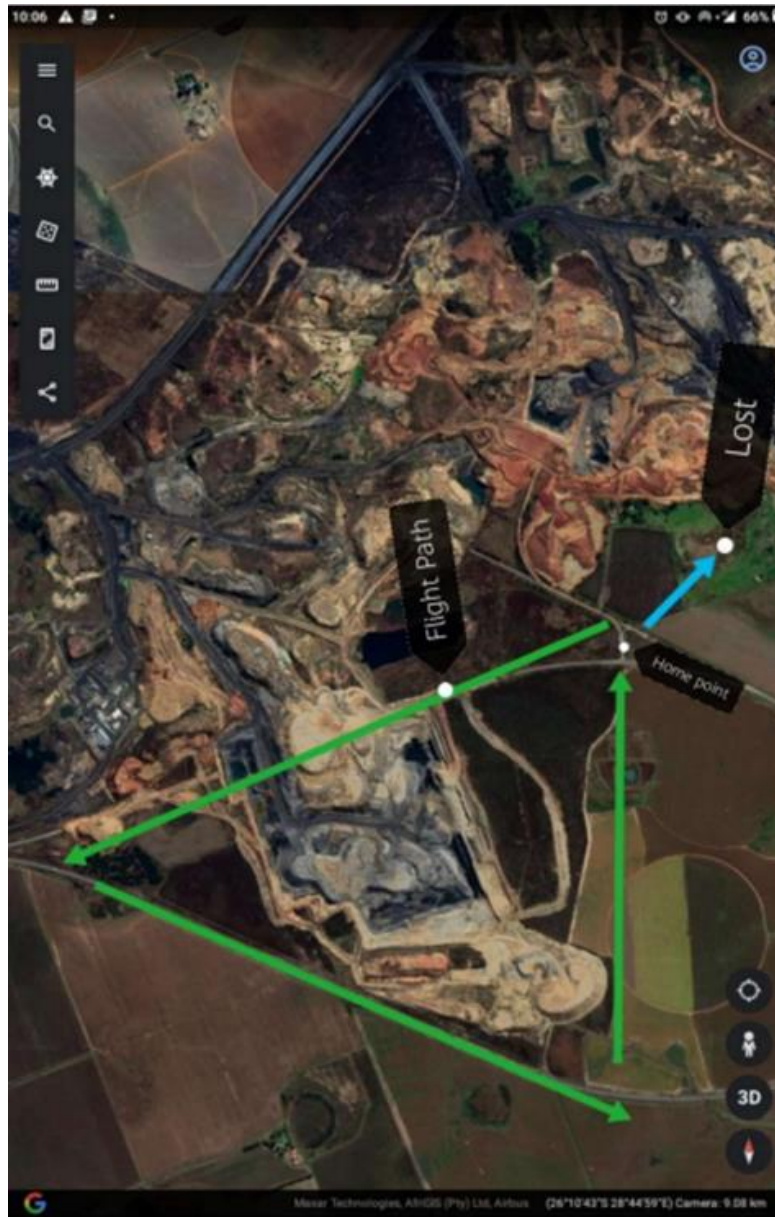
<p>On Tuesday evening, 20 December 2022, a pilot controlling a remotely piloted aircraft (RPA) with registration ZT-YIX was engaged in aerial surveillance operation at Exxaro Leeuwpan Coal Mine in Mpumalanga province. Visual meteorological conditions (VMC) by night prevailed at the time of the flight. The flight was conducted under beyond visual line of sight (BVLOS) rules and under the provisions of Part 101 of the Civil Aviation Regulations (CAR) 2011 as amended.</p> <p>The pilot stated that after conducting pre-flight checks with no anomalies detected, he launched the RPA at 2118Z with 100% battery power available. After approximately 19 minutes into the flight, the RPA headed back to the launch site with a critically low battery indication on the controller unit. The RPA activated an emergency landing (automatically without the pilot's input) approximately 450 metres (m) from the launch site in a wetland; the RPA was not recovered. There were no injuries reported.</p>

Figure 2: The flight path followed by the RPA. (Source: Pilot)
