LIMITED OCCURRENCE INVESTIGATION REPORT – FINAL

Reference Number	CA18/2/3/10264					
Classification	Accident	Date	8 January 2023	Time	2028Z	
Type of Operation	Remotely Piloted Aircraft Systems – Surveillance (Part 101)					
Location						
Place of Departure	Anglo American Mine, Amandelbult, Limpopo Province		Place of Intended Landing	Anglo American Mine, Amandelbult, Limpopo Province		
Place of Occurrence	Anglo American Mine at Dishaba Mine, 61 Holding Section					
GPS Co-ordinates	Latitude	24°43'46.4" S	Longitude	027°23'55" E	Elevation	3145 ft
Aircraft Information						
Registration	ZT-XFN					
Make; Model; S/N	UAV Drone Solutions; Condor (Serial Number: CON0001)					
Damage to Aircraft	Substantial		Total Aircraft Hours	37.40		
Pilot-in-command						
Licence Type	Remote Pilot Licence (RPL)		Gender	Male	Age	26
Licence Valid	Yes	Total Hours	1578.19	Total Hours on Type	11.21	
Total Hours 30 Days	37.35		Total Flying on Type Past 90 Days	11.21		
People On-board	N/A	Injuries	0	Fatalities	0	Other (on ground) 0

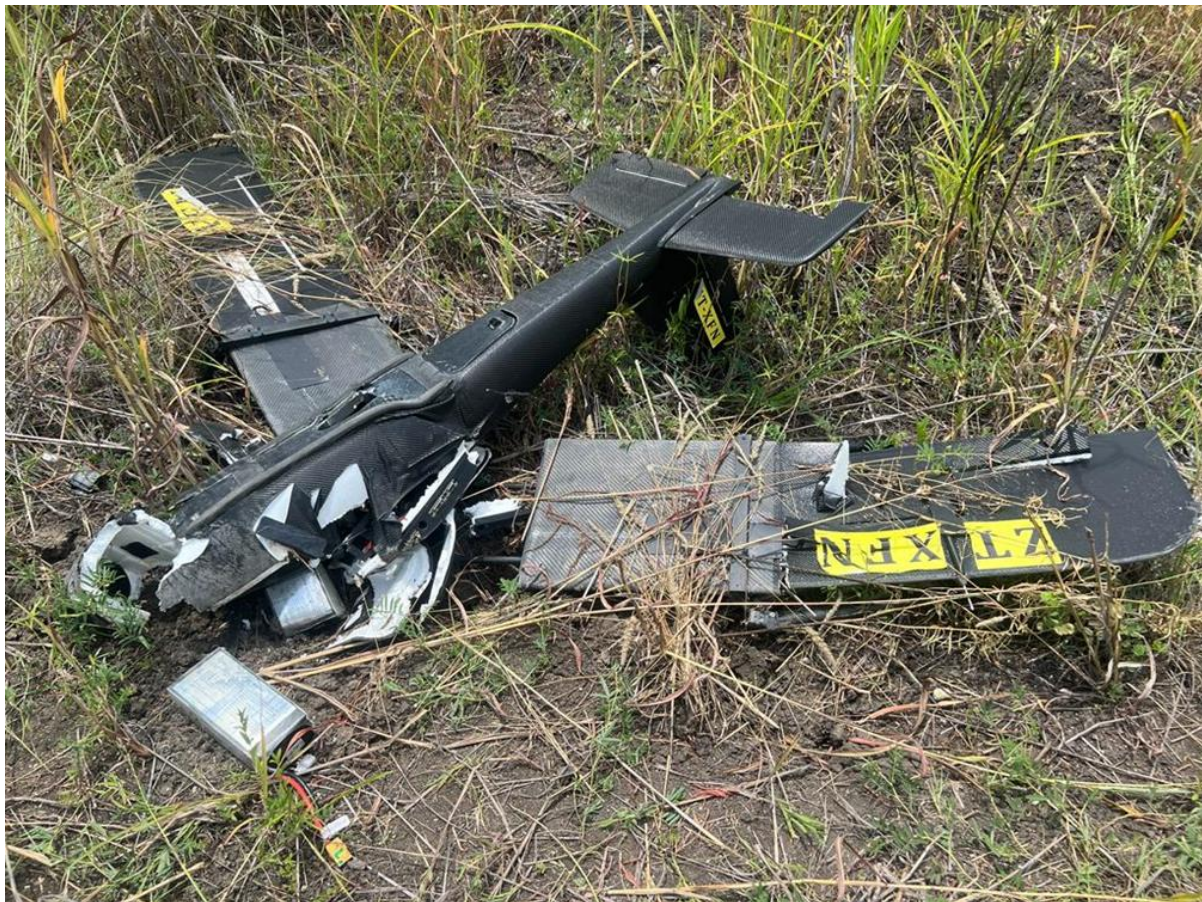
What Happened						
<p>On Sunday evening, 8 January 2023, a remotely piloted aircraft (RPA) with registration ZT-XFN was engaged in an aerial survey operation at Anglo American Mine Amandelbult in Limpopo province. Visual meteorological conditions (VMC) by night prevailed at the time of the flight. The flight was conducted under beyond visual line of sight (BVLOS) rules and under the provisions of Part 101 of the Civil Aviation Regulations (CAR) 2011 as amended.</p> <p>The pilot stated that after conducting the pre-flight checks with no anomalies detected, he launched the RPA with 99% battery power with 2 hours endurance at 2000Z. After approximately 20 minutes into the flight, the RPA became erratic and lost data link from the ground station controller. The pilot engaged the return-to-launch (RTL) function, but the RPA did not return to the launch position.</p> <p>An extensive search was conducted, and the RPA was located 10 days later, approximately 0.3 nautical miles south-west of the launch site with substantial damage to the wings, fuselage and operating equipment. There were no injuries reported.</p>

Figure 2: The RPA at the accident site. (Source: Operator)

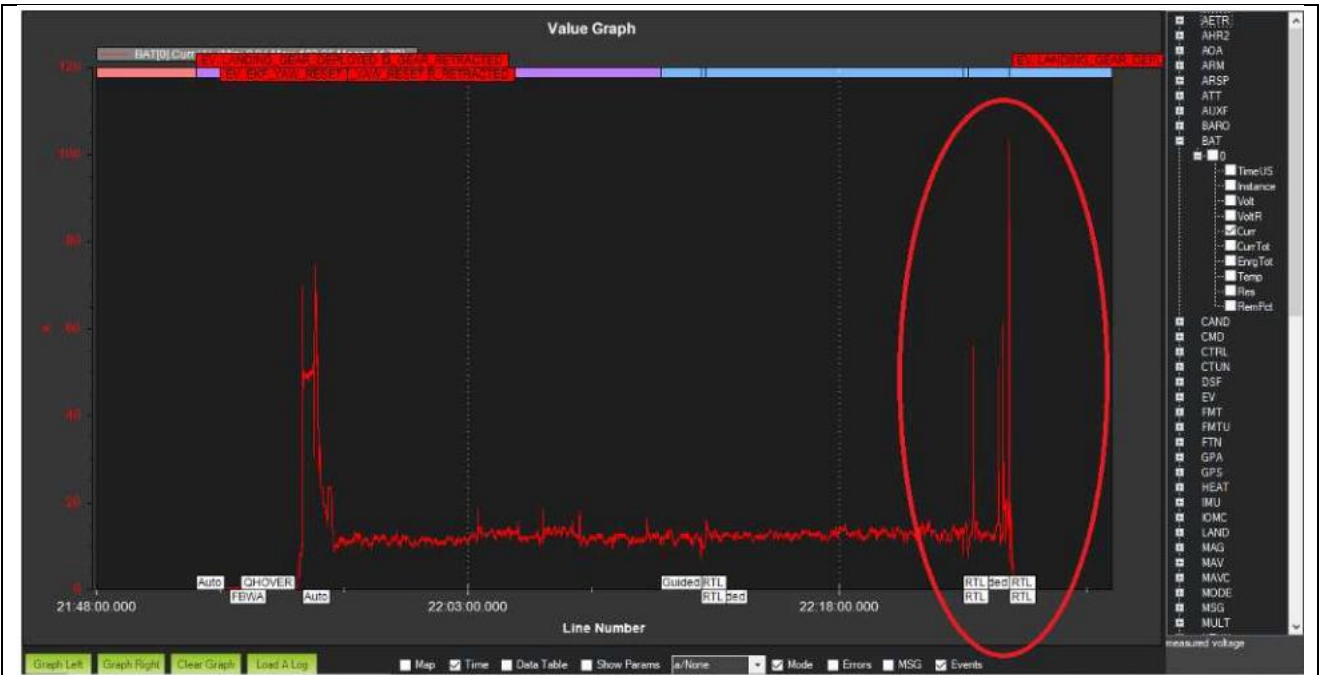
Graph 1: The battery current spikes. (Source: Operator)

5. The flight log graphs showed spikes in battery current which led to the increase in the revolutions per minute (RPM) on the number 1 and 4 motors (RPM). This caused the aircraft to roll about 180° following the failure of the Electronic Speed Controller (ESC). The RPA banked sharply and lost control and altitude before it crashed.

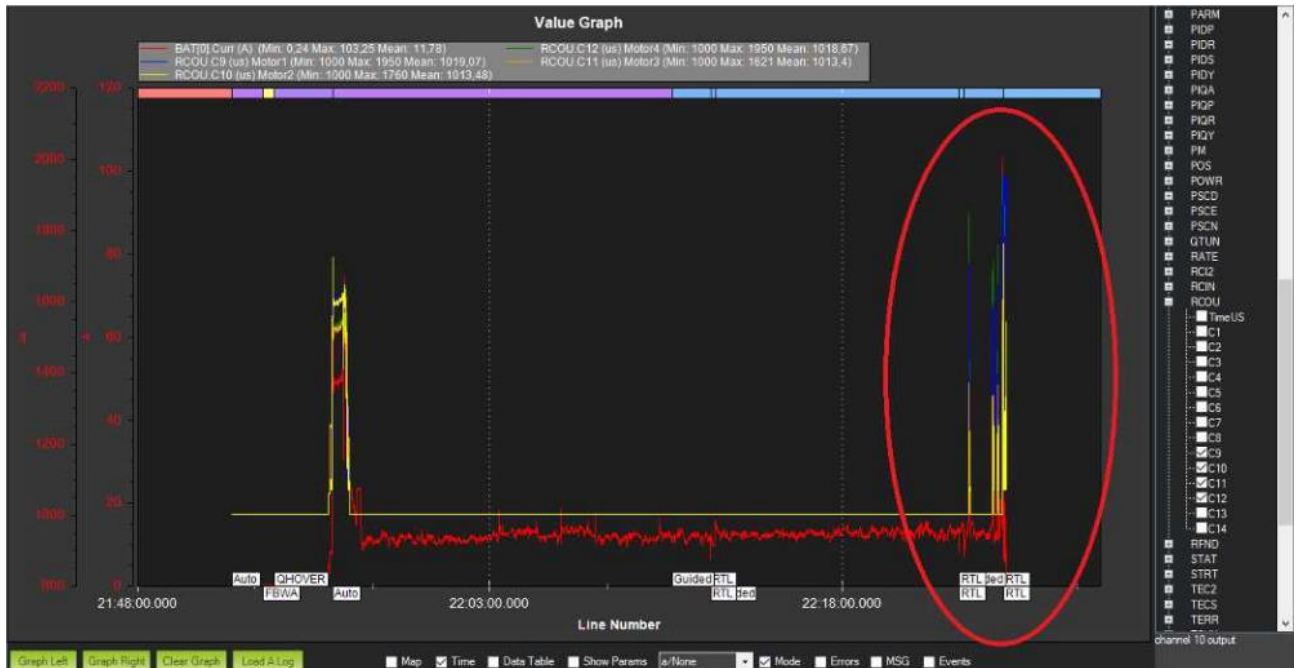
Graph 2: Readings of motor 1 and 4 during the current spikes. (Source: Operator)

Loss of control following the failure of the ESC which caused the RPM to increase to 180° on the number 1 and 4 MR propellers before it rolled and crashed. The cause of battery spikes and ESC failure could not be determined.

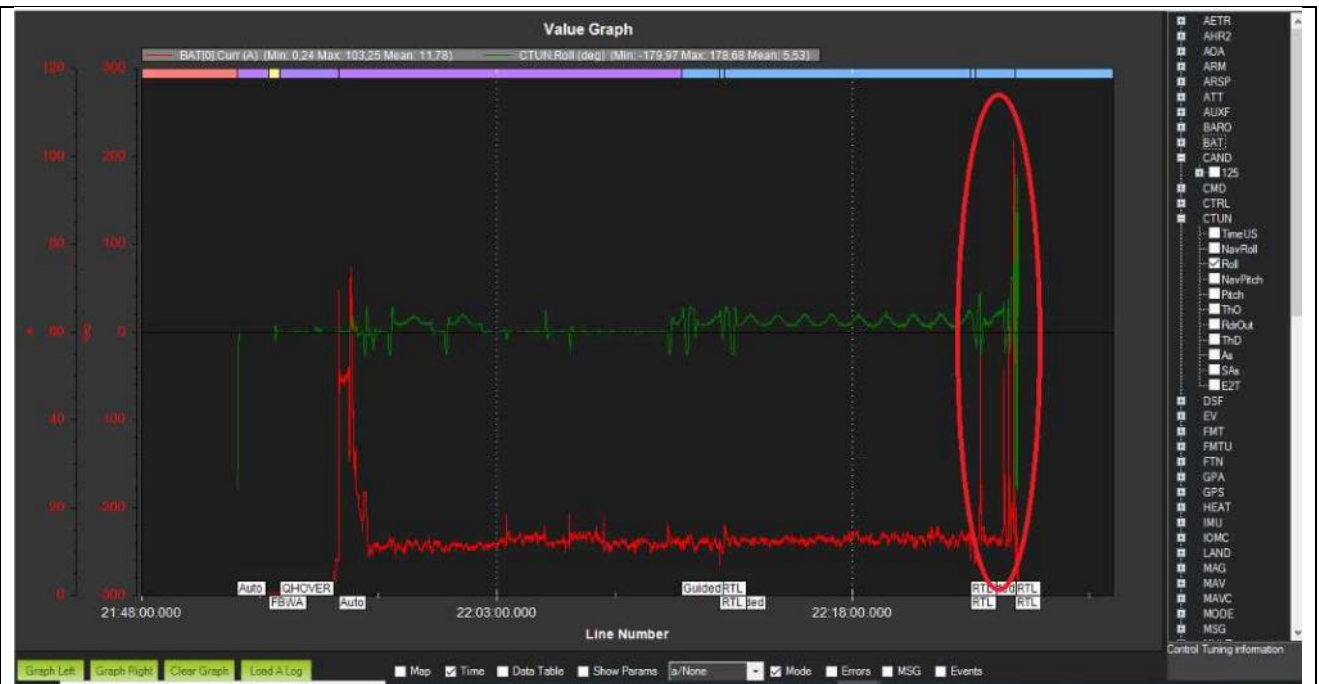
Graph 3:The RPA roll. (Source: Operator)
