AIRCRAFT ACCIDENT REPORT AND EXECUTIVE SUMMARY

Reference:		CA18/2/3/10265	
Aircraft Registration	ZU-TAM	Date of Accident	15 February 2023		Time of Accident	0637Z	
Type of Aircraft	Skyleader 600		Type of Operation		Private (Part 94)		
Pilot-in-command Licence Type	Private Pilot Licence (PPL) Aeroplane		Age	66	Licence Valid	Yes	
Pilot-in-command Flying Experience	Total Flying Hours		1321.9	Hours on Type	Unknown		
Last Point of Departure	Eagle's Creek Airfield, Gauteng Province						
Next Point of Intended Landing	Brakpan Airfield (FABB), Gauteng Province						
Damage to Aircraft	Destroyed						
Location of the accident site with reference to easily defined geographical points (GPS readings if possible)							
At 314m from the threshold of Runway 26 at Eagle's Creek Aviation Airfield in Centurion; GPS co-ordinates 25°54'14.67"S 28° 2'30.59"E at an elevation of 4620.8 feet (ft)							
Meteorological Information	Surface wind: 190°/03; Visibility: 10km; Temperature: 19°C; Dew point: 18°C; Clouds: FEW; Cloud Base: 1500 feet; QNH: 1018

Reference Number : CA18/2/3/10265
Occurrence Category : Accident
Type of Operation : Private (Part 94)
Name of Operator : Betts Townsend Aviation (PTY) LT

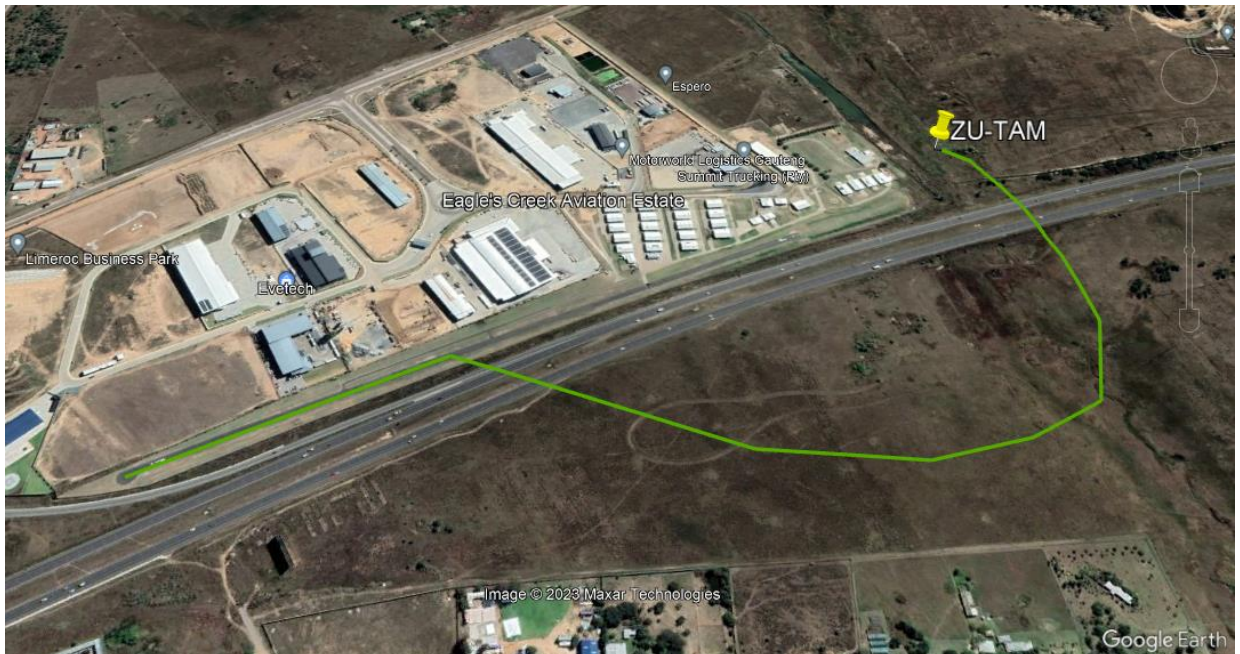
Figure 1: The green line depicts the path that was followed by ZU-TAM. (Source Google Earth)

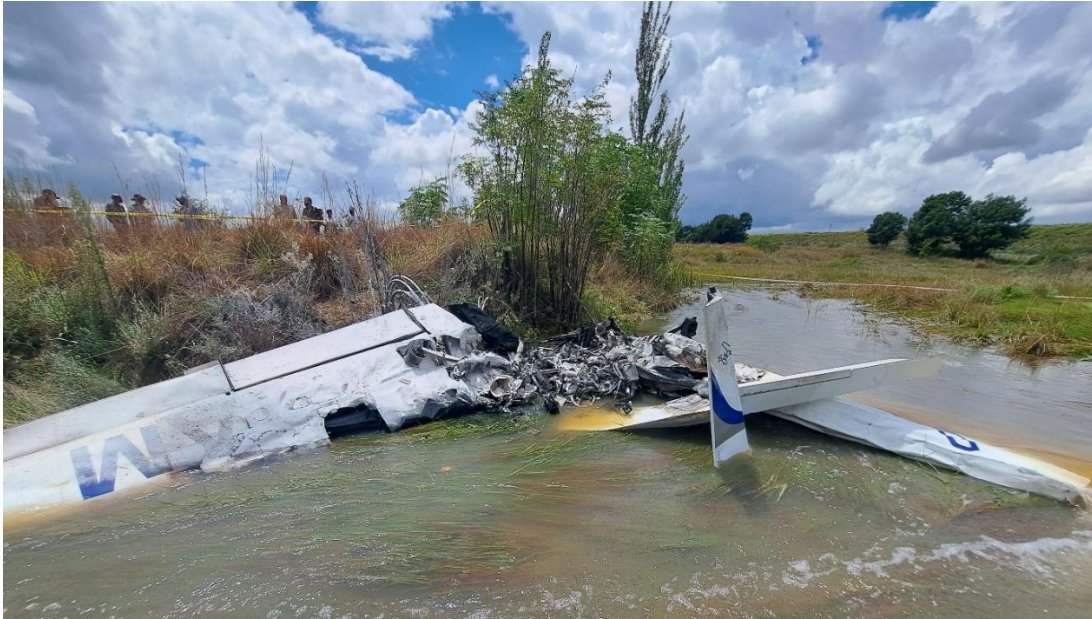
Figure 2: Moments after the fire was extinguished.

1.3.1. The aircraft was destroyed by impact and a post-impact fire.

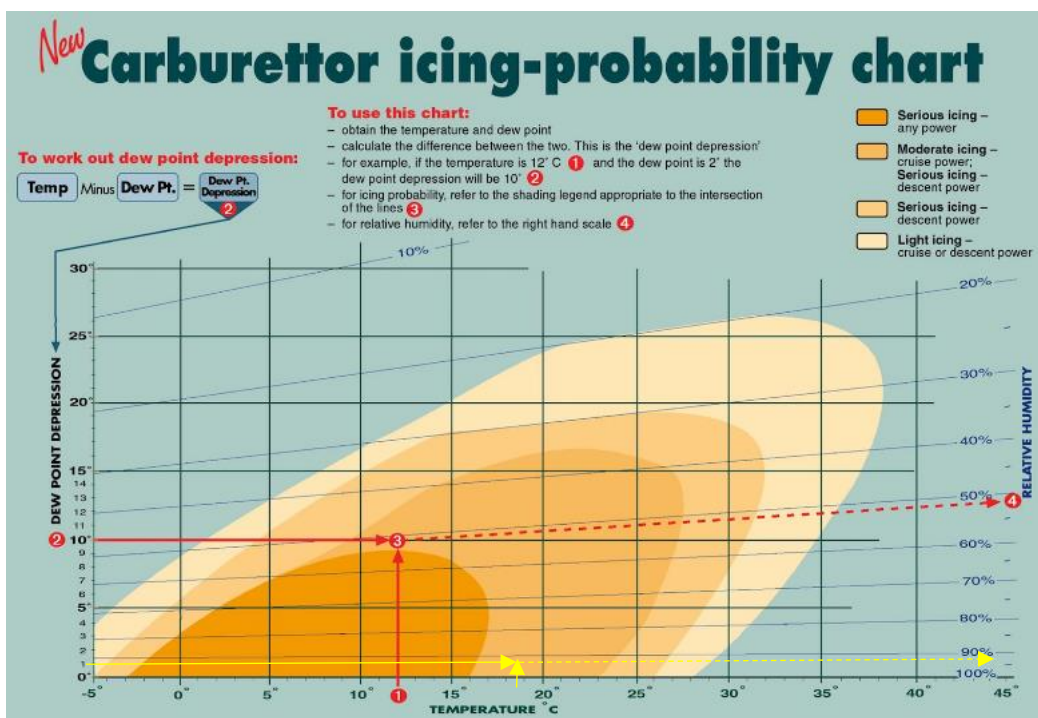
1.7.2. The carburettor icing chart above indicates a 92% relative humidity with dew point depreciation at 1°C and temperature at 19°C. This would place the engine or carburettor at risk of moderate icing on cruise power (serious icing descent power setting).

- 2.2.3 The calculation on the carburettor icing chart indicated a 92% relative humidity with dew point depreciation at 1°C and the temperature at 19°C. This places the engine or carburettor at a risk of moderate icing on cruise power (serious icing descent power setting). In addition, the calculated carburettor icing would lead to engine power loss, hence, the pilot's decision to return to the departure runway.

4.2.1. Pilots are advised to conduct proper flight planning prior to undertaking any flight. In their planning, pilots are to ensure correct interpretation of the weather report.

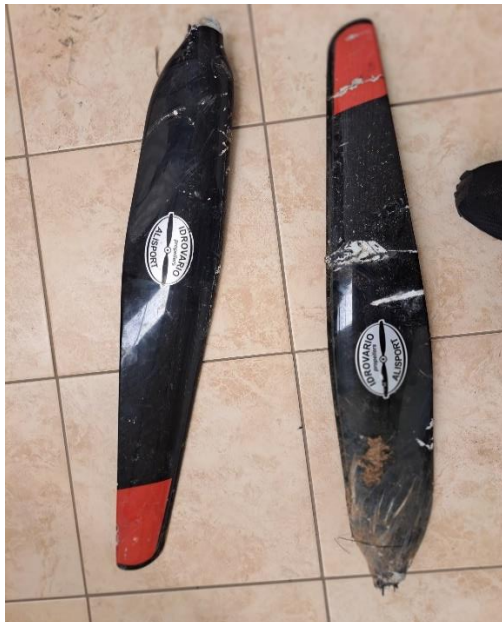
Figure 3: The damaged propellers.

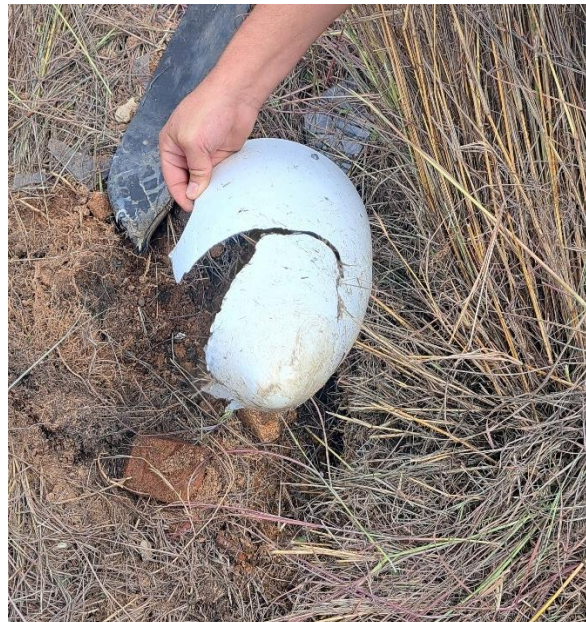
Figure 4: The cracked aircraft spinner.

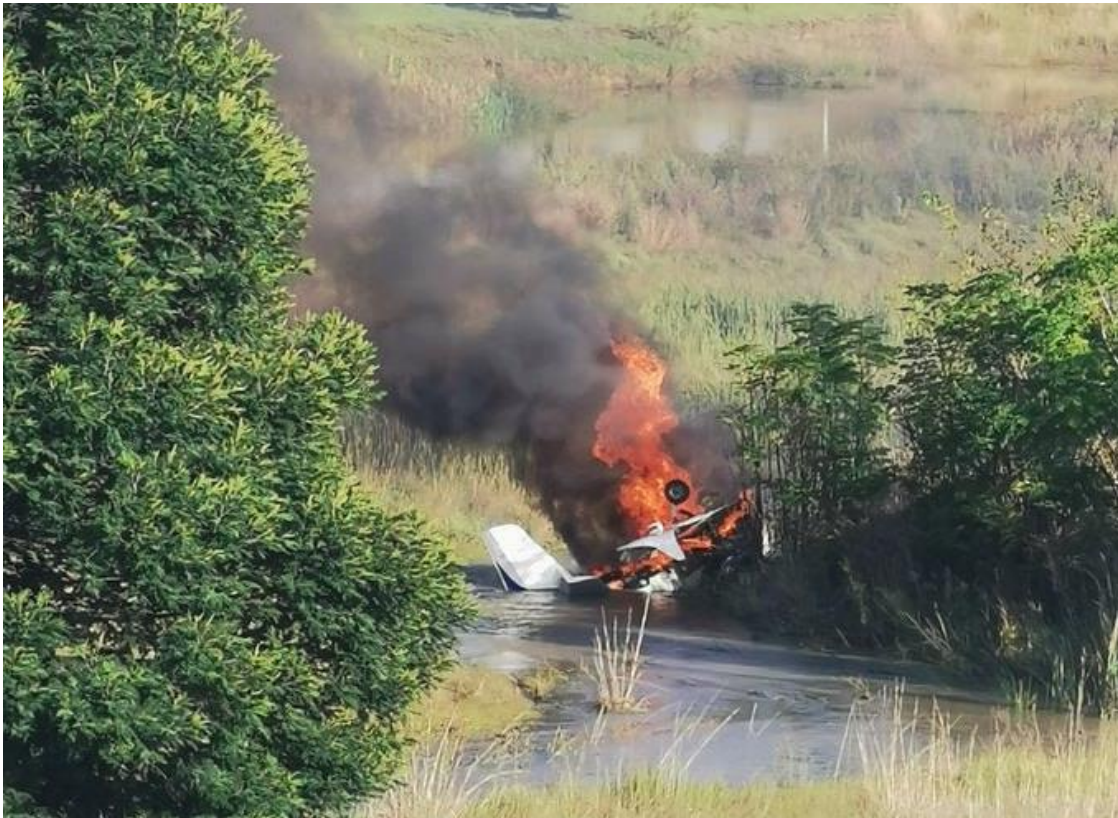
Figure 7: The aircraft burst into flames immediately after impact. (Source: On-call-investigator)

1.14.1 The aircraft burst into flames moments after impacting the ground. The fire was extinguished by the running water as it sank.

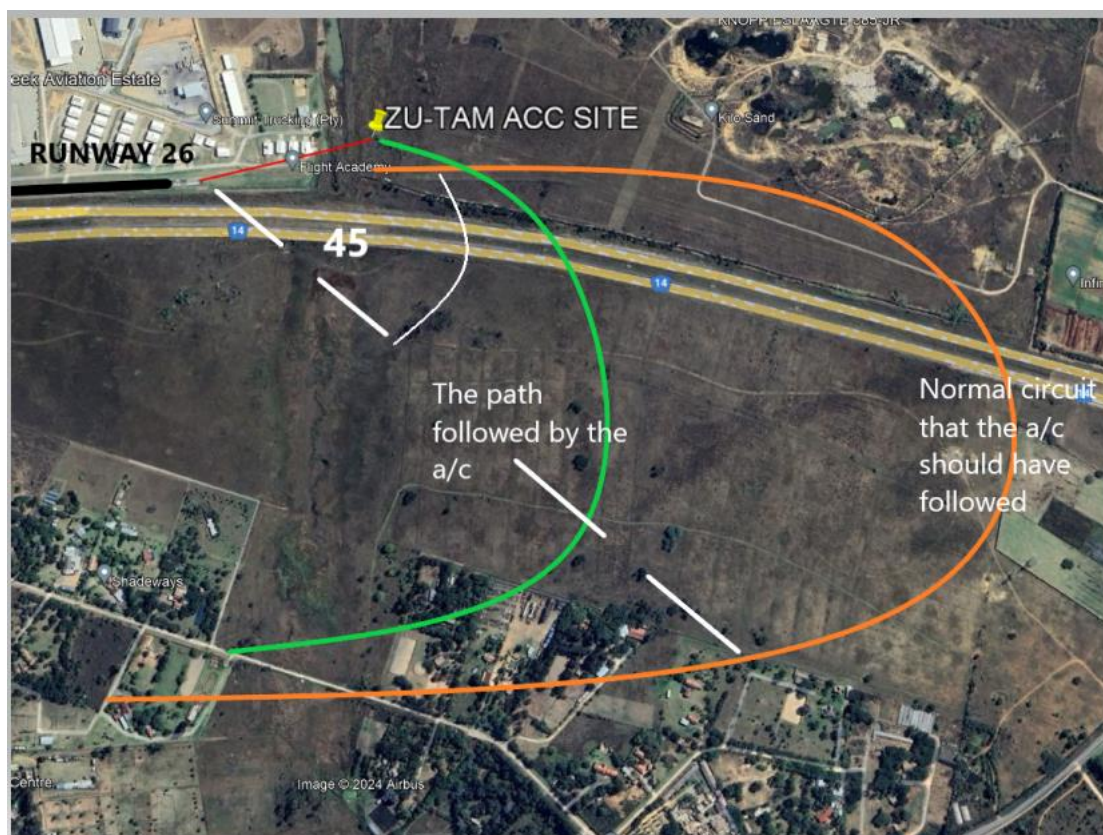
Figure 11: The orange line depicts an approximate circuit that ZU-TAM should have followed using the white dotted line that is at 45° from the threshold of Runway 26. The green line is the approximated path followed by ZU-TAM. The accident site is 297m (red line) from the threshold of RWY 26.
(Source: Google Earth)

- 2.2.4 After getting airborne and making a slight right turn (Figure 11), the aircraft turned left and did not follow a normal circuit. This meant that there was a problem or performance issues which prompted the pilot to shorten the circuit. In terms of landing direction, Runway 26 is the preferred runway at Eagle's Creek Airfield. The witness stated that he saw the aircraft make a tight left turn and in the final manoeuvre, the right-side wing dropped excessively and, thereafter, the aircraft impacted the ground and bursts into flames.

3.2.9 The pilot followed Eagle's Creek Aviation Airfield recommendations which states: *land uphill RWY 26; take-off RWY 08, wind permitting*. However, the aircraft's final two turns of the circuit were short, which resulted in overbanking and loss of control.
