LIMITED OCCURRENCE INVESTIGATION REPORT – FINAL

Reference Number	CA18/2/3/10266						
Classification	Accident	Date	13 February 2023		Time	0525Z	
Type of Operation	Private (Part 94)						
Location							
Place of Departure	Paradise Beach Aerodrome (FAPX), Eastern Cape Province		Place of Intended Landing		Paradise Beach Aerodrome (FAPX), Eastern Cape Province		
Place of Occurrence	Runway 26 Paradise Beach Aerodrome (FAPX), Eastern Cape Province						
GPS Co-ordinates	Latitude	34° 06' 08.22" S	Longitude	024° 52' 56.77" E	Elevation	15ft	
Aircraft Information							
Registration	ZU-COD						
Make; Model; S/N	Windlass Aquilla Trike (Serial Number: WA 936)						
Damage to Aircraft	Substantial			Total Aircraft Hours	482.2		
Pilot-in-command							
Licence Type	National Pilot Licence (NPL)		Gender	Male		Age	62
Licence Valid	Yes	Total Hours	29.54		Total Hours on Type	29.54	
Total Hours 30 Days	5.6		Total Flying on Type Past 90 Days		14.7		
People On-board	1+1	Injuries	1	Fatalities	0	Other (on ground)	0

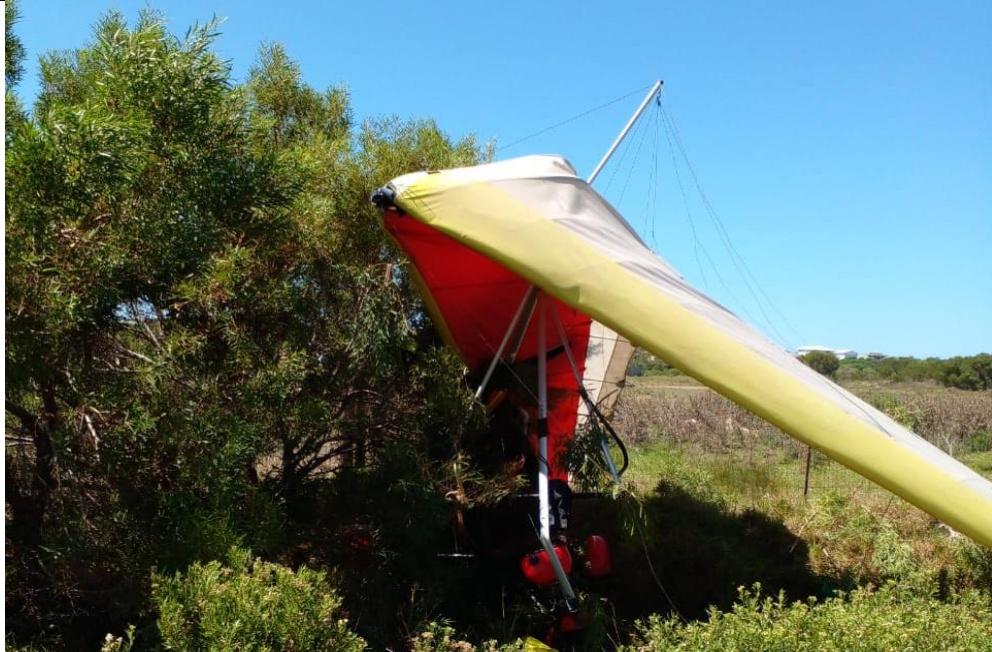
came to a stop. The pilot switched off the engine and disembarked from the microlight. The pilot sustained injury to his right ear, and the passenger was not injured. The aircraft's undercarriage, aft wing beam, instrument pod, engine propeller blades and the fabric on the left-wing were damaged.

Figure 2: The final resting position of the microlight. (Source: Pilot)

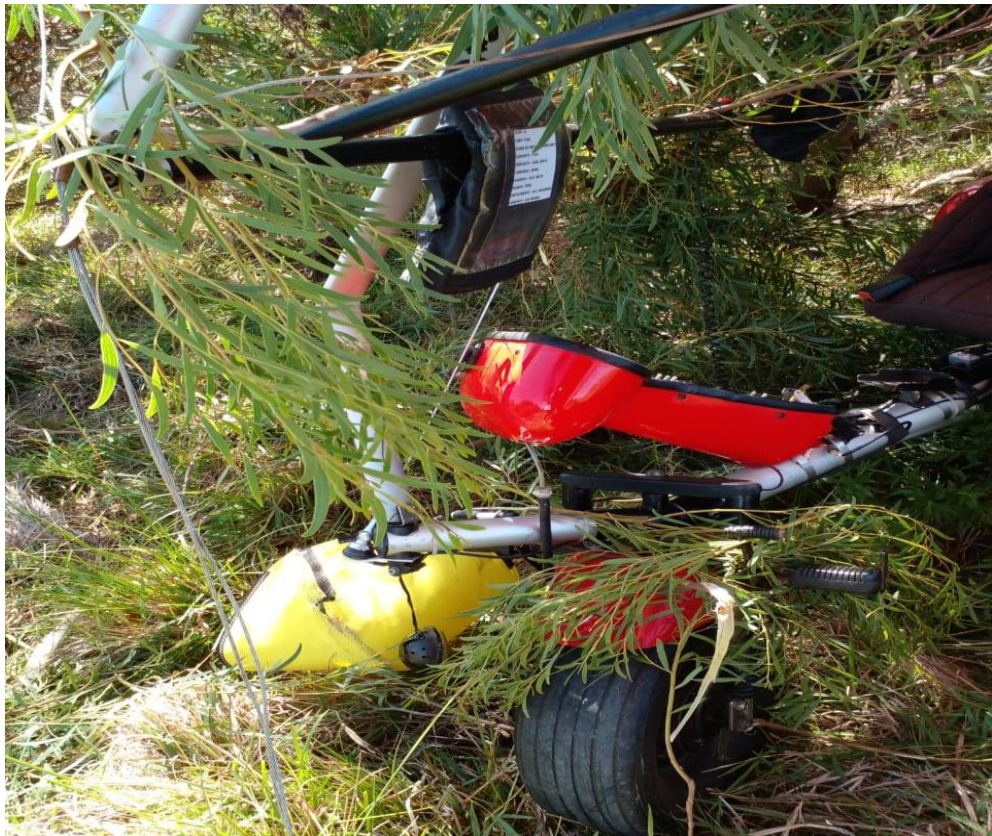
Figure 3: The damaged instrument pod and nose gear. (Source: Pilot)
