LIMITED OCCURRENCE INVESTIGATION REPORT – FINAL

Reference Number	CA18/2/3/10267						
Classification	Accident	Date	11 January 2023		Time	2052Z	
Type of Operation	Remotely Piloted Aircraft System – Surveillance (Part 101)						
Location							
Place of Departure	Transnet, Camperdown, KwaZulu-Natal Province		Place of Intended Landing	Transnet, Camperdown, KwaZulu-Natal Province			
Place of Occurrence	Transnet grounds in Camperdown, KwaZulu-Natal Province						
GPS Co-ordinates	Latitude	29° 43' 8.51" S	Longitude	30° 29' 37.14" E	Elevation	2713 ft	
Aircraft Information							
Registration	ZT-XOM						
Make; Model; S/N	UAV & Drone Solutions; Condor (Serial Number: CON0009)						
Damage to Aircraft	Substantial			Total Aircraft Hours	1.5		
Pilot-in-command							
Licence Type	Remote Pilot Licence (RPL)		Gender	Male		Age	28
Licence Valid	Yes	Total Hours	3052.4		Total Hours on Type	0.25	
Total Hours Past 90 Days	112.2		Total Flying Past 90 Days on Type	0.25

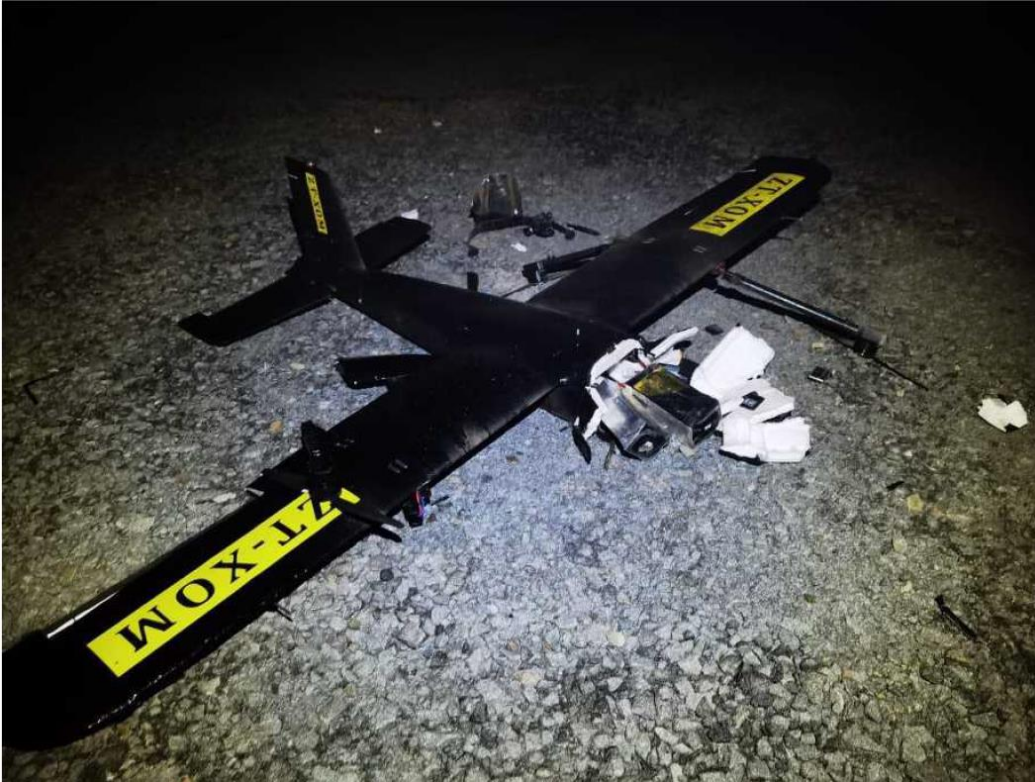
People Controlling	1	Injuries	0	Fatalities	0	Other (on ground)	0
What Happened							
<p>On 11 January 2023, a remotely piloted aircraft (RPA) with registration ZT-XOM was engaged in a surveillance flight at a Transnet facility in Camperdown, KwaZulu-Natal province. Visual meteorological conditions (VMC) by night prevailed at the time of the flight which was conducted under beyond visual line of sight (BVLOS) rules and under the provisions of Part 101 of the Civil Aviation Regulations (CAR) 2011 as amended.</p> <p>The pilot reported that he configured the RPA for the first flight of the night and, thereafter, conducted a pre-flight inspection and created a waypoint. He then selected the vertical take-off and landing (VTOL) mode on the RPA unit controller and launched it. The RPA climbed to 145 feet (ft) above ground level (AGL). Twenty three (23) seconds later and approximately 2 metres (m) north of the pilot's position, the RPA motors (throttle) disarmed, and the RPA descended uncontrollably to the ground and crashed.</p> <p>The RPA sustained substantial damage; there was no reported injury to persons or damage to property.</p>

Figure 1: The RPA at the accident site. (Source: Operator)

The throttle was inadvertently disarmed shortly after take-off and the RPA descended uncontrollably to the ground.
