LIMITED OCCURRENCE INVESTIGATION REPORT – FINAL

Reference Number	CA18/2/3/10268						
Classification	Accident	Date	24 February 2023	Time	2157Z		
Type of Operation	Remotely Piloted Aircraft System – Surveillance (Part 101)						
Location							
Place of Departure	Pullens Hope, Mpumalanga Province		Place of Intended Landing	Pullens Hope, Mpumalanga Province			
Place of Occurrence	Hendrina Power Station, Mpumalanga Province						
GPS Co-ordinates	Latitude	26° 1'37.58"S	Longitude	29°36'12.00"E	Elevation	5235.2ft	
Aircraft Information							
Registration	ZT-XXN						
Make; Model; S/N	Arace Sirin (Serial number: SIR 0078)						
Damage to Aircraft	Substantial		Total Aircraft Hours	365.51			
Pilot-in-command							
Licence Type	Remote Pilot Licence (RPL)		Gender	Male	Age	23	
Licence Valid	Yes	Total Hours	670.27	Total Hours on Type	667.35		
Total Hours Past 30 days	63.14		Total Hours on Type Past 90 days	155.32			
People Controlling	1	Injuries	0	Fatalities	0	Other (on ground)	0

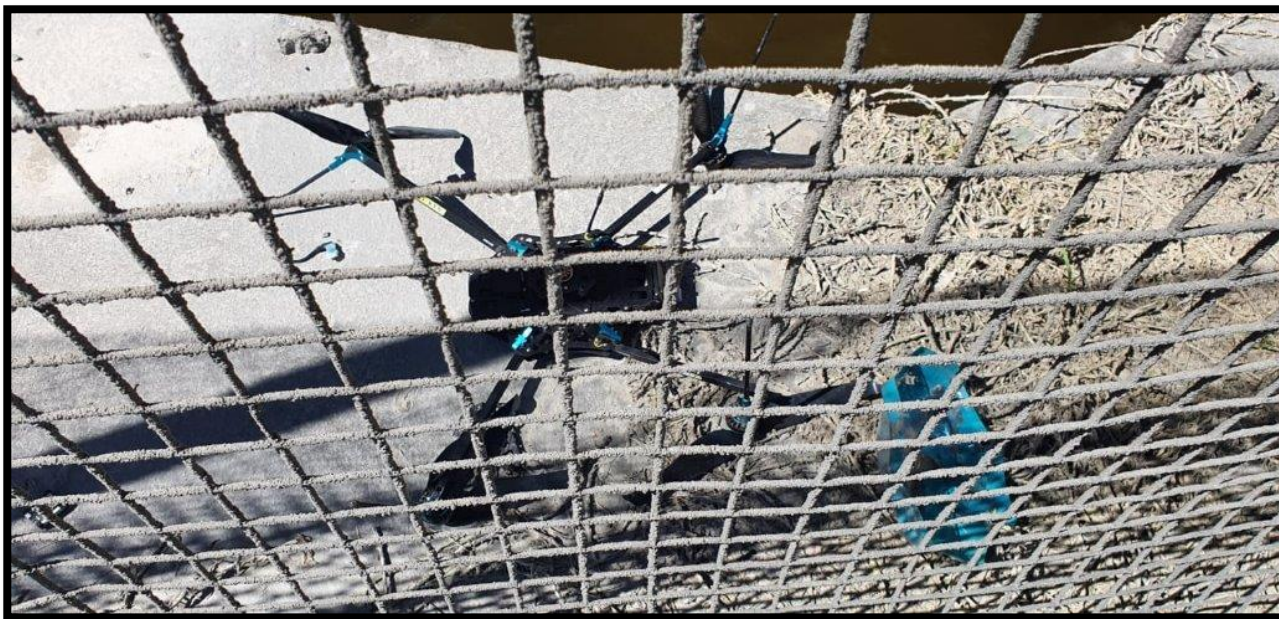
tower is 116m (371 ft) and the base diameter is 80 metres (m) (256 ft). The RPA sustained substantial damage. No injuries were reported during this accident.

Figure 1: ZT-XXN at the accident site. (Source: Operator)

Findings
<ol style="list-style-type: none"> 1. The pilot was issued a Remote Pilot Licence (RPL) with a beyond visual line of sight (BVLOS) rating on 21 December 2021, valid until 31 December 2023. His Class 3 medical certificate was issued on 4 December 2021 with an expiry date of 4 December 2023 and with distant vision correction eyewear restriction. 2. The Mandatory Periodic Inspection (MPI) carried out on the RPA prior to the accident was conducted on 9 December 2022 at 354.19 airframe hours. The RPA operated a further 11.40 hours after the inspection. The next MPI was due at 429.19 airframe hours. 3. The RPA was issued a Remotely Piloted Aircraft Systems Letter of Approval (RLA) on 12 April 2022 with an expiry date of 11 April 2023. 4. As per the pilot questionnaire, the weather was as follows: surface wind, north-westerly at 3 to 5 knots; temperature, 19°C; clouds, few (no level mentioned); visibility, greater than 10km. 5. The operator was issued an RPAS Operating Certificate (ROC) with an endorsement of Part 101 by the Regulator (SACAA) on 31 October 2022 with an expiry date of 31 October 2023. 6. The operator found that the pilot erred because he flew the RPA behind the cooling towers and, thus, it disconnected and switched to return-to-launch mode (RTL). The RTL flight is programmed to take a straight line back to launch location. In this instance, the RPA's RTL flight path cut through the cooling tower to reach launch location. The RTL altitude was set to 93.7m (300 feet), this caused the RPA to collide with the cooling tower.

Probable Cause
The RPA lost signal with the controller unit as it was flown behind the cooling towers which resulted in the RPA engaging a RTL mode; however, the programmed straight line RTL path cut through the cooling towers, and this led to the impact.
Contributing Factors
The RPA's flight path followed the railway line which curved behind the cooling towers, this led to the RPA engaging an RTL mode after losing signal, and thus, the subsequent impact with the tower.
Safety Action
None.
Safety Message and/or Safety Recommendation/s
None.
About this Report
<i>The decision to conduct a limited investigation is based on factors including whether the cause is known and the evidence supporting the cause is clear, the level of safety benefit likely to be obtained from an investigation</i>

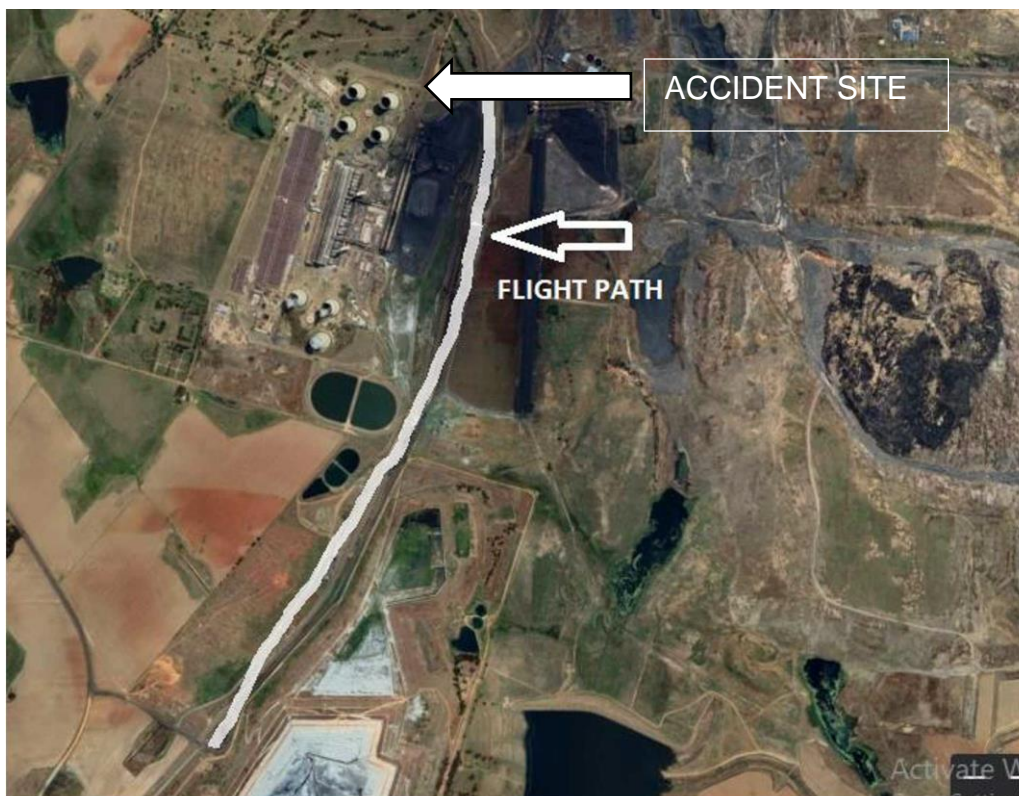
Figure 2: Aerial view of the accident site. The RPAS was flying in a northerly direction.
(Source: Google Earth)
