**LIMITED OCCURRENCE INVESTIGATION REPORT – FINAL**

<b>Reference Number</b>	CA18/2/3/10269					
<b>Classification</b>	Accident	<b>Date</b>	20 February 2023		<b>Time</b>	2310Z
<b>Type of Operation</b>	Remotely Piloted Aircraft System – Surveillance (Part 101)					
<b>Location</b>						
<b>Place of Departure</b>	Wolverdiend Pump Station, Springbok, Mpumalanga Province		<b>Place of Intended Landing</b>		Wolverdiend Pump Station, Springbok, Mpumalanga Province	
<b>Place of Occurrence</b>	Mining area at Wolverdiend Pump Station, Springbok, Mpumalanga Province					
<b>GPS Co-ordinates</b>	<b>Latitude</b>	26° 02' 39" S	<b>Longitude</b>	29° 24' 45" E	<b>Elevation</b>	5 246 ft
<b>Aircraft Information</b>						
<b>Registration</b>	ZT-YIT					
<b>Make; Model; S/N</b>	DJI, Mavic 2 Enterprise Advanced (Serial Number: MAV130)					
<b>Damage to Aircraft</b>	Unknown (Missing)		<b>Total Aircraft Hours</b>	221.25		
<b>Pilot-in-command</b>						
<b>Licence Type</b>	Remote Pilot Licence (RPL)		<b>Gender</b>	Male		<b>Age</b> 21

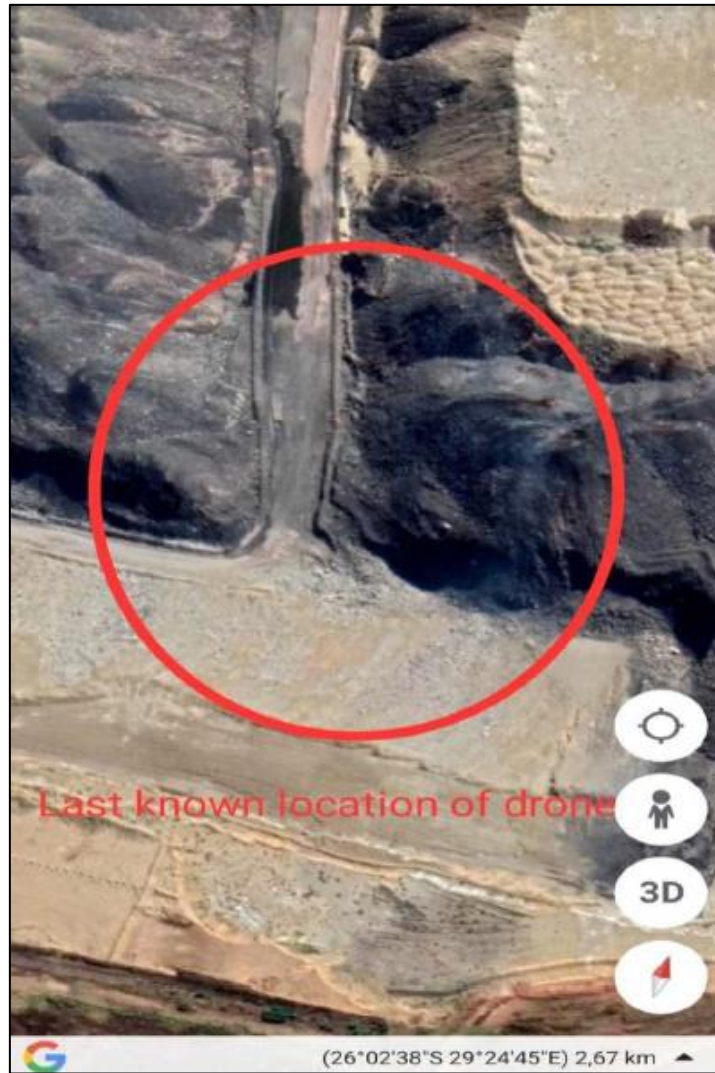
**Figure 1:** Red circle indicates the last recorded location of ZT-YIT RPA using Google Earth. (Source: Operator)

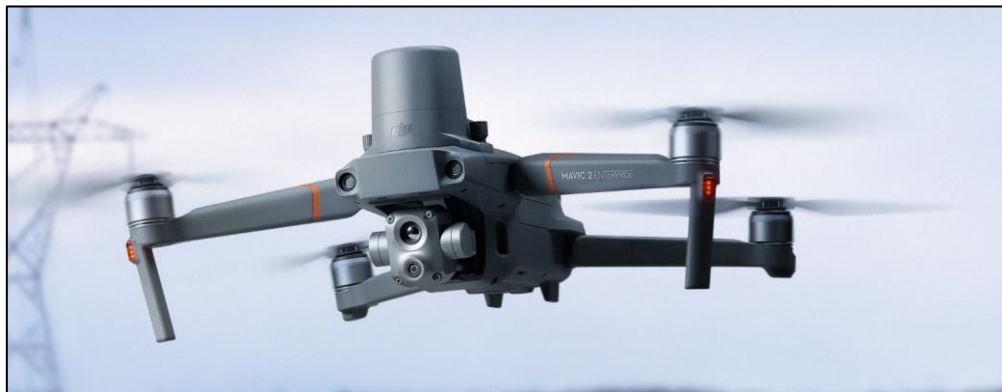
**Figure 2:** The DJI Mavic 2 Enterprise Advanced RPA type similar to the lost ZT-YIT. (Source: <https://www.dji.com/mavic-2-enterprise-advanced>)
